# Inner Forth Landscape Initiative: Evaluation Excavations at Valleyfield Stables Data Structure Report

# **Inner Forth Landscape Initiative: Archaeological Investigations Valleyfield Stables Data Structure Report**

**On Behalf of: Inner Forth Landscape Initiative**

**AOC Project No: 60079**

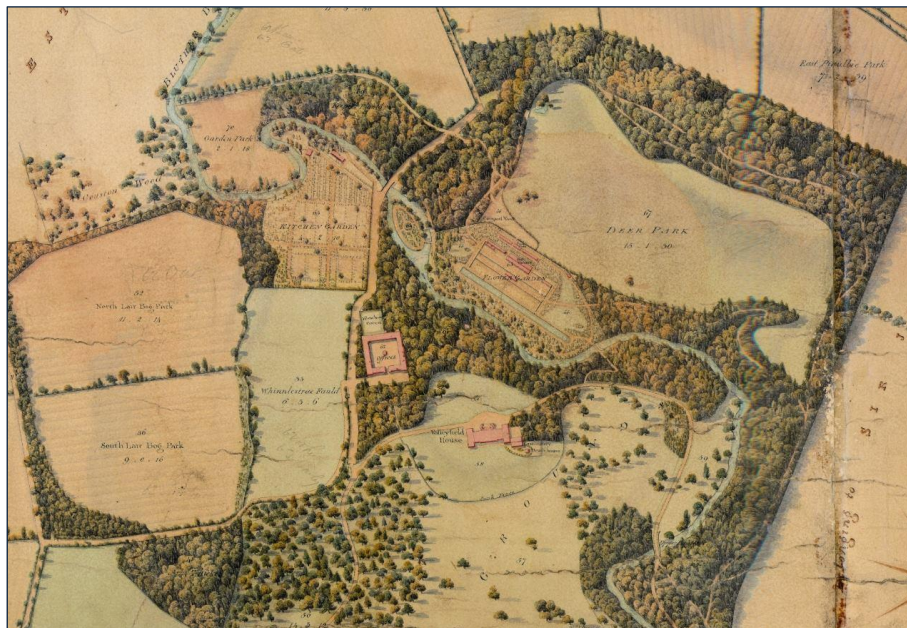
Plate 1: Estate plan of 1810 showing house and stables.

An estate plan of 1810 (Plate 1) clearly shows the stable building although on the plan it is labelled as 'offices'. The stable/office block forms a quadrangle with a central feature and a bleaching green

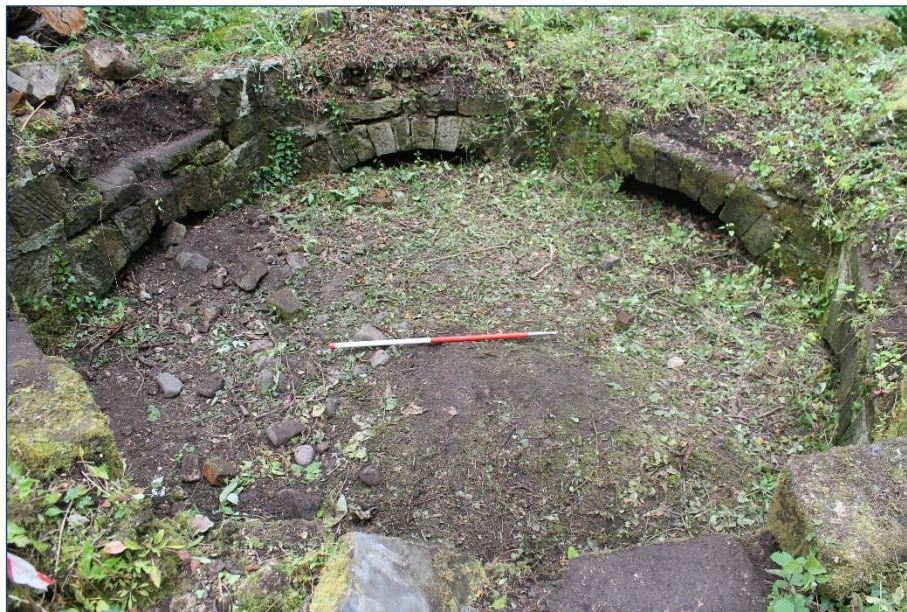
Prior to the survey the central stone doocot or fountain had been partially cleared of demolition rubble. This structure was hexagonal, measuring 5.1m externally and 4.1m internally. The interior of the structure comprised a series of arches, one on each of the six sides.

Plate 3: Central stone feature showing arches.

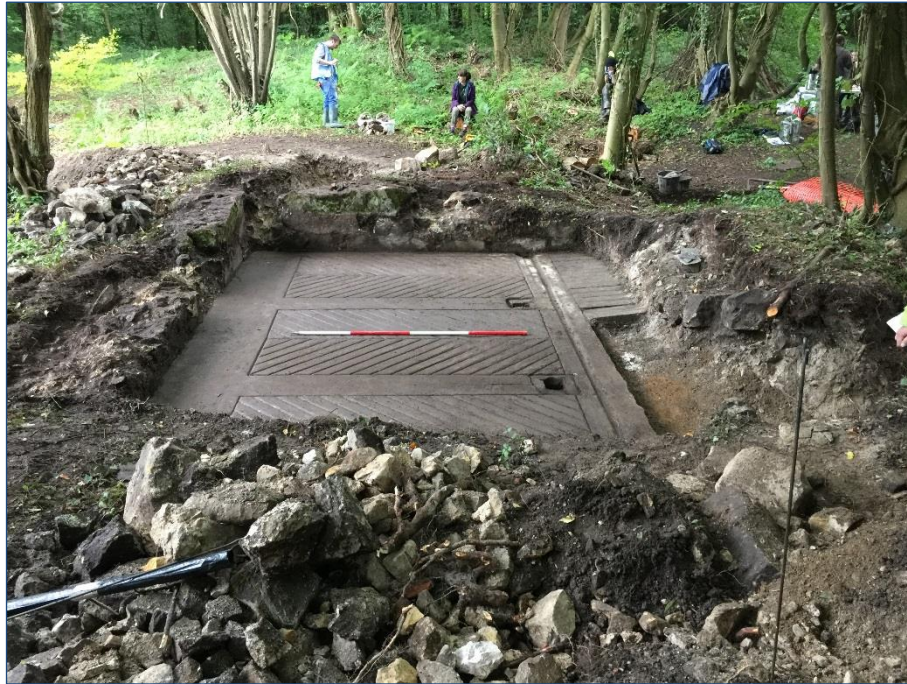
The walls of the building [103, 104, 105] comprised two facing courses of well dressed and squared limestone blocks with a rubble core all bonded with a pale grey sandy lime mortar. Within the interior of the building there was a concrete floor [106] with a repeating chevron pattern impressed on its surface. Within the floor there were two post-settings for square posts [115 & 116], these along with the chevron pattern impressed on the floor demarcated a separation between individual stalls within the stable block. The floor sloped gently from the NW providing drainage to the horse stalls, running across the centre of the floor was a drainage channel [117], this also appeared to form one end of the horse stalls. Beyond the drainage channel there was a rectangular pattern impressed on the floor, this area appears to have been a corridor to and from the horse stalls. On the SW wall of the stable block [105] there was an iron door fitting [107] in line with one of the post settings [115]. This appears to have been a hinge for a door or gate to block the corridor level with the stalls.

Plate 3: Trench 1 showing impressed patterns on floor demarcating individual horse stalls along with post-settings [115] & [116] and drain [117], from SW.

Trench 1 was excavated over the remains of the main building of the Valleyfield stables and this has shown that a well-preserved series of remains relating to the use of the building for stabling of horses is preserved below the demolition rubble. Here the impressed concrete floor and associated post settings demarcated the stalls for individual horses. Associated remains such as gate fittings and drainage features survive in the walls and floor of the stables.

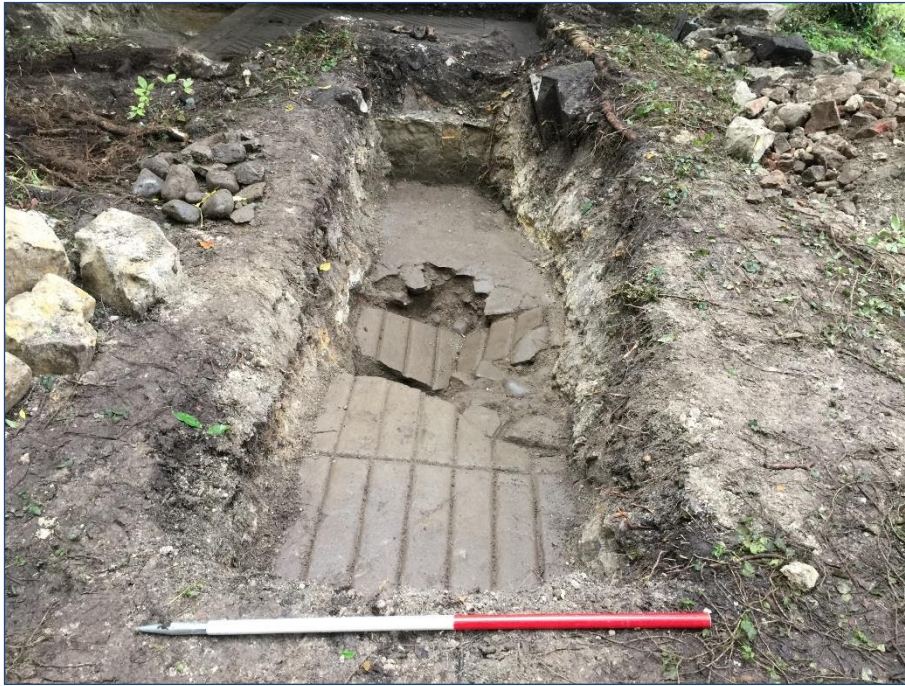
Two extensions to trench 1 (trenches 1a & b) were excavated to investigate the entrance and passage into the courtyard of the stables. Trench 1a extended across one of the walls [104] of the stables and into the entrance passage of the stable block. Removal of topsoil (101) and demolition rubble (102) exposed a concrete floor [108] impressed with a rectangular pattern. Set into the concrete floor at the NW corner of the trench was a cast iron drain cover [111]. Extending across the concrete floor [108] of the entrance passage was a linear cut [109] oriented NW – SE. This was capped by a layer of rough cobbling (110).

Plate 4: Trench 1a showing patterned concrete floor [108] with drain [111] and cut [109], from NE.

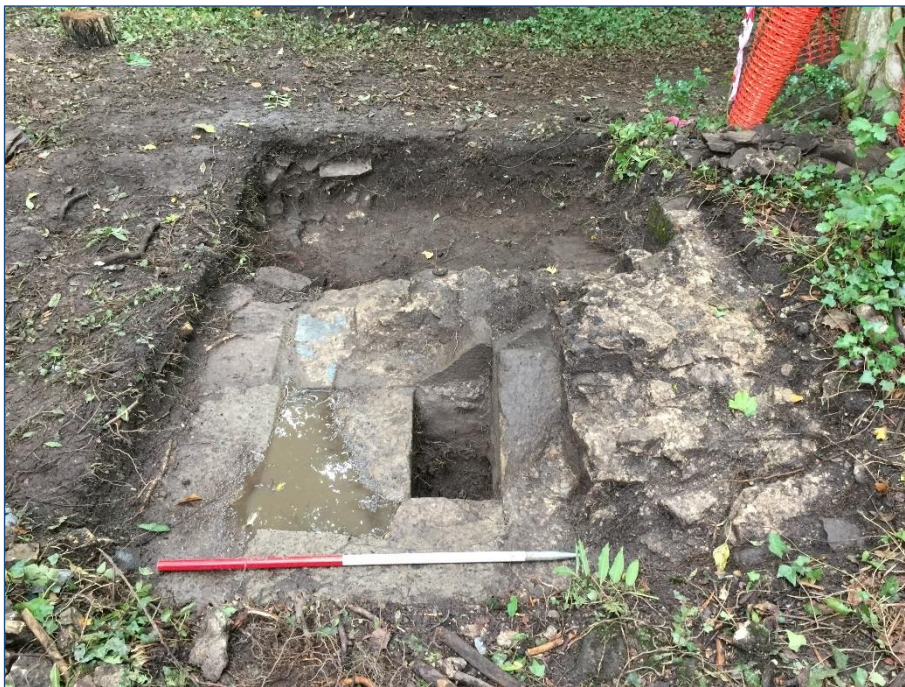
Trench 1b investigated the outside of the entrance passageway. Removal of topsoil (101) and demolition rubble (102) exposed the continuation of wall [104] extending NW-SE along with a buttress [114]. At the junction of walls [104] & [114] there was a rectangular post setting [113], this appears to have been the gate post for outer gates of the stable block. The entrance passage was again surfaced with a concrete floor [112].

Plate 5: Trench 1b showing walls [104] and [114] with post setting [113] at junction, from NW.

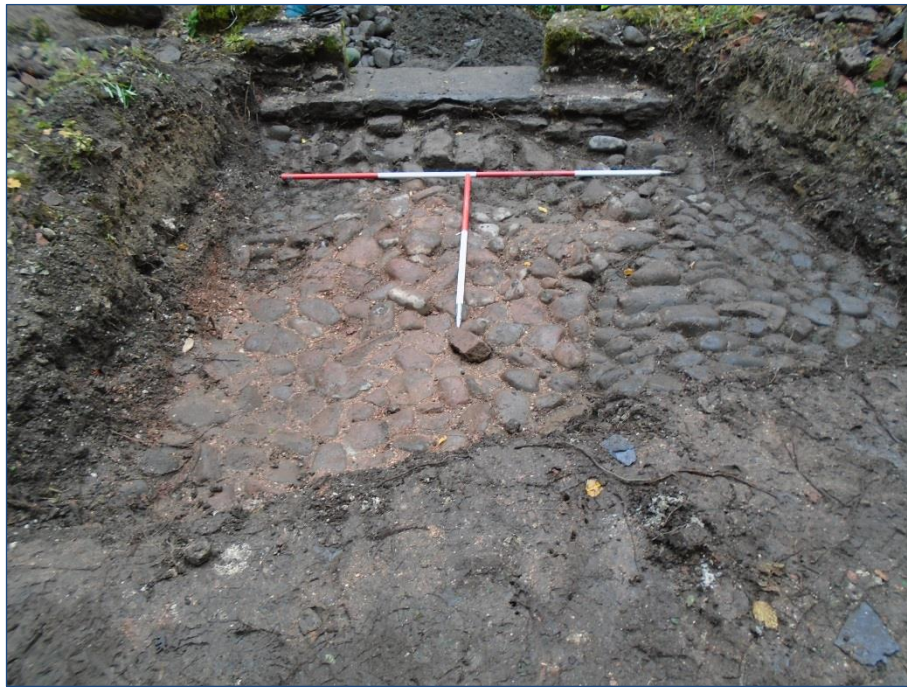
Plate 6: Trench 2 showing cobble surface [203] within courtyard of stables, from SE.

To the exterior of the structure removal of recently accumulated rubble (201), cleared from the centre of the structure during recent excavations exposed an accumulated topsoil (202) post-dating the abandonment of the stables. Underlying the topsoil was a well preserved cobbled surface [203] comprising water rounded cobbles up to 0.2m by 0.2m in size set close together in a single layer. This cobbled surface was left in-situ and not disturbed. Protruding through the cobbles were the upper stones of one of the arches of the central stone structure [204].

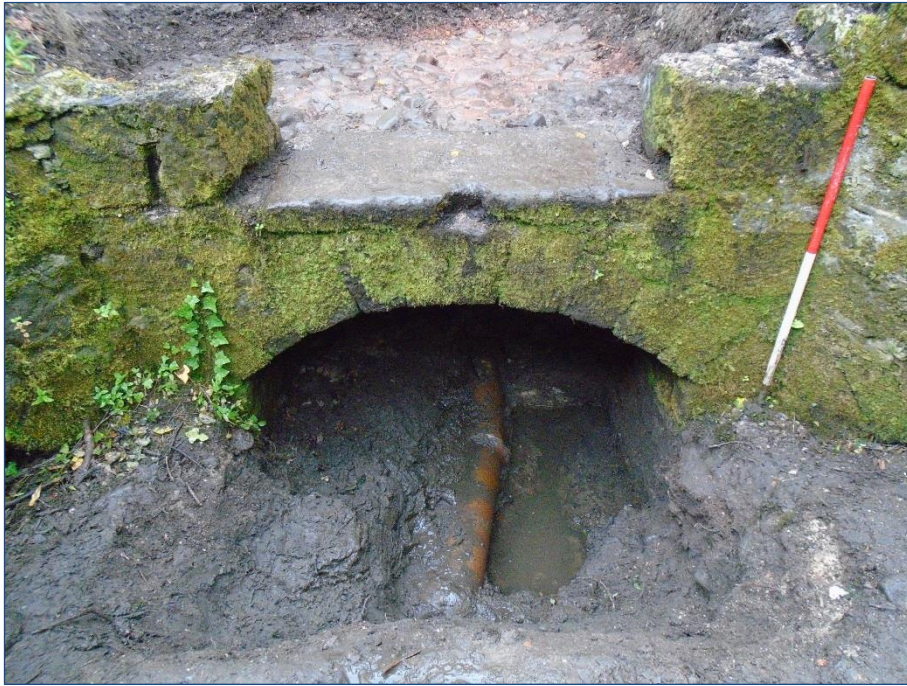
Plate 6: Trench 2 within centre of structure showing drain pipe [210] set in silting deposit (211) with dumped cobbles (208) above, from NW.

Within the centre of the stone structure a trench was excavated against and within one of the arches of the structure. Removal of demolition rubble (209) exposed a deposit of cobblestones (208) seemingly dumped into the centre of the structure. Underlying the cobbles was a waterlogged deposit of sandy silt (211) that appears to be an infilling of the structure. This deposit was not fully excavated. Set within silting deposit (211) was a ceramic drain pipe [210] that had been inserted through the outer wall of the structure. This drain pipe appears to have been a later addition to the structure.

Trench 2 excavated over the central stone feature and courtyard interior revealed the cobbled surface of the courtyard as well as investigating the nature of the central feature within the courtyard. Previous descriptions of this structure have described it as a doocot, however no evidence for this was recovered during the excavations. The excavation into the interior of the structure has demonstrated that a deep structure has been constructed, this later filled in with a silting deposit and was used for drainage before being sealed with a dump of stone. This leads to the suggestion that this central feature is a well or font rather than a doocot.

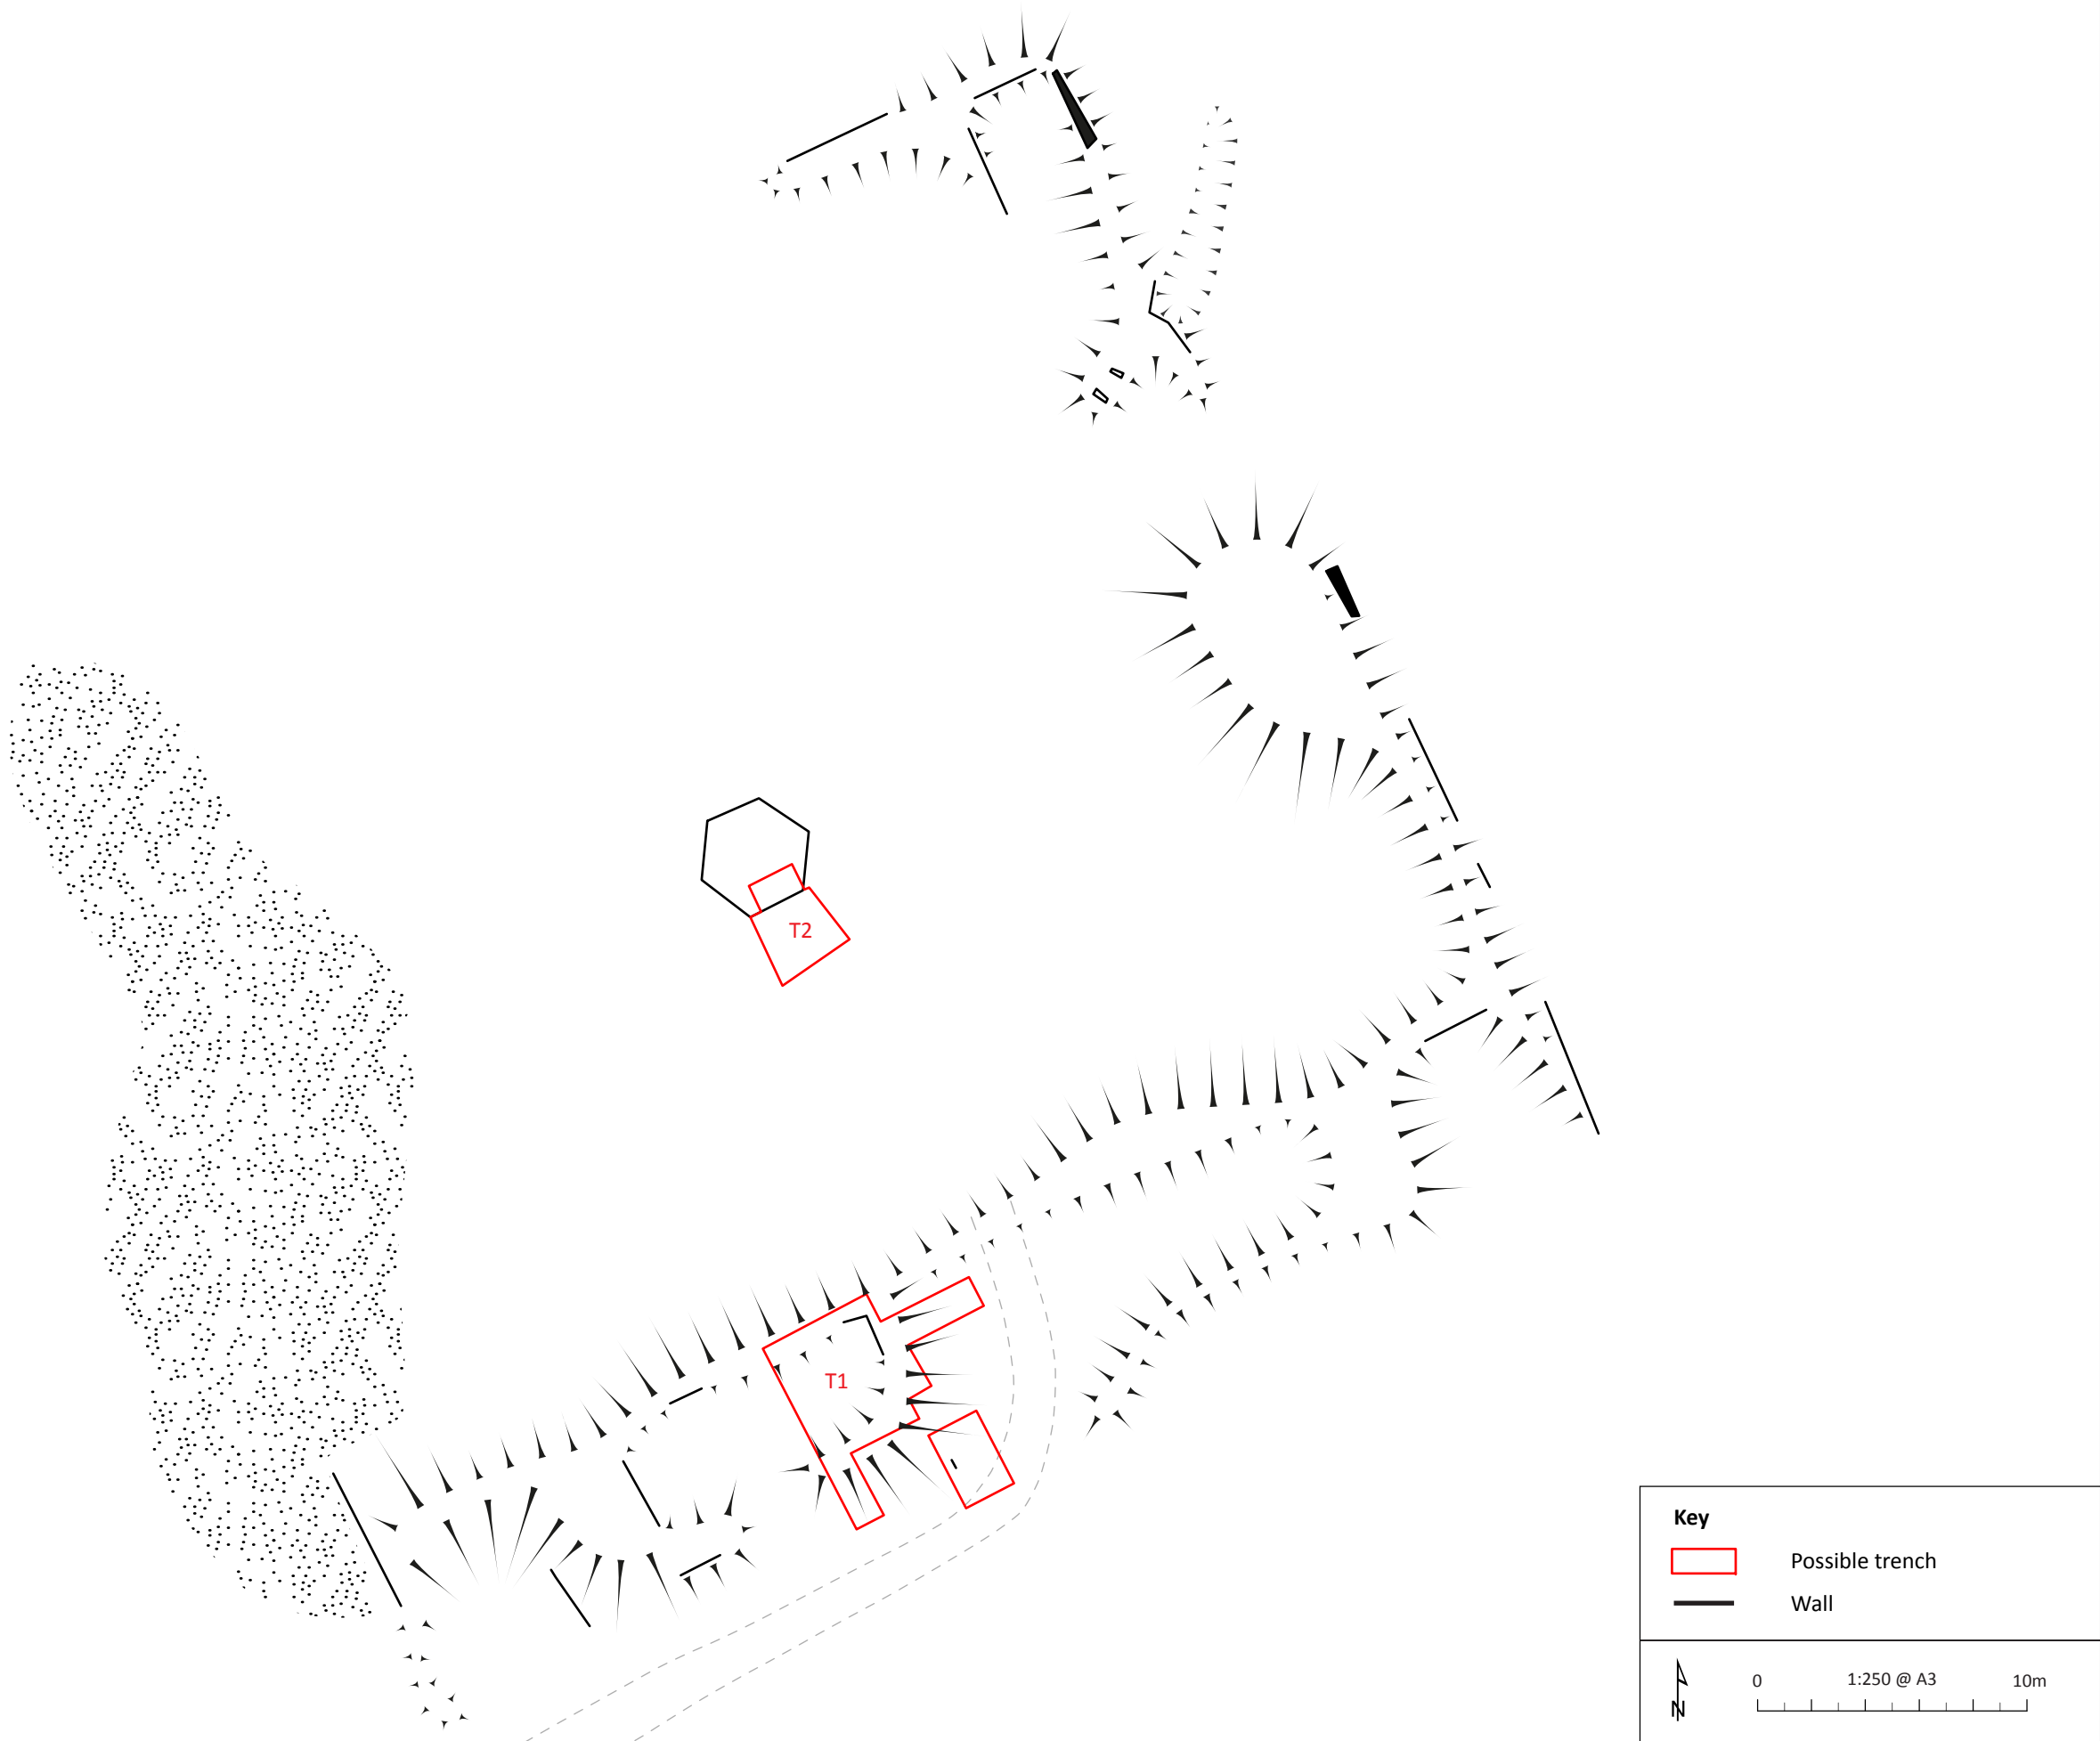
Figure 2: Topographic Survey

The topographic survey (Figure 2) recorded the upstanding remains of the stable courtyard and associated remains. For the most part the demolished buildings are covered by deep deposits of demolition rubble masking the layout of the building; thick overgrowth has further masked the remains of the stable block. The remains of the stables were clearest on the southeast and northeast sides and the survey focussed on these areas. The stable block forms a rectangular structure 48m by 46m in overall size. While for the large part details of the structure could not be made out above ground there were in places sections of upstanding wall projecting above ground.
