CAMBUSKENNETH BELL TOWER, STIRLING

A SURVEY OF MASONS' MARK'S 2015

A survey of stonemasons marks was undertaken at the Cambuskenneth Abbey bell tower over 3 days in October 2015 by the Mason's Mark Project with the help of volunteers.

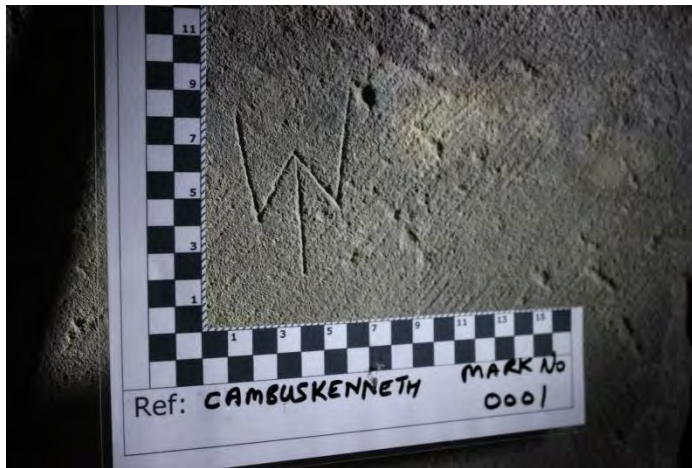
Mason 1- Mark 0001

Mason 1. This mason was one of the most prolific, with 43 examples of his mark recorded, but only on the ground floor. His mark was generally a fairly well-balanced clear cut, although not cut across the dressing in any specific way.

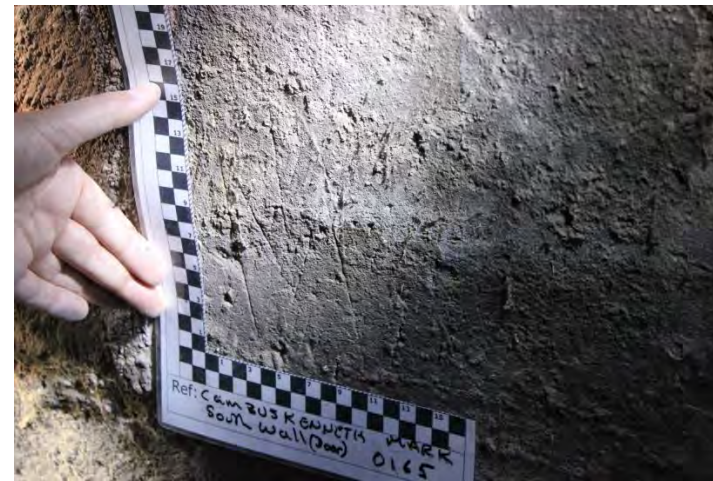
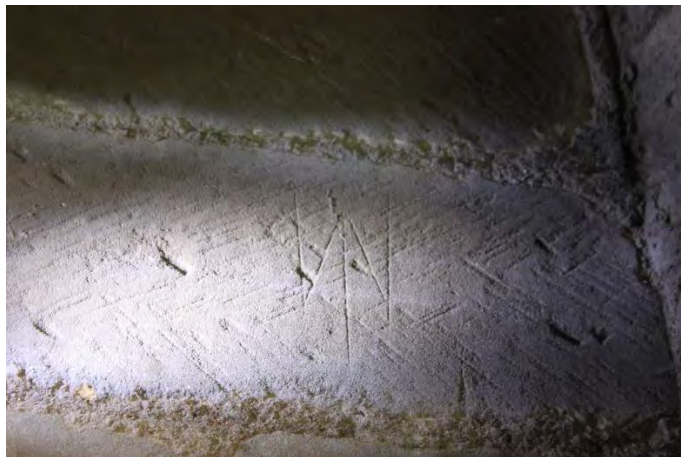
However, there are a number of examples of his mark which were not so evenly cut and some of a larger size.

Mason 1- Mark 0155

Mason 1 – Mark 0165

Mason 1 – Mark 0435

This could possibly indicate that he was allowing one of his longer serving and experienced apprentices to apply his mark for him.

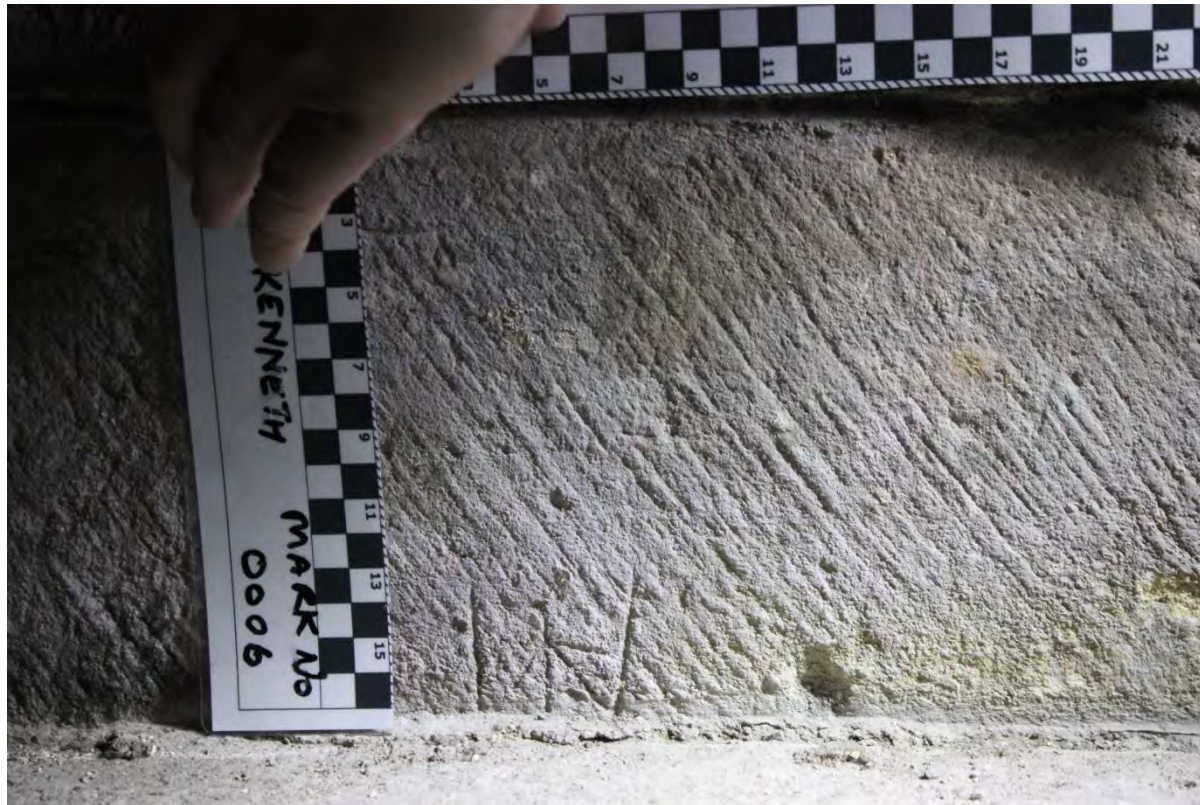
Mason 5 - Mark 0006

Only one example of this mason's mark was found on the ground floor, but unfortunately partly hidden by the stone bench. The extra cut coming off the central upright appears to be a deliberate cut and not a chance cut. It is therefore possible that this may have been a family member of Mason 1, who had perhaps become a Journeyman.

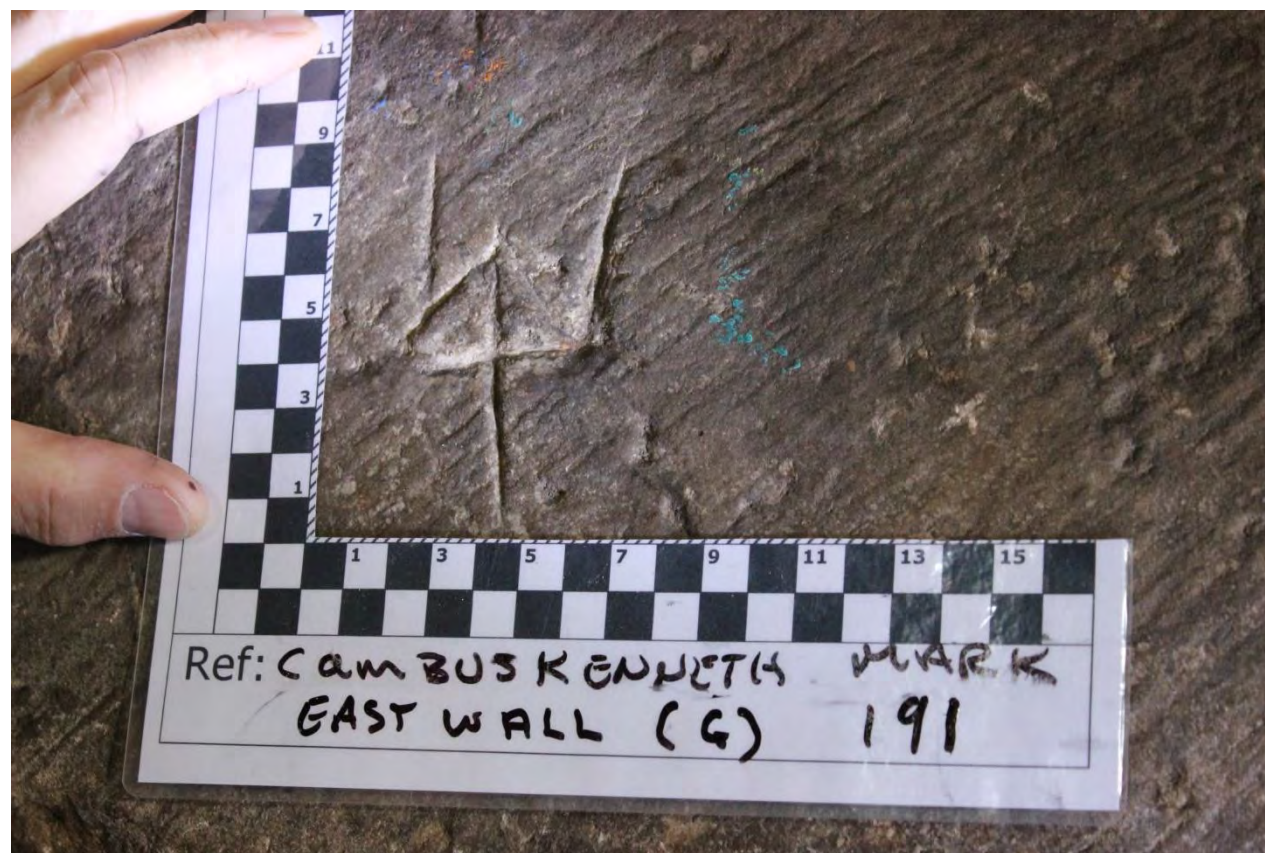
Mason 33 – Mark 0191

Mason 33. Only one example of this mason's mark was found on the ground floor. Again the similarity to Mason 1, but with an extra cut across the upright and again only found on the ground floor.

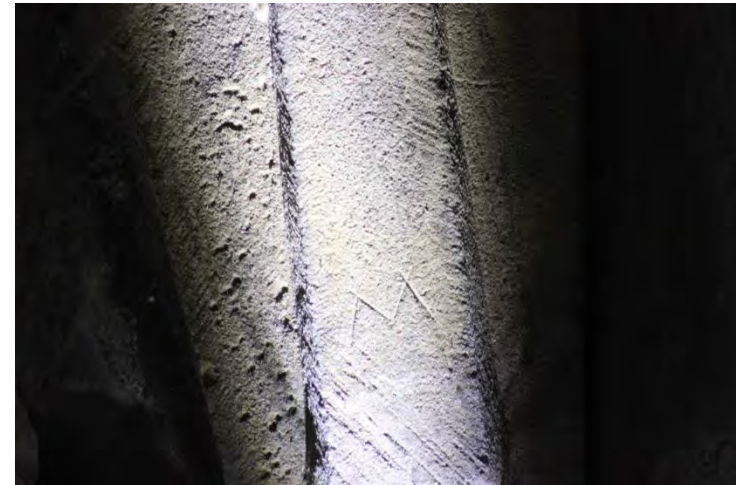
Mason 39. Only two examples of this mark were found. Both marks were on the carved stone of the ribbed vaulting of the ground floor.

Mason 39 – Mark 0282

Mason 39 – Mark 0281

It is probable that this mason generally worked on carving rib vaults rather than dressed ashlar blocks.

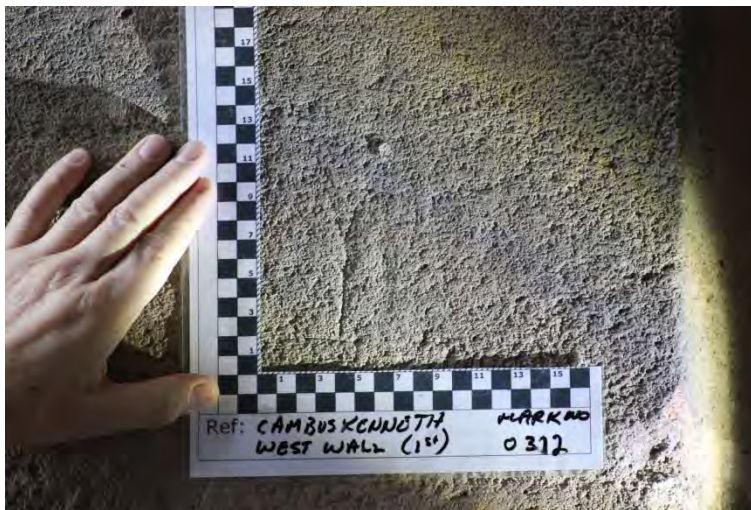
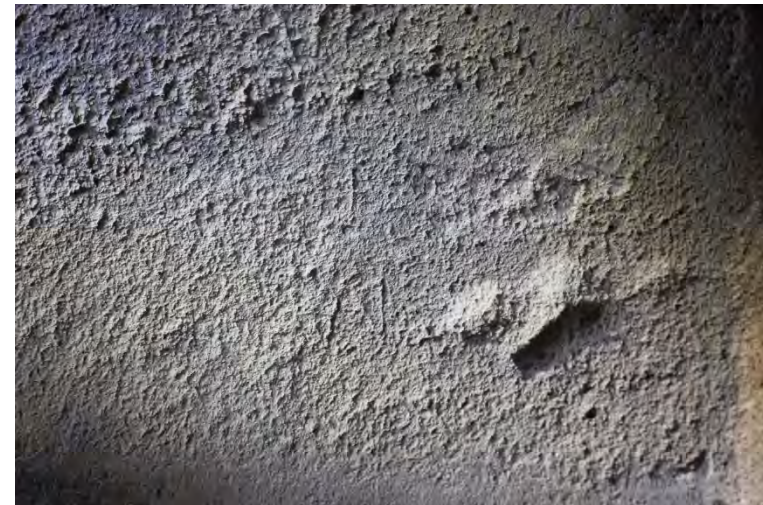
Mason 43. This mason only appeared to work on the 1st floor of the tower. Only three marks were recorded and unfortunately none were particularly good clear marks.

Mason 43 – Mark 0312

Mason 43 – Mark 310

Both marks were recorded on the West wall of the 1st floor only, on 5th & 8th course.

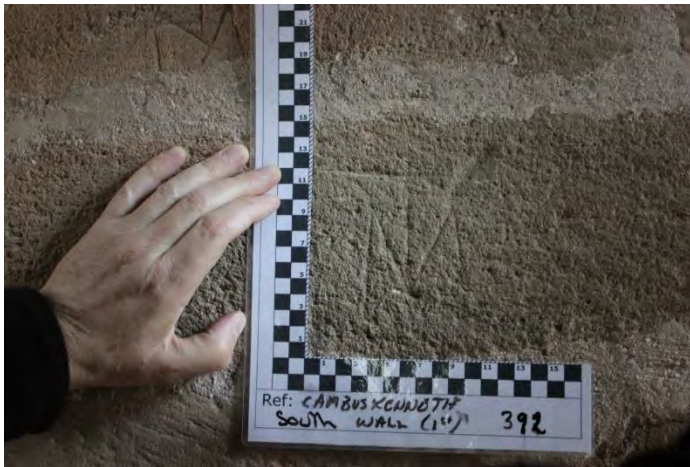
Mason 49- Mark 0392

Mason 49. A total of 15 records of this mark were found on the 1st floor and also on the spiral stair.

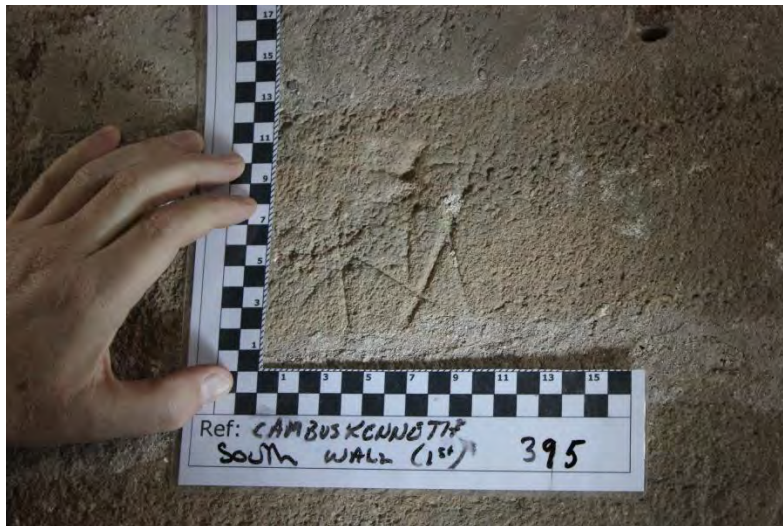
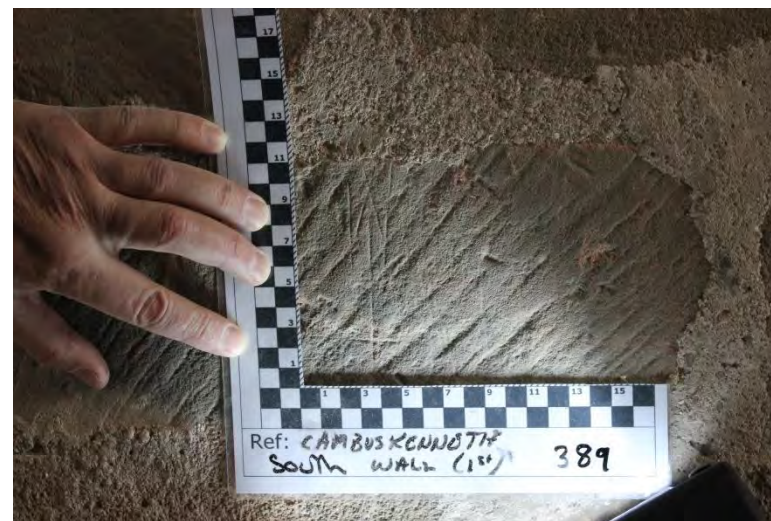
Again there could be the possibility of his mark being made by an apprentice, as some examples show very uneven cutting of the mark and in the case of Mark 0389, elongation.

Mason 49 – Mark 0395

Mason 49 – Mark 0389

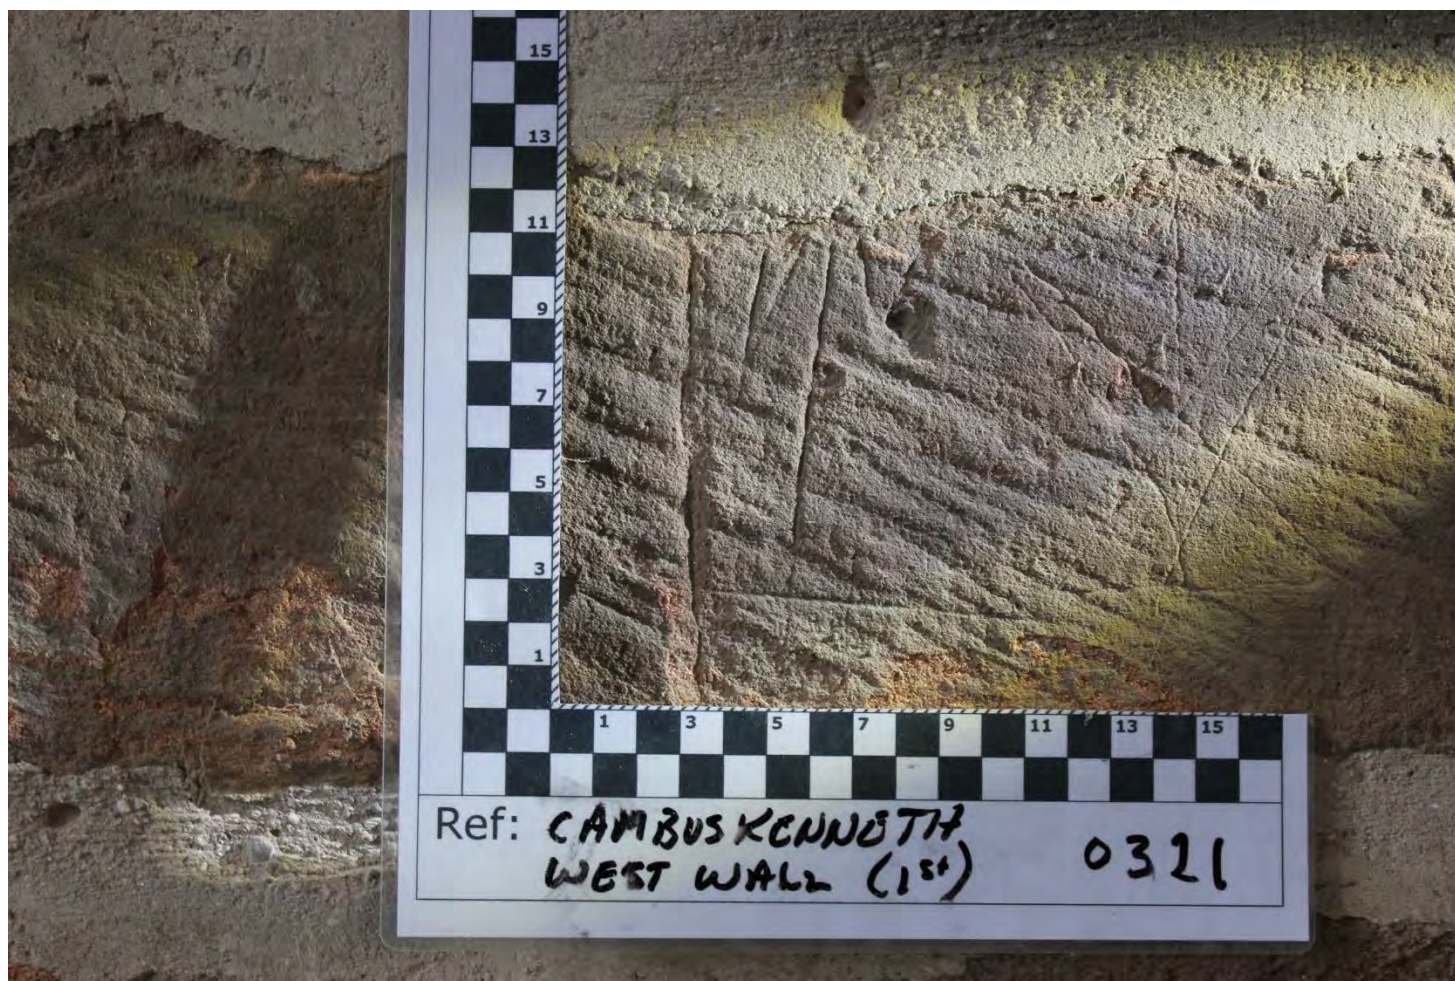
There is also an example of this mark on a block along with another mark. This could indicate two possibilities. One is that this is simply a re-used block, or the second, that one mason was approving the work of another, who may have been a journeyman or a former apprentice (see below).

Mason 49 – Mark 0321, along with Mason 52. Two marks on the same block.

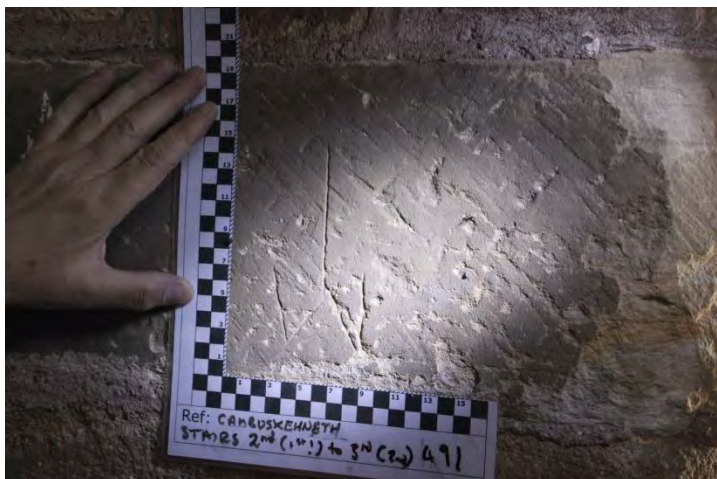
Mason 60 – Mark 0491

Mason 60. This mason only worked on the 1st floor and the spiral stair, with 10 examples of his mark recorded.

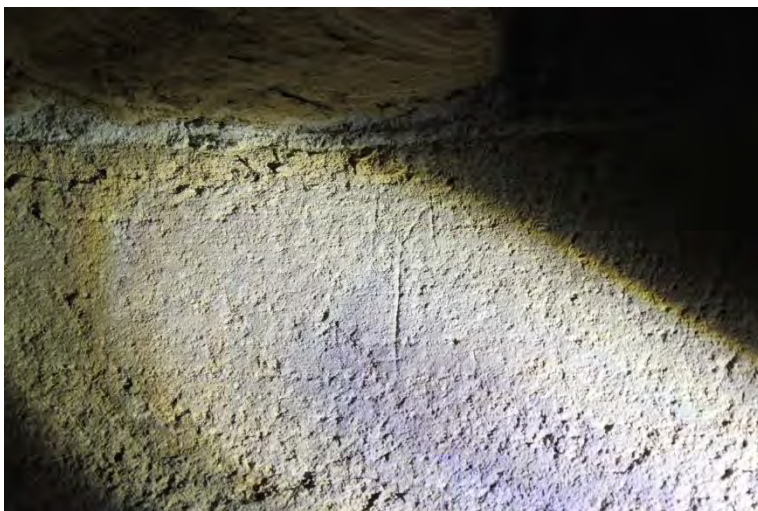
Mason 63 – Mark 0451

Mason 63. Four examples of this mason's mark were found only on the 1st floor and the spiral stair. Very similar to Mason 49 but the vertical extends from the central point, rather than running into it. Also similar to Mason 60 but with an added cut across.

All examples have a longer extension than on Masons 49 or 60's central cut.

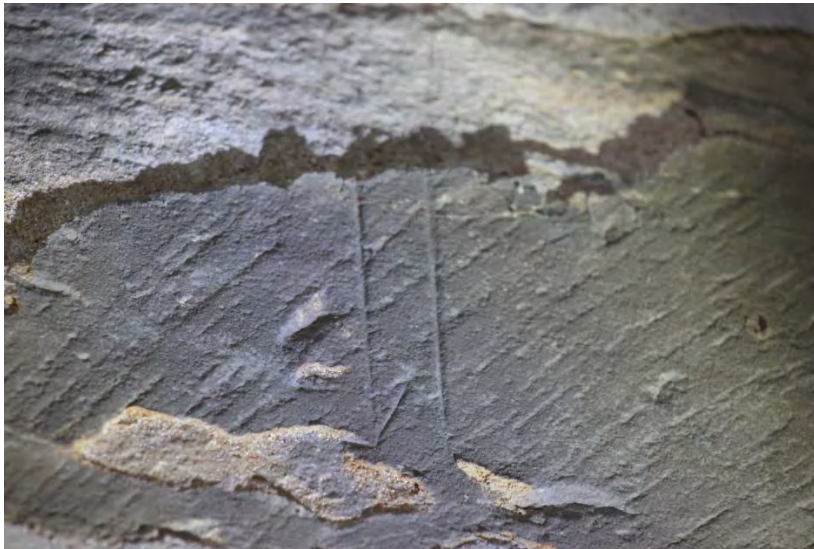
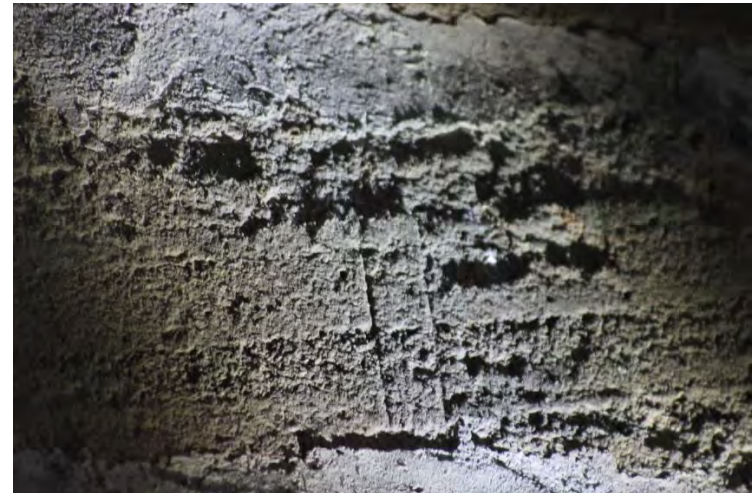
Mason 61 only worked on the 1st floor, where 3 of his marks were recorded. It is in the form of an elongated, narrow M. Unfortunately two of the examples are in a poor state due to spalling of the stone.

Mason 61 - Mark 0354

Mason 61 – Mark 0410

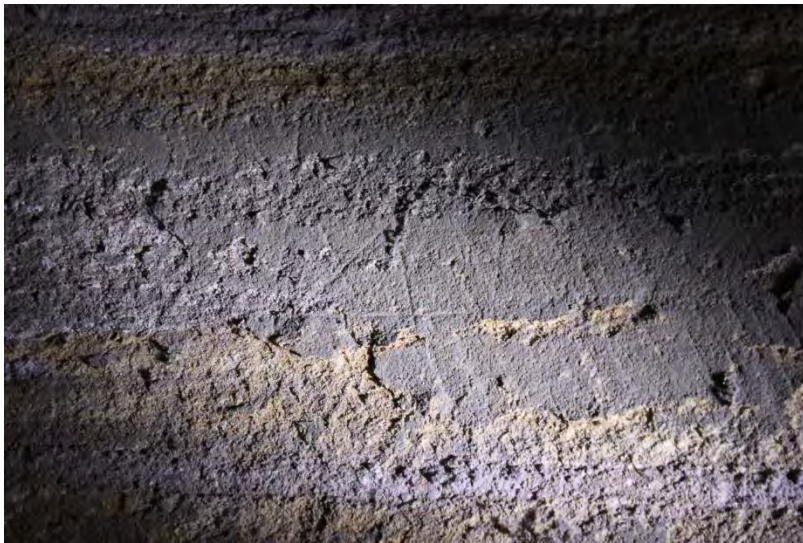
Mason 84- mark 478

All marks belonging to Mason 84 were in a poor state of preservation so none are really clear.

Due to their locations on the stairway, and the spalling of the stones, all marks belonging to Mason 84 are in danger of being destroyed completely.

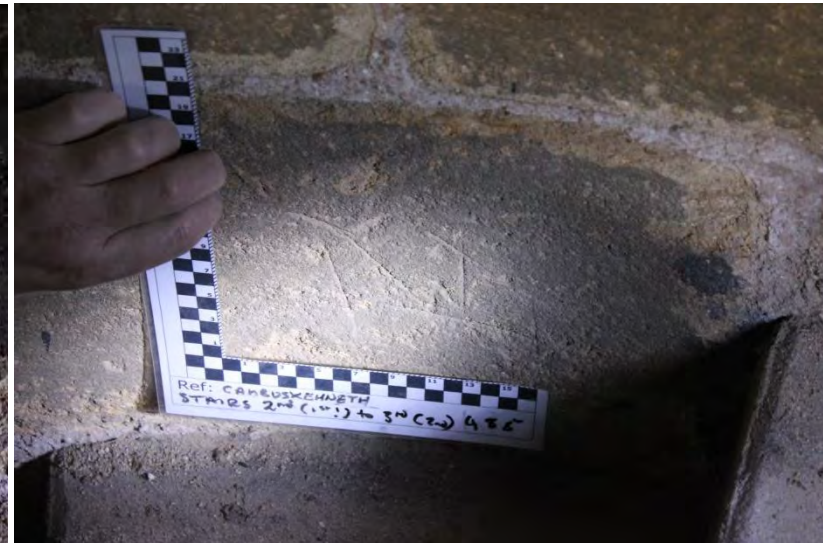
Mason 85 – Mark 485

Mason 82, 84 & 85 only worked on the spiral stair, where 3 examples of 84 were found and only one example each of 82 and 85.

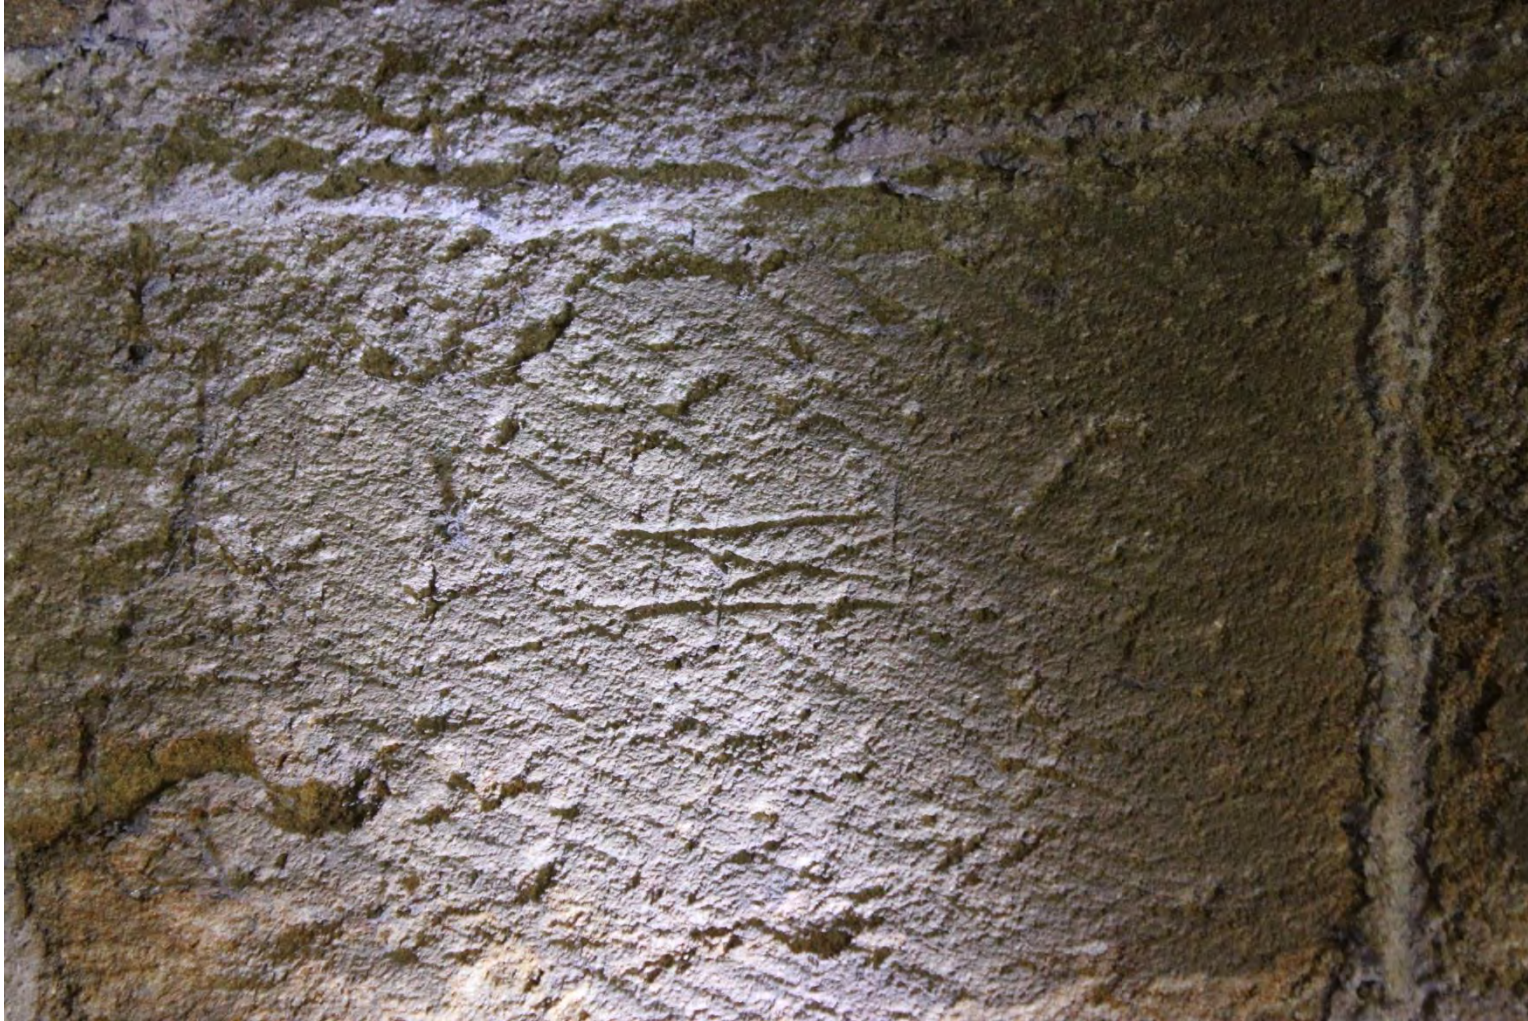
The only example of Mason 82 – Mark 468 was found on the wall of the spiral stair.

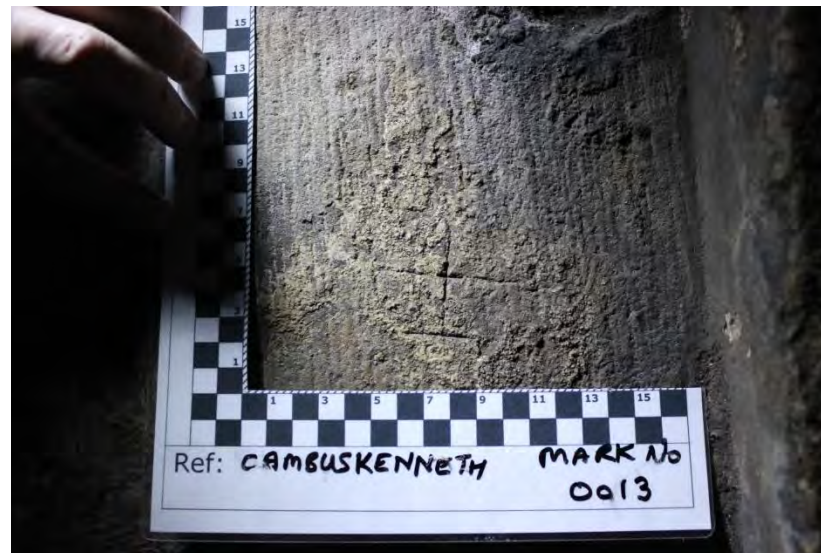
Mason 2 – Mark 0013

Mason 2 Only two examples of this mark were found, both on the ground floor. One mark record 0002 was not a clear example as it was partly hidden by a stone bench.

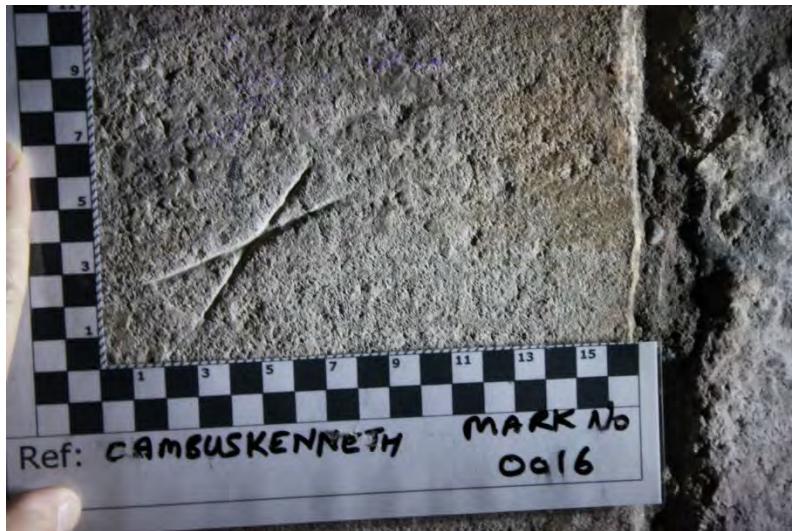
Mason 7. Thirty-one examples of this mason were found, again only on the ground floor. His mark is based on a simple St Andrews cross.

Mason 7- mark 0016

Mason 7 – Mark 0022

Some of his marks are showing evidence of spalling or erosion in some cases.

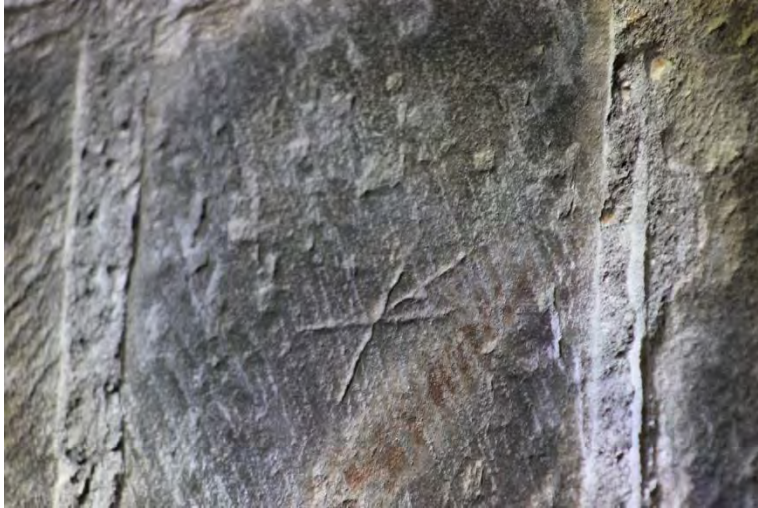
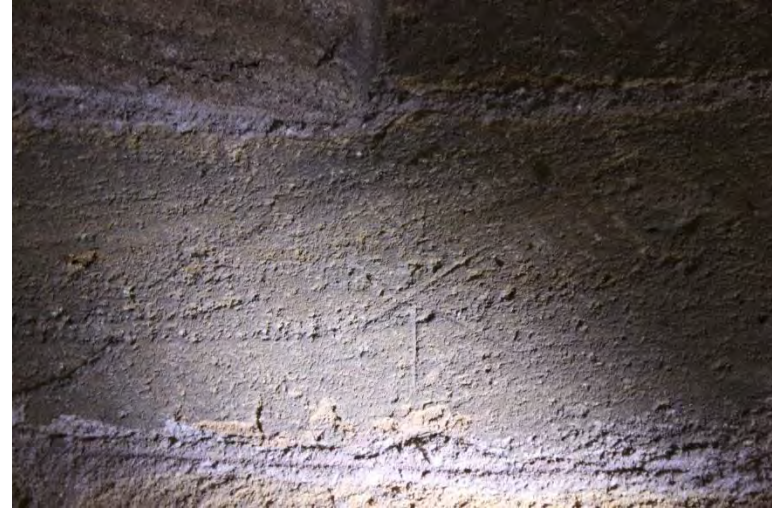
Only 3 examples of Mason 14's mark were found, one on the ground floor and the other two on the stairs, where they are in a poor condition due to erosion and stone spalling.

Mason 14- Mark 48 on the ground floor.

Mason 14- Mark 479 on the spiral stair

Mason 14- Mark 488 on the spiral stair

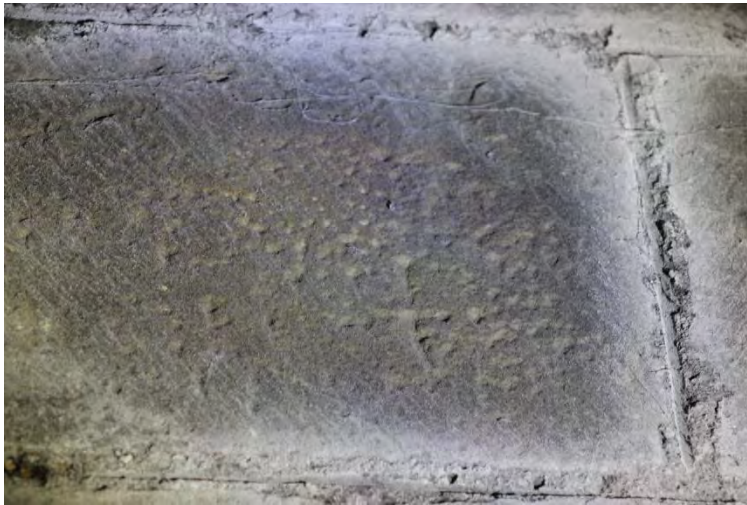
Mason 21 – Mark 103 on ground floor wall

The only example of **Mason 21** was found on a ground floor wall and 3 examples of **Mason 30**, two on a ground floor wall and the other on the stairs.

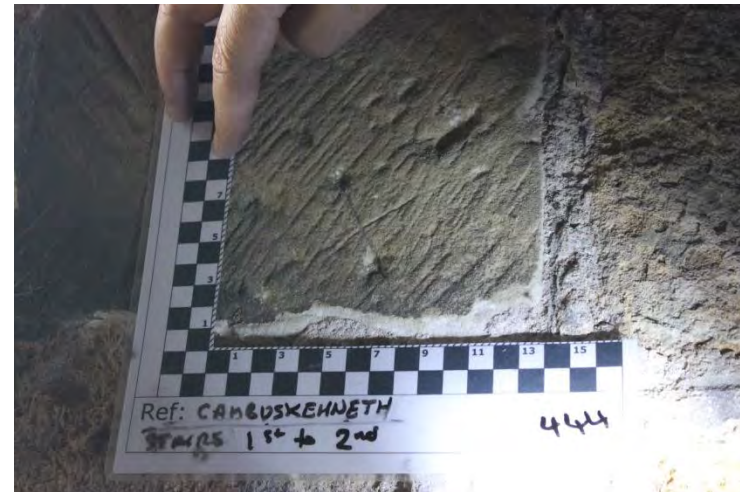
Mason 30 – Mark 444 on the stairs

However the marks of **Mason 30** found on the ground floor would appear to be of a later date, as it is on the same block with a mark belonging to **Mason 7**, and also a later mark 29. Both this mark and **Mason 29** looks as if they were cut at the same time, whereas the mark on the stair looks like an earlier mark. It is also found on a block with **Mason 31**, again both look later marks (see below).

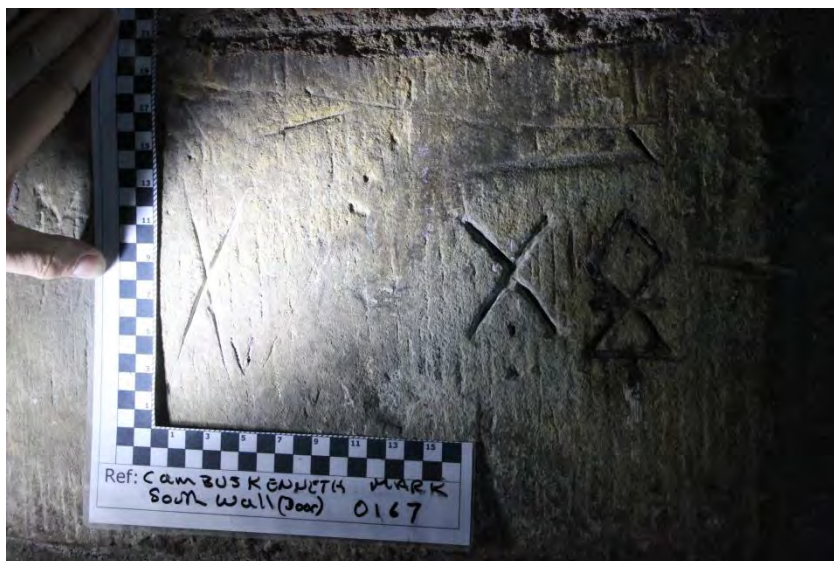
Mason mark 30 on the same block as Mason 7 and later mark Mason 29- mark record 0169

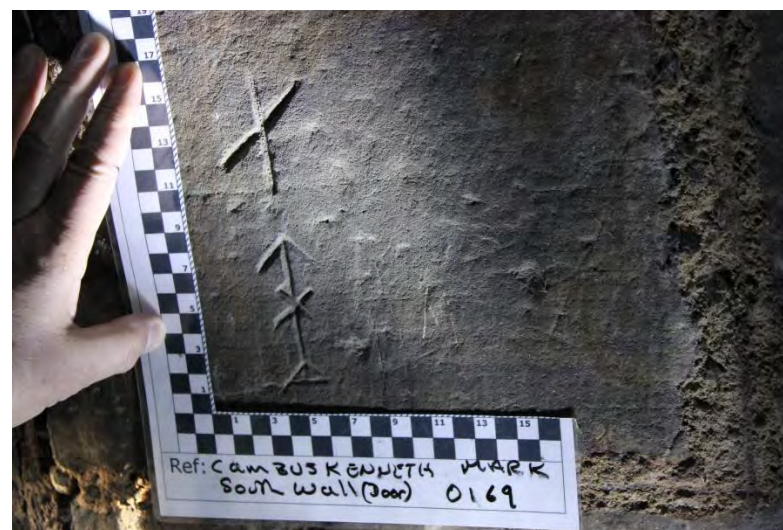
Again Mark 30 on the same block as a later mark 31-Mark record 0169. Both look as if they may have been cut at the same time.

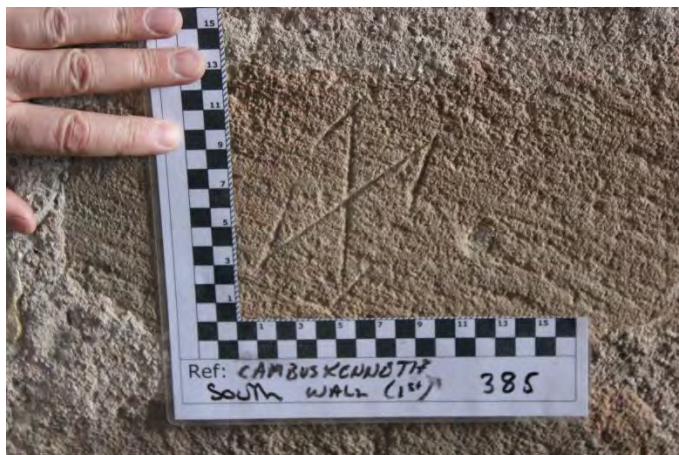
Mason 46 – Mark record 0385

Mason 46 worked on the 1st floor and spiral stair way only, with 15 examples of his mark recorded.

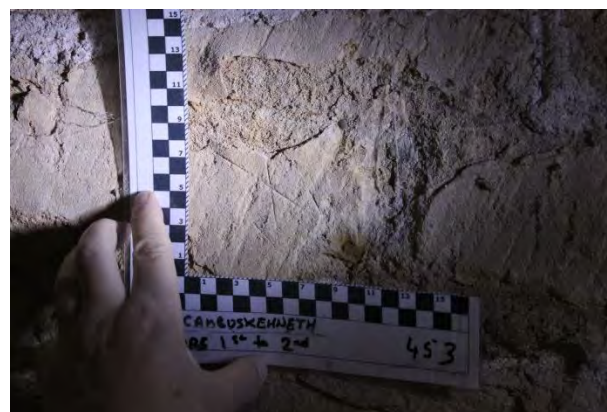
Mason 46- Mark record 0453 with spalling of stone

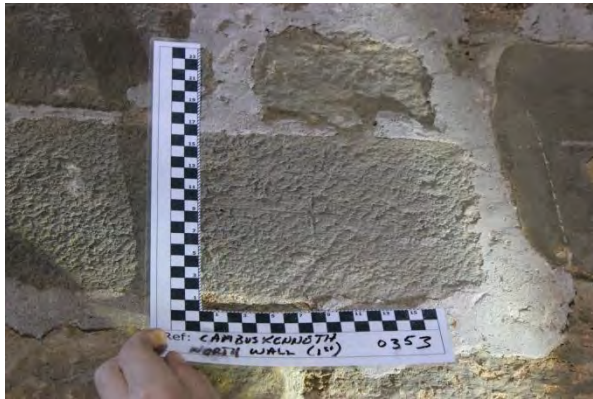
Mason 59 – Mark record 0353

Mason 59 worked only on the 1st floor and there is only one record of his mark evident. Also with only one mark recorded and also found on the stairs is **Mason 79**, whose mark is of a later date.

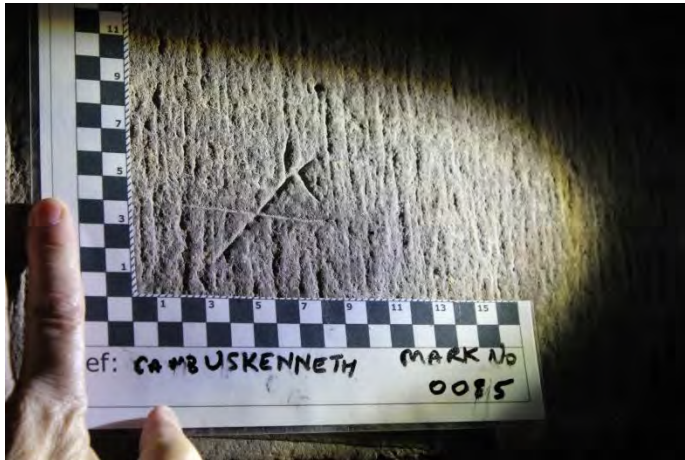
Mason 3 - Mark record 0085

Mason 3 worked on the ground floor as well as in the area at the bottom of the stairs. He is also one of the few masons who worked on the ribbing of the ground floor roof. Five examples of his mark were visible.

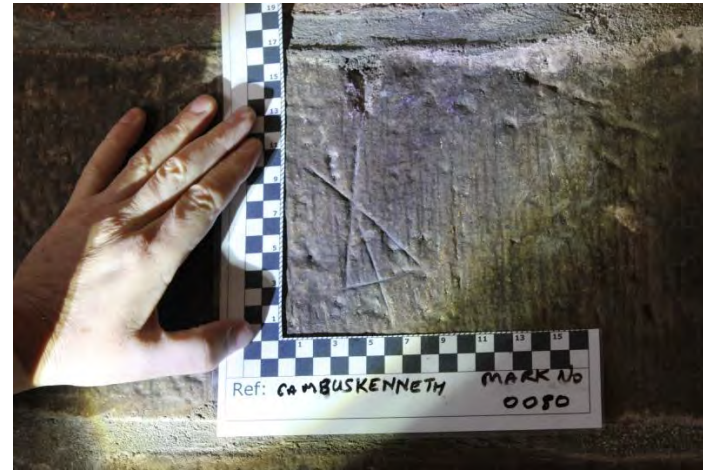
Mason 13 – Mark record 0080

Mason 13 worked only on the ground floor, where 13 of his marks were recorded, both on the walls and 2 on the ribbing of the roof vault.

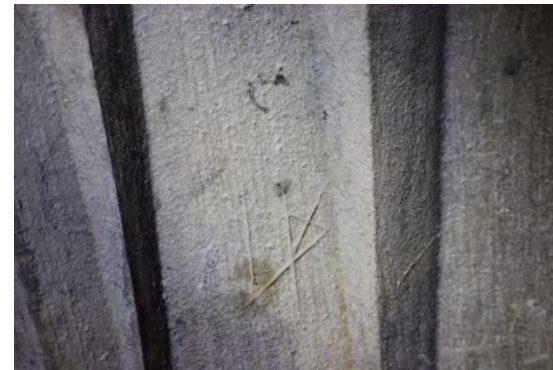
Mason 13 – Mark record 0233 on the ribbing

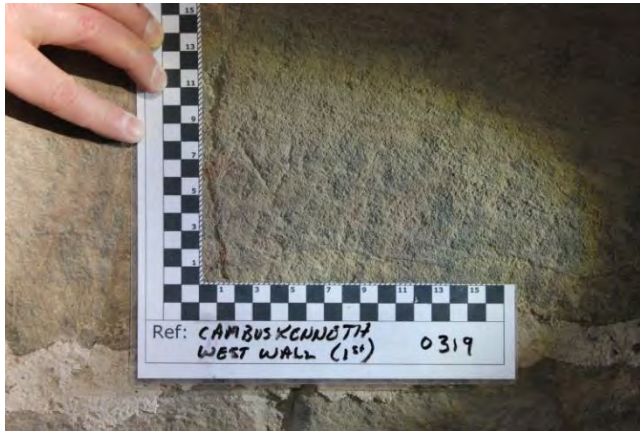
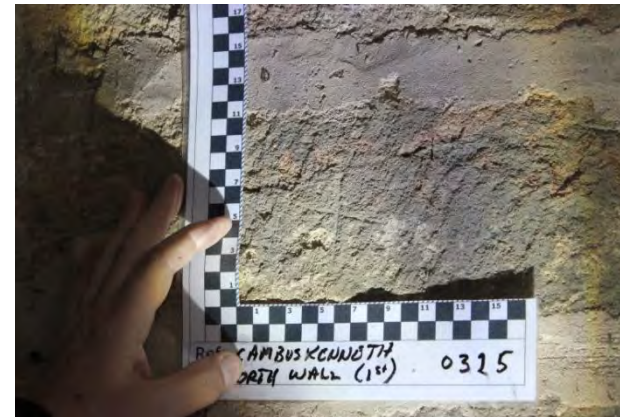
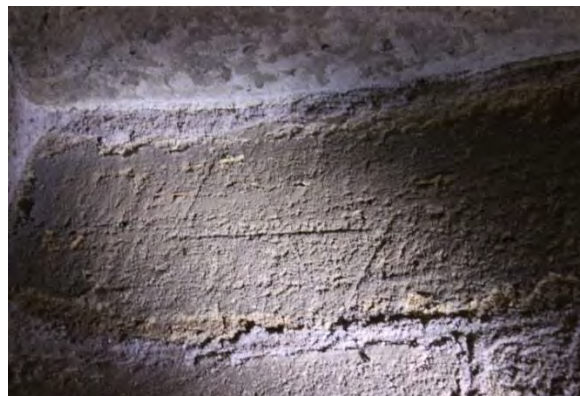
Mason 25 used a double triangle, or 'hourglass', as his mark and worked on the ground floor with one mark on the stairs. Four marks were recorded in total. Again 2 show damage from erosion and spalling of the stone.

Mason 25 – Mark Record 0319

Mason 25 – Mark record 0325

Mason 25 – Mark record 0476

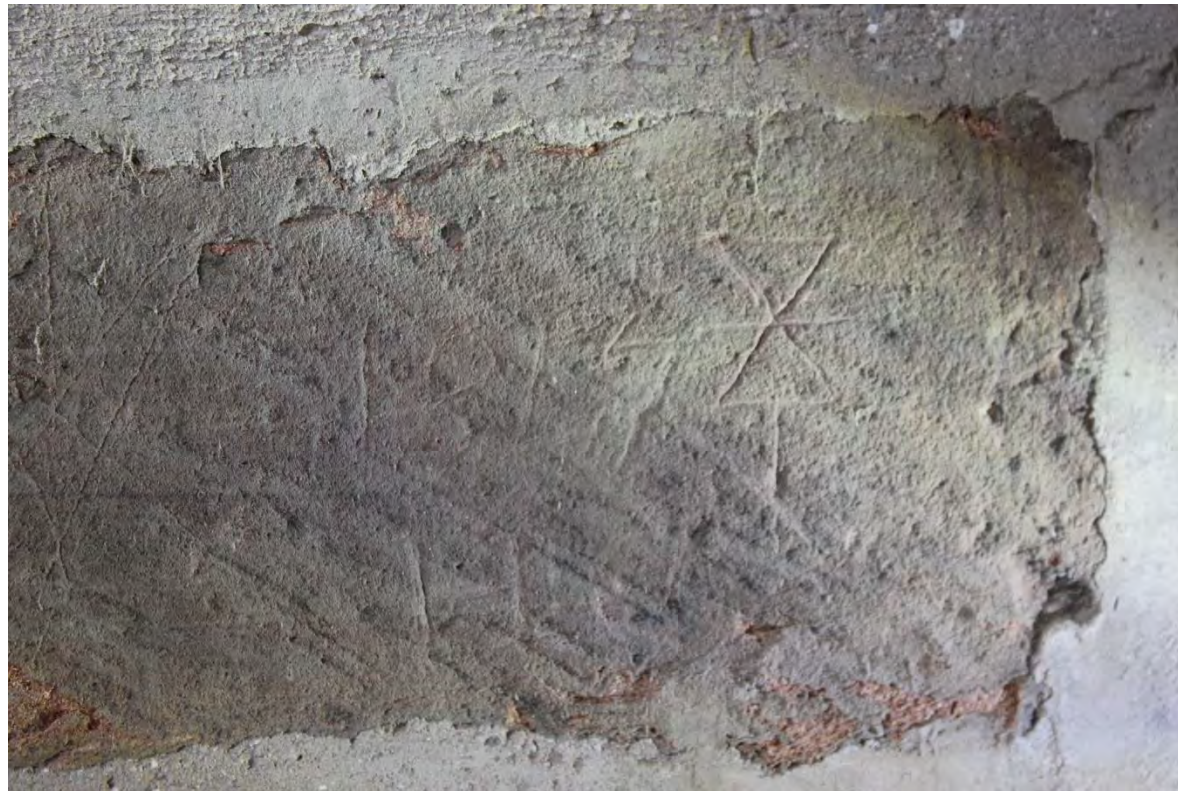
Also using an hourglass shape is **Mason 48** with 2 of his marks recorded on the 1st floor. However one of them, mark record 0321b, is on a block where 2 other marks are also visible Marks 47 & 49. There is also other graffiti evident on this block on the 1st floor.

Mason 48 – Mark record 0321b with part of Mark 47 visible and other graffiti

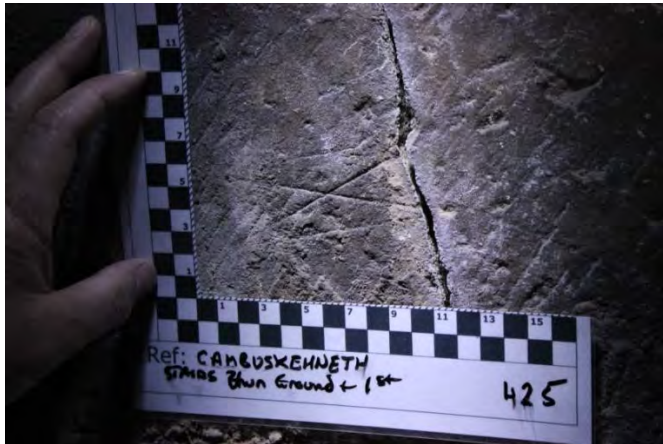
Mason 54 – Mark record 0425

Mason 54 worked on the 1st floor and in the area at the foot of the stairs. 9 of his marks were recorded, one of which was recorded in the corner of the small hall way to the 1st floor. His mark is like an hourglass but the triangles are more compacted.

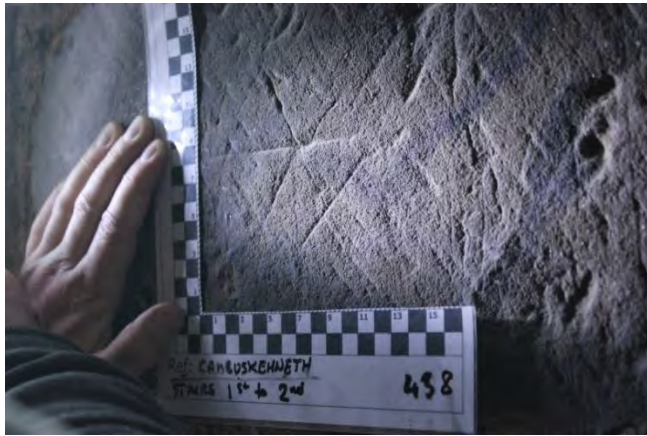
Mason 78 – Mark record 0438

Four examples of **Mason 78** were found on the stairs. Again he is using a tight hourglass shape but with a line leading from the centre out.

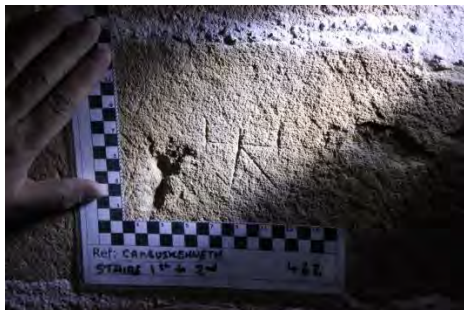
Mason 64-Mark record 0462

Four marks were also found of **Mason 64** on the 1st floor and stair areas. He uses a small triangle with a bar across the apex of the triangle and two vertical slashes at either end of the bar.

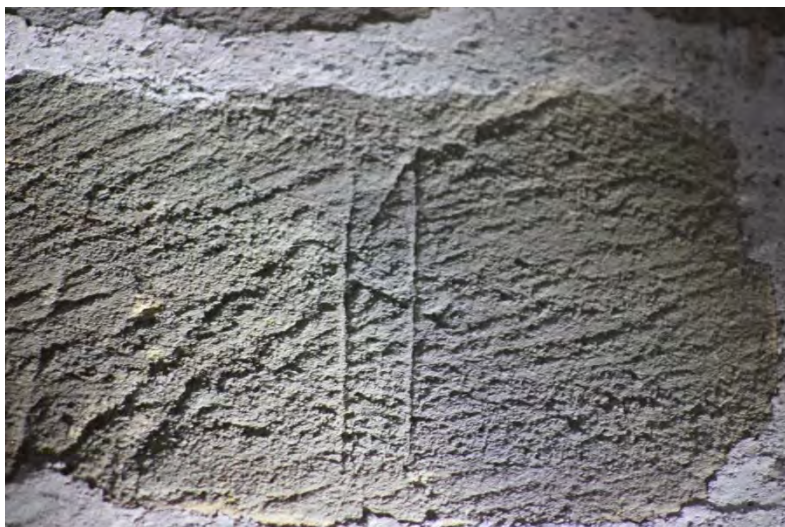
Mason 57 – Mark record 0342

Only one mark was recorded of **Mason 57** on the 1st floor. His mark is a small triangle within two parallel lines. Also only one mark of '**Mason 74**' was found on the 2nd floor but, as this is pencilled in, it may cover an earlier mark but is more likely to be part graffiti, as the other few marks below, also found on the 2nd floor, and are unlikely to be earlier masons' marks, apart perhaps for Mark 73.

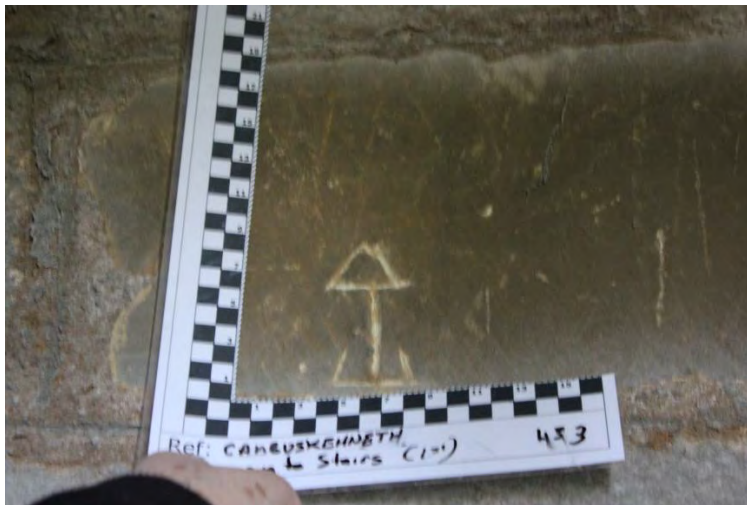
Mason 36 is an obviously later mason, possibly undertaking some restoration work and left his mark on the ground floor and in the area at the foot of the stairs. Three examples of this mark were found. The date of this work is unknown but possibly 18th or 19th century.

Mason 36 – Mark record 0433

Mason 36- Mark record 0224

This is one of 13 later masons who left their marks on the walls.
