Two Estates Project

The Clackmannanshire Field Studies Society [SCIO]

The Two Lades Project - The Gartmorn Lades

1890 - 2006

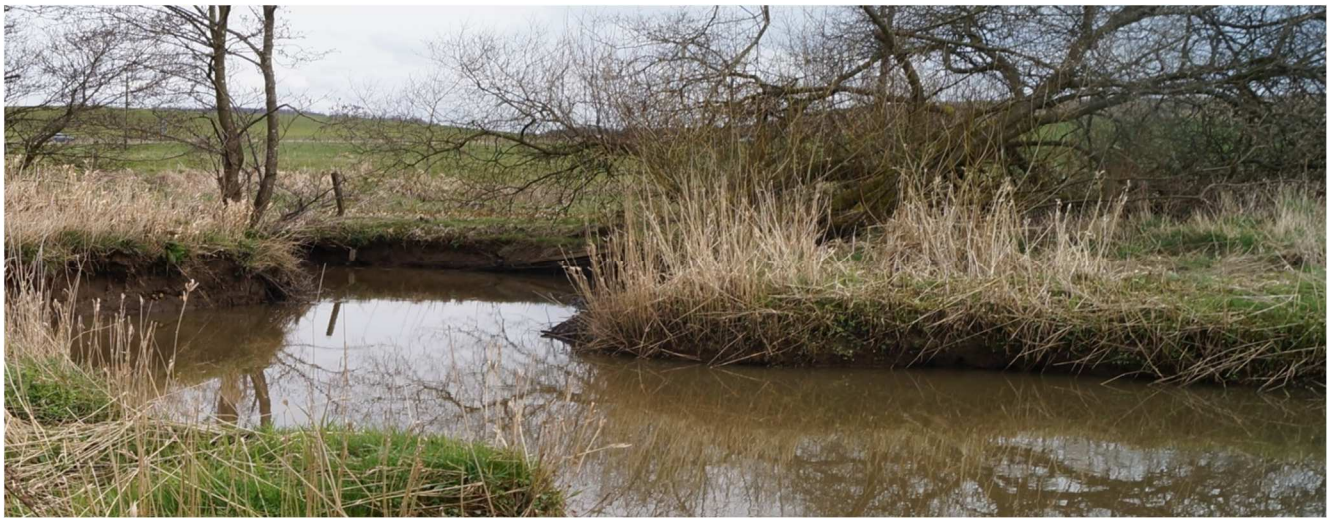
Figure 3. Lade at the pool behind the weir.

The work undertaken by Alloa Burgh in 1892-93, when they purchased the Gartmorn dam and its lades from the Erskine family; included widening and deepening the Forestmill lade. ⁽³⁰⁾ The lade starts as an open ditch from the northern side of the pool behind the weir which was rebuilt in the summer of 1835 by the Coal Company, with the work being completed later in the year by the Alloa Coal Company. ⁽³¹⁾ The lade turns westwards, parallel to the river.

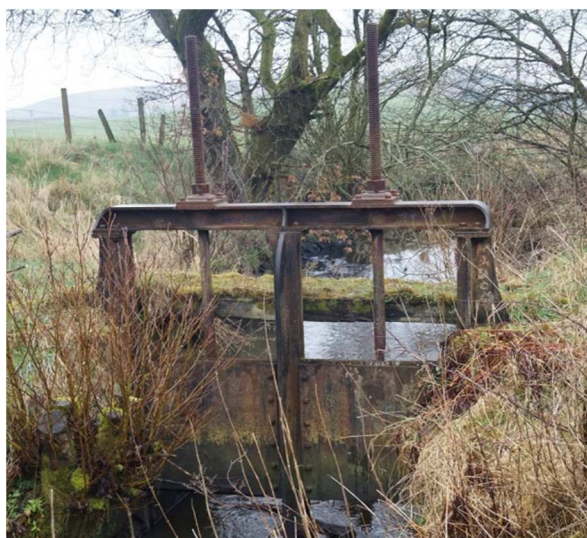
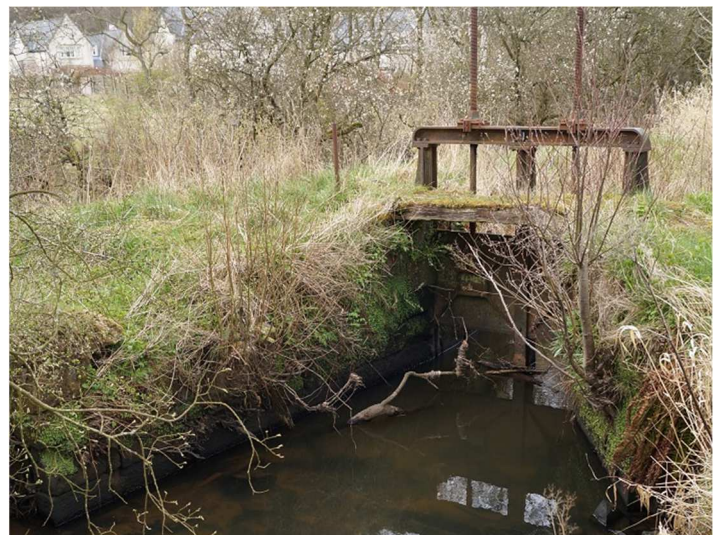
Figure 5. Sluice mechanism.

Figure 4. Alloa Burgh sluice.

The first structure from the 1891-92 work is the well preserved remains of a sluice to control the flow of water from the river Black Devon into the lade.

The sluice is extremely well preserved. Both the metalwork and the woodwork are substantially intact. A number of trees are growing out of the stonework. These have been cut down, but are coppicing and require to be trimmed and treated.

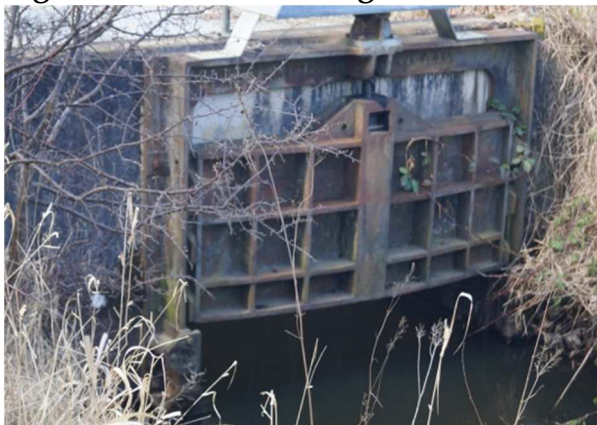
Figure 9. Modern sluice gate.

The lade was taken over by Central Regional Council in 1975 and parts were refurbished. A modern, substantial concrete-walled sluice was built in the lade just below the Alloa Burgh sluice. ⁽³²⁾ A steel gate controls the flow of water into the concrete sluice and a second controls the flow of water into the lade.

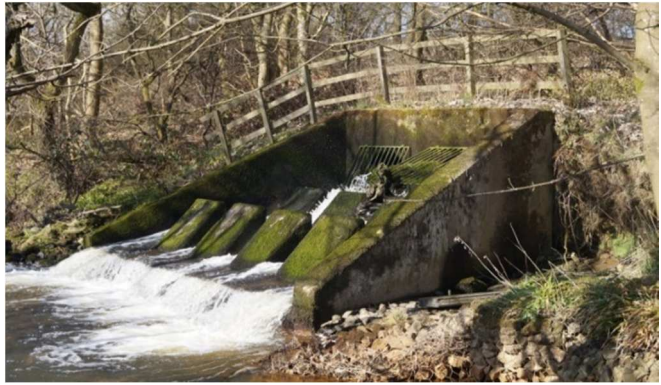
Figure 10. Modern spillway exit.

The spillway directs water through a culvert under the lade path into a concrete structure on the bank of the river. This has grids to prevent large items getting back into the river and a set of baffles which encourage oxygenation of the water.

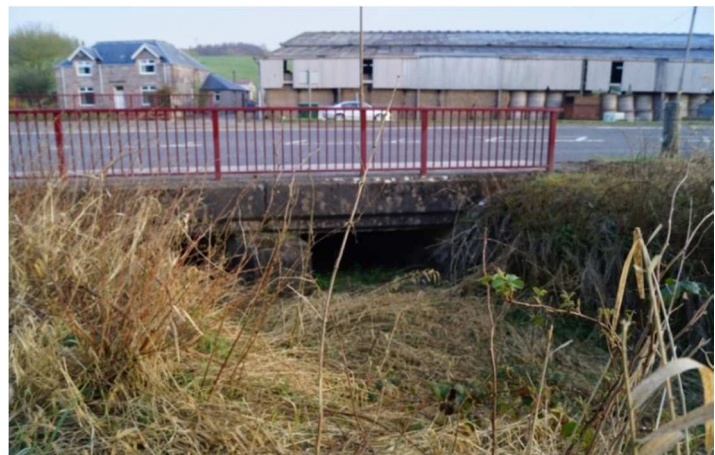
Figure 12. Modern concrete road bridge.

A modern concrete bridge now carries the busy A977 road across the lade [NS 95289 93899]. The bridge separates the lade into two culverts. The modern bridge is built adjacent to and replaces an older stone-built bridge.

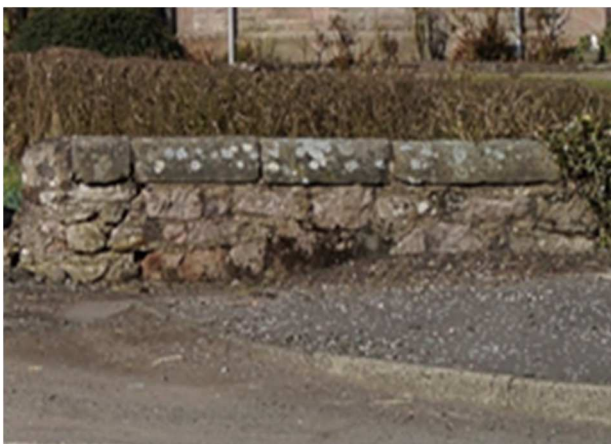
Figure 13. Older stone bridge.

This bridge is built of well-cut sandstone with a rounded sandstone coping. It still provides access to the steadings of Forestmill farm [NS 95282 93908]. The metalled road to Forestmill Cottages and Aberdona estate branches off from the A977 here.

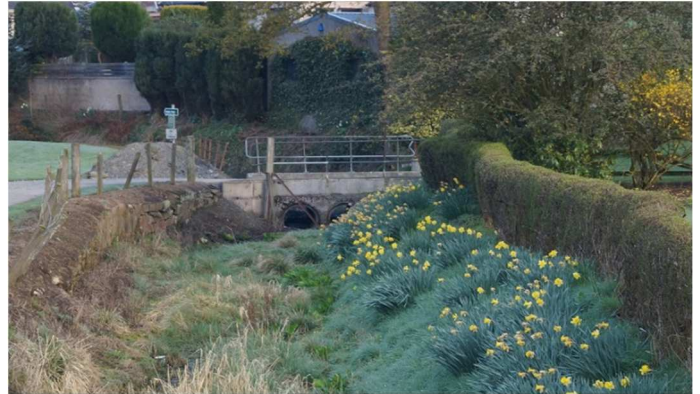
Figure 14. Refurbished iron bridge.

Just beyond this older stone bridge is a modern concrete bridge built over three pipes. This replaced one built of iron which was constructed in 1892 by Mr Peter Rintoull, engineer of Alloa, as part of the Alloa Burgh improvements. ⁽³³⁾ The road which crosses it gives access to Aitkenhead farm and the Aberdonna estate.

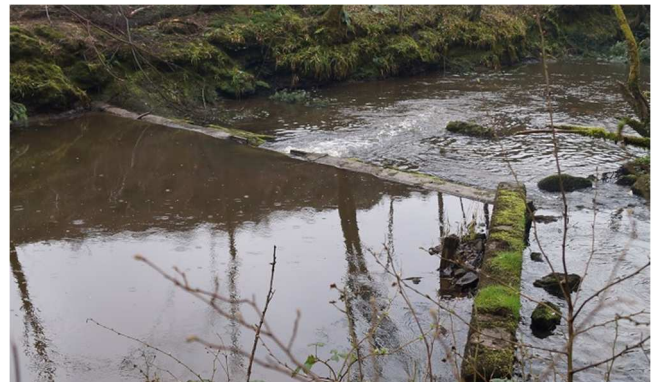
Figure 16. Forestmill river gauge.

Just downstream from the Forestmill cottages there is a small weir across the river Black Devon [NS 95139 93949]. There is a metal gauge plate in the sill of the weir. This acted as a check on the volume of water flowing over the weir. If the flow of water was insufficient to at least fill the cut in the plate, the sluice at the main weir had to be closed to divert more water into the river.

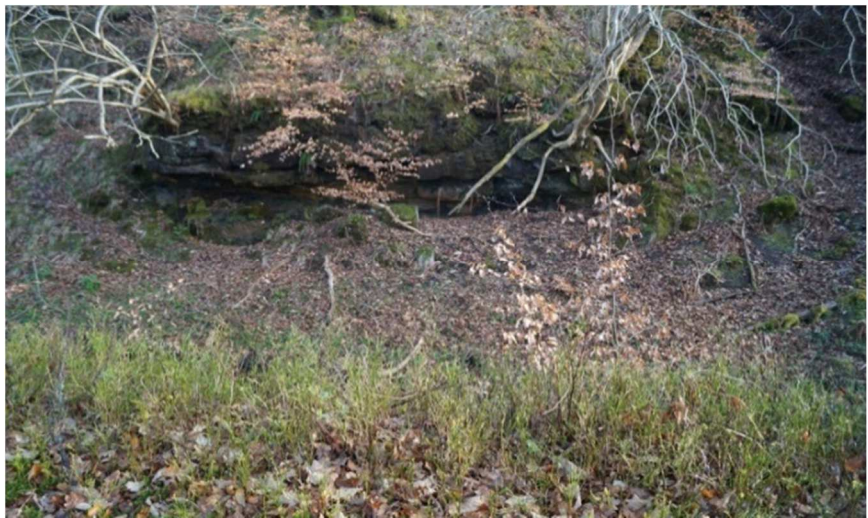
Figure 18. Lade cut through sandstone.

After passing the cottages, the lade is partly cut into the sandstone bedrock [NS 94992 95050]. The cutting exceeds six metres in depth and, in places, the lade is completely cut into the bedrock. The embankment is partly bedrock with an overlay of excavated material on the river side.

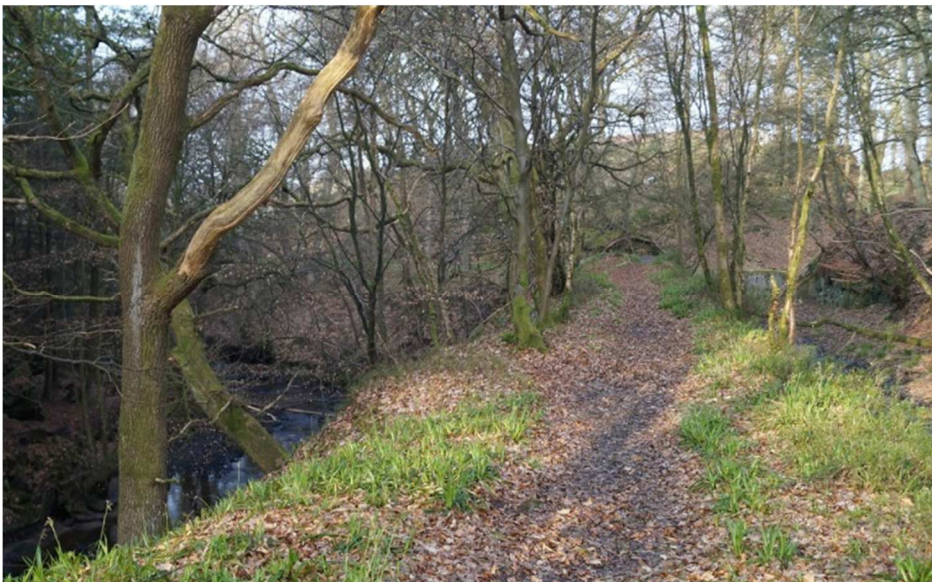
Figure 19. Levels of river and lade.

As the lade contours along the top of the gorge of the river Black Devon it maintains its height, while the river drops slowly in level as it proceeds into the gorge. This section of the lade runs through woodland, regularly fills with rainwater and the bed is covered with leaves and a thin layer of vegetation.

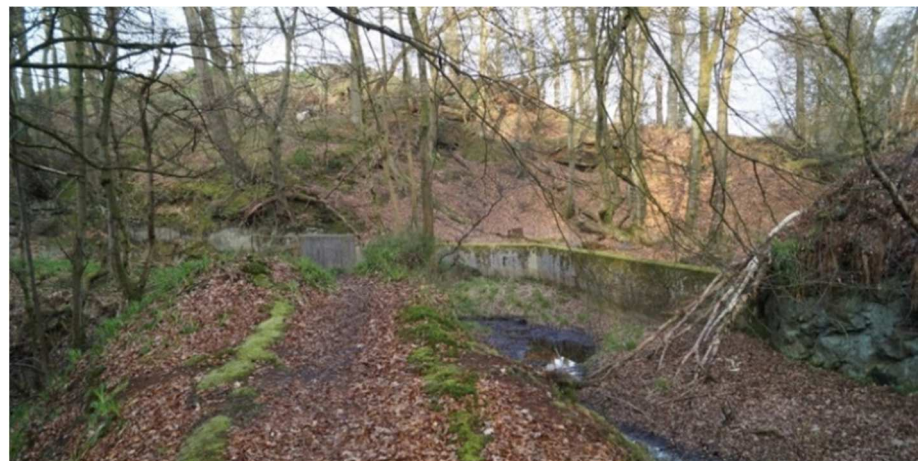
Figure 20. Combined sluice and culvert.

As the lade approaches close to the Aitkenhead farm it is carried across a small stream to the East of the farm steading [NS 95714 64062]. The stream enters a small trough cut into the bedrock under the lade.

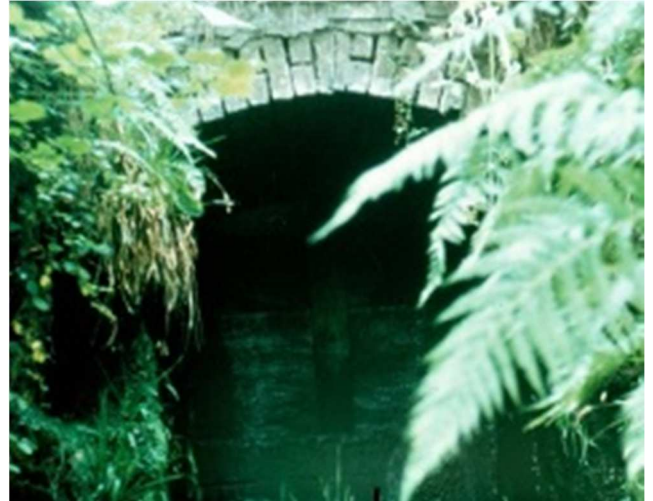
Figure 21. Culvert (1975)

In 1975 the lade-side path was carried on a brick-arched bridge over the culvert and the sluice gate was made of wood. William Hutton, the 6th Earl of Mar's colliery manager, refers to the work carried out here in 1712 in a letter he wrote to the 6th Earl of Mar's brother Lord Grange. He had redirected workman away from the cutting through the watershed to carry out further work at Aitkenhead. ⁽³⁴⁾

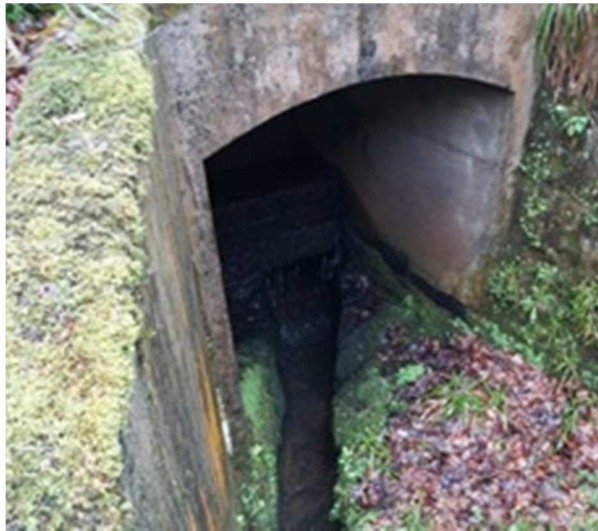
Figure 22. Culvert (2017)

The stone-built culvert has been partially replaced with concrete in the 1970s but you can still see parts of the original stonework above the rock-cut trough carrying the stream under the lade and to the right hand side of the archway.

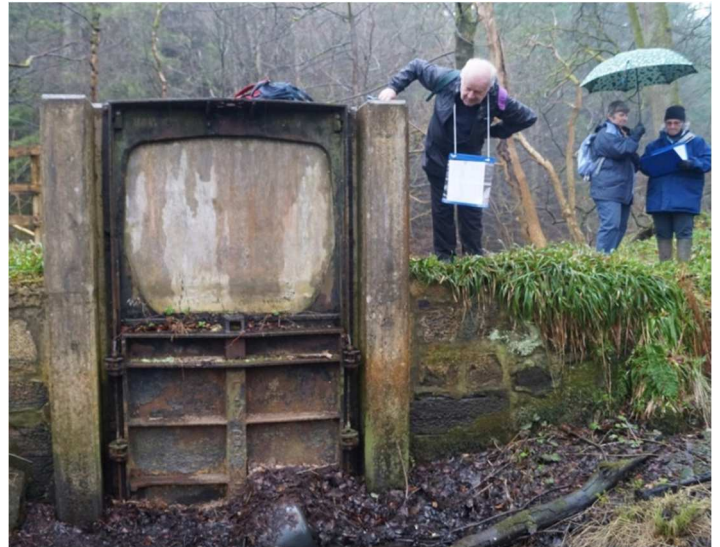
23. New sluice gate.

The old wooden sluice gate has been replaced by a new sluice made of steel. The new gate sits between two concrete pillars. It is similar in design to the gates in the new overspill sluice at Forestmill weir. The screw mechanism has been removed. When opened, it drained the water from the lade into the valley of the stream which the lade crossed, directing it to the river Black Devon.

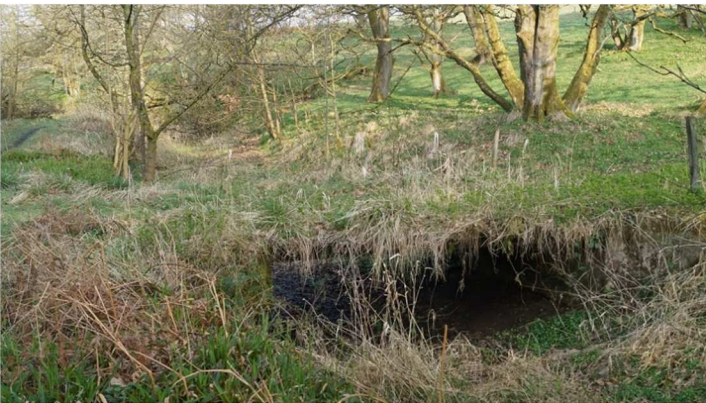
Figure 25. Small bridge over the lade.

Beyond the sluice there is a small bridge [NS 94587 93913]. This carries a track from the farm steading over to a wider section of the lade-side path and then down to provide access to into a field on the southern side of the lade. Westwards from here the lade bed is often wet and the vegetation less well developed.

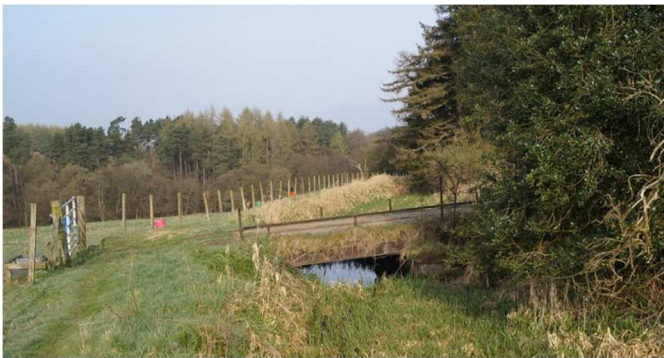
Figure 29. Shawbernaig bridge.

This iron bridge was built in 1892 by Mr Peter Rintoull, engineer of Alloa, for the sum of £140 ⁽³⁵⁾ "with new piers, new iron girders, concrete top, and girders along the sides". ⁽³⁶⁾ The metal work on the bridge is of a style found elsewhere on the 1892-93 works [NS 93943 93841].

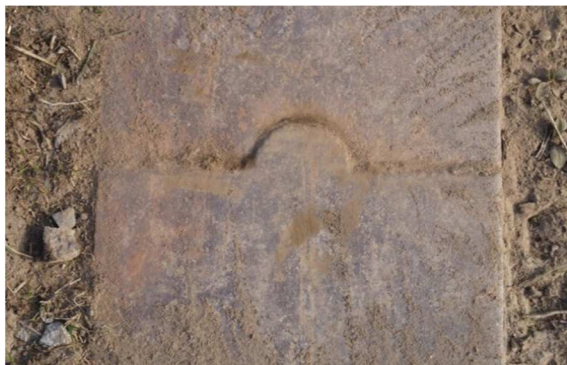
Figure 31. Detail of plate.

There are two parallel cast iron wheel plates set into the top of the bridge. They would have protected the top surface of the bridge from wear by the iron-rimmed wheels of the horse-drawn carriages and farm carts.

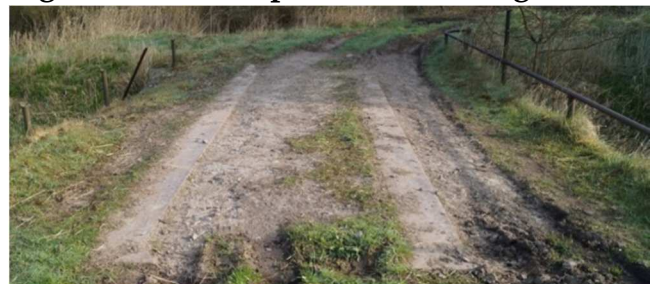
Figure 30. Wheel plate on the bridge.

The cast iron wheel plates are extremely well made and are closely dove-tailed together at the ends.

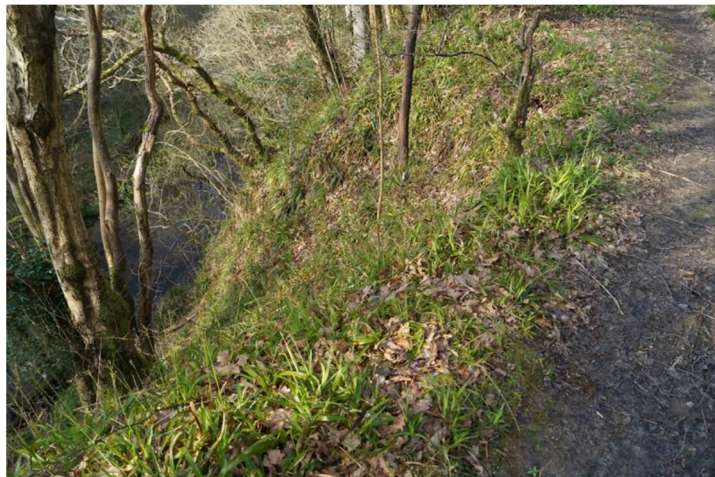
Figure 34. Cliff edge location.

In the 1950s a section of the lade suffered a catastrophic collapse into the gorge of the river Black Devon [NS 93582 94049 to NS 93518 94038].⁽³⁷⁾ The collapse was due in part to the proximity of the cliff-like edge of the river gorge here and partly to the mode of construction, where much of the embankment on the river side of the lade was constructed of excavated material.

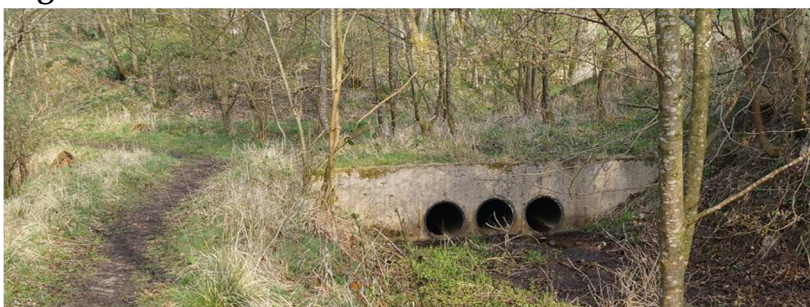
Figure 35. Modern culvert.

The lade was reconstructed with three concrete pipes to provide additional support.⁽³⁸⁾ These were replaced with plastic pipes as part of the refurbishment of the system by Central regional Council in the 1990's.⁽³⁹⁾

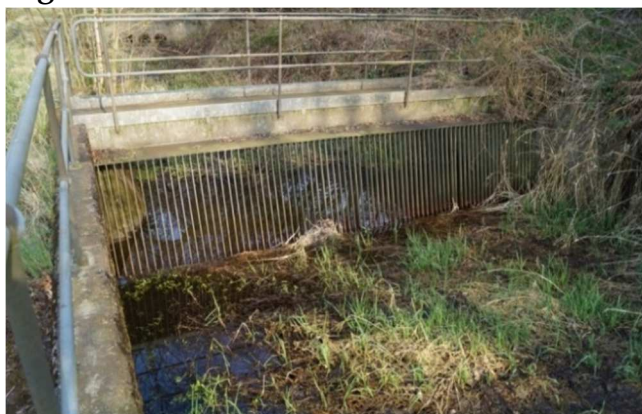
Figure 36. Modern sluice.

A sluice with a leaf catcher and spillway was built before the start of the pipelines. [NS 93587 94051]. The sluice has a spillway to regulate the level of water and a valve to allow water to be directed into the river. The construction style is similar to that of the sluice at Forestmill and at Aitkenhead.

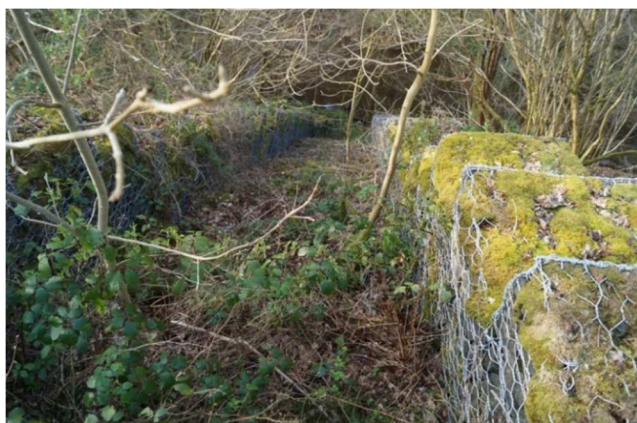
Figure 38. Run-off channel.

Wire gabions were used to construct a run-off down the cliff to the river Black Devon.

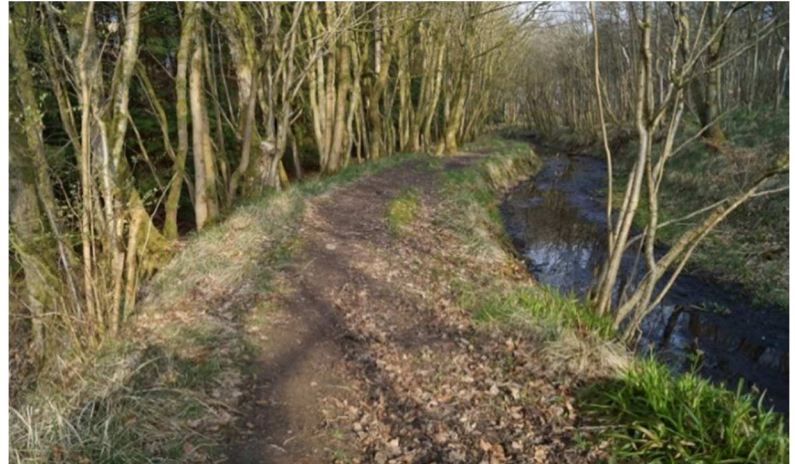
Figure 39. Lade heads for the watershed.

From this point the lade runs through woodland is shaded by trees and is often filled with rainwater, so has very little vegetation growing in the bed. It heads towards the small valley which crosses the watershed between the river Black Devon and the Brothie burn.

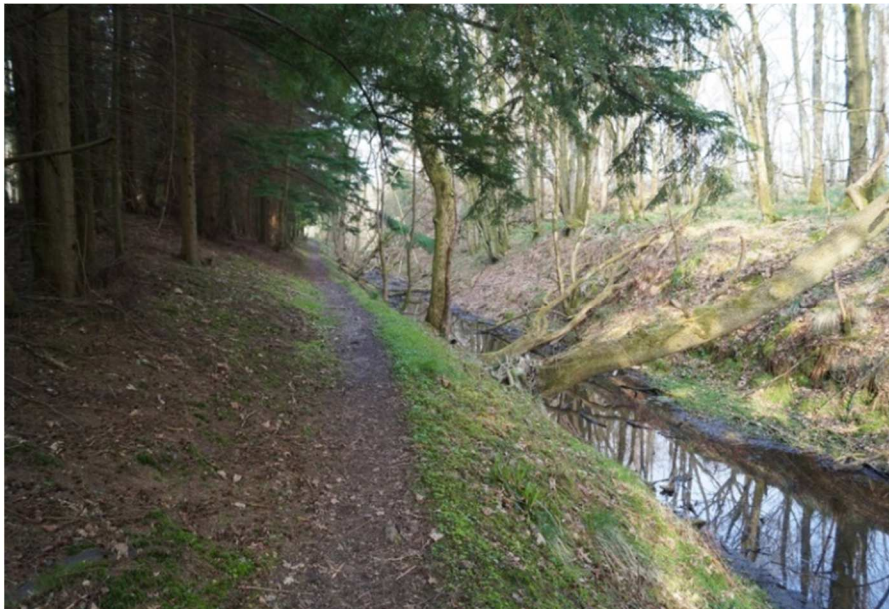
Figure 40. Lade in cutting in valley.

Entering into the valley, the lade now has higher ground on both sides for the first time in its course. Using this valley, the depth of cutting required to take the lade across the watershed has been reduced by more than half. It is likely that the western end of this valley provided the base level for Sorocauld's survey of the route of the lade in 1711.

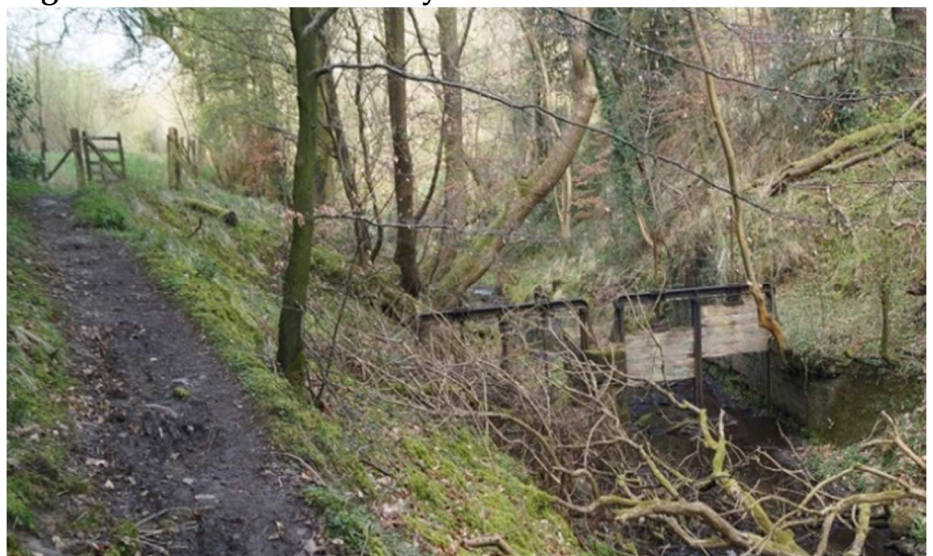
Figure 41. Sluice at the valley end.

There is a sluice at the eastern end of the small valley [NS 93184 94116]. The sluice is at the site of an old bridging point on the stream, carrying the road from Linn Mill [NS 92499 92868] to meet with the road from Fishcross to Coalsnaughton [NS 93341 95638].

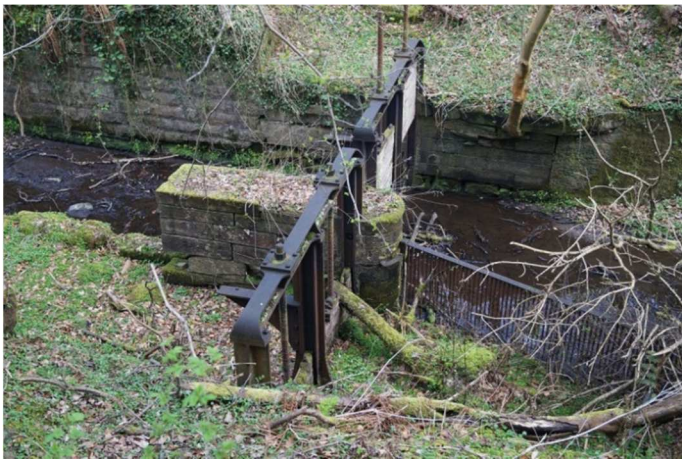
Figure 44. Twin sluice gates.

The lade becomes wider at this point and enters a double sluice with a central pier separating the lade bed into two channels. Each channel has a cast iron frame bolted into the stone walls and each frame has two wooden gates. The southern (nearer) channel has a fixed metal leaf catcher in front of the gates.

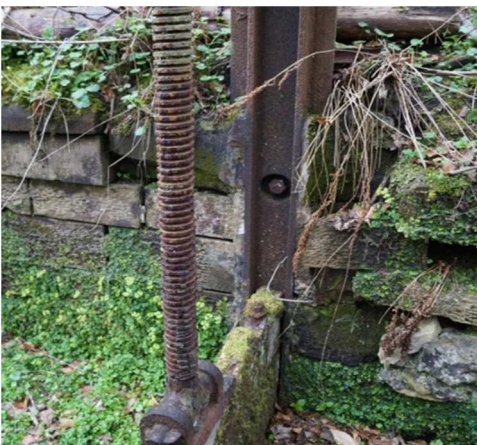
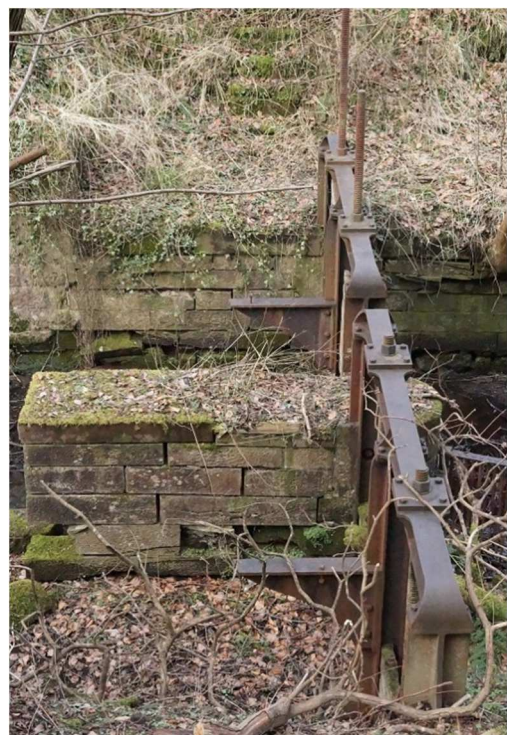
Figure 46. Slots and risers.

The gates are made of wood and sit in slots in a frame which is bolted to the wall. Turning a nut on top of the screw lifted up the gates.

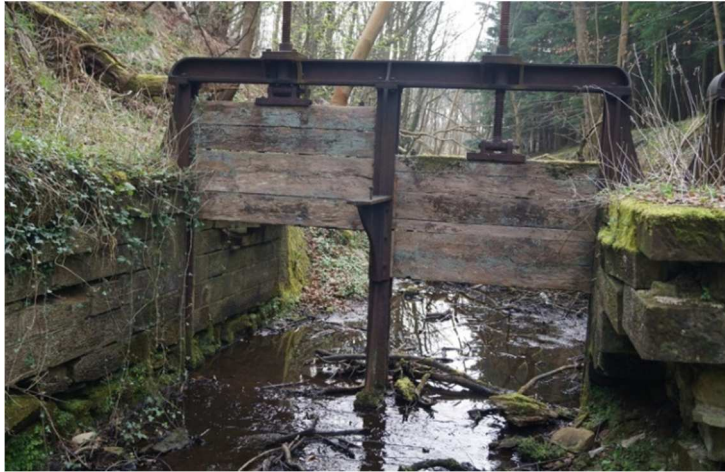
Figure 47. Northern double sluice gates.

The frames of the sluice gates have been cast in the same mould. The method of lowering and raising the gates is identical. Both sluices had a fixed wooden board to allow access to the screws.

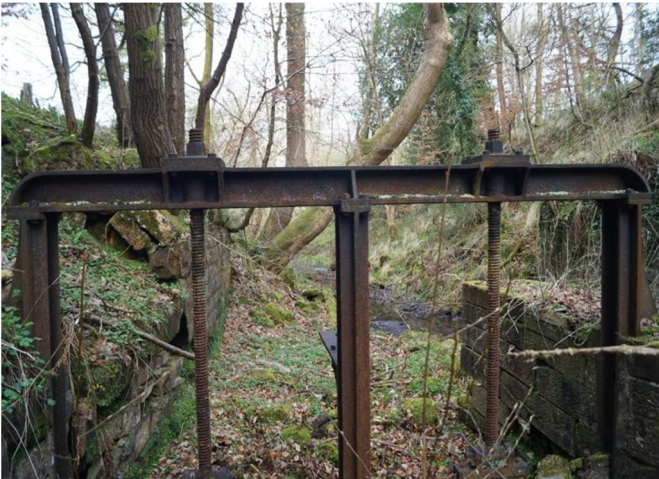
Figure 51. The southern channel.

Looking downstream along the line of the southern channel, it is clear that some of this debris is stonework from the bridge pier, which has been dislodged by tree roots. Some is leaves and wood deposited over time. Historical research shows that this southern channel was directed into an 18 inch (46 cms) fire-clay pipe which took water along the southern shore of Gartmorn Loch to a pond on the southern end of the Gartmorn dam.⁽⁴⁰⁾

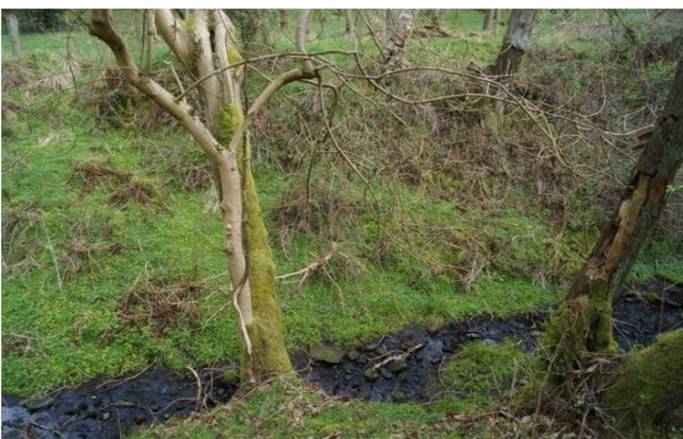
Figure 53 Lade below the sluice

Beyond the sluice the nature and the gradient of the Forestmill lade changes dramatically. It becomes a small stream, running on the sandstone bedrock and having a gradient of 1:100 or 1%.

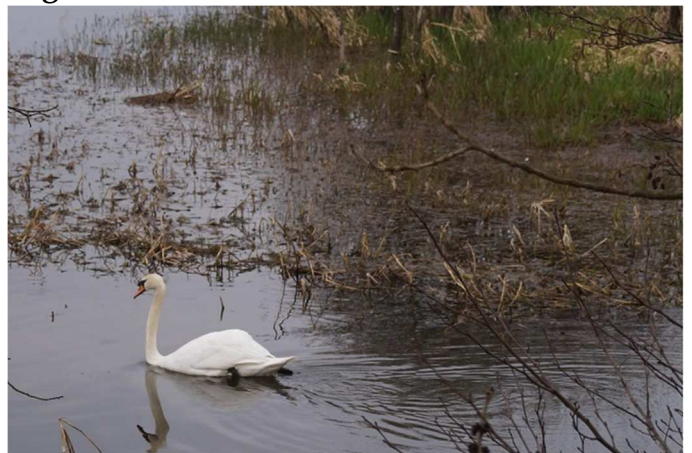
Figure 58. Lade enters Gartmorn loch.

Finally, the lade enters into the loch in a small inlet. The Forestmill lade, now a tiny stream, was some two to three feet (61 cms to 91 cms) deep in 1892 and delivering two million gallons (9,092,180 litres) a day to the Gartmorn water system ⁽⁴⁴⁾

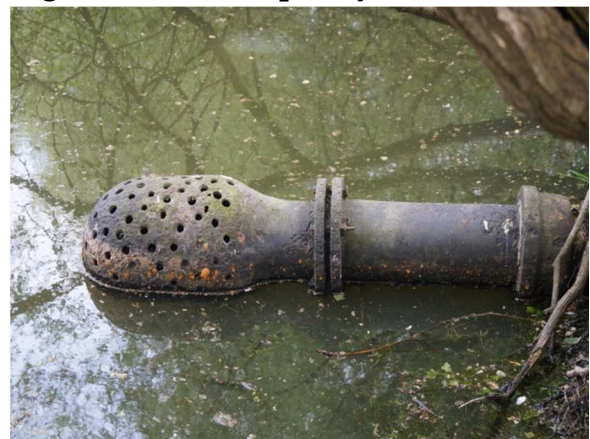
Figure 60. Contemporary rose.

From this record we know that there was a system of filtration and control at the sluice and the input pipe was associated with a "rose". Figure 60 shows a contemporary rose from the Gartmorn high level settling pond. We hope that further investigation of the site will reveal more details.

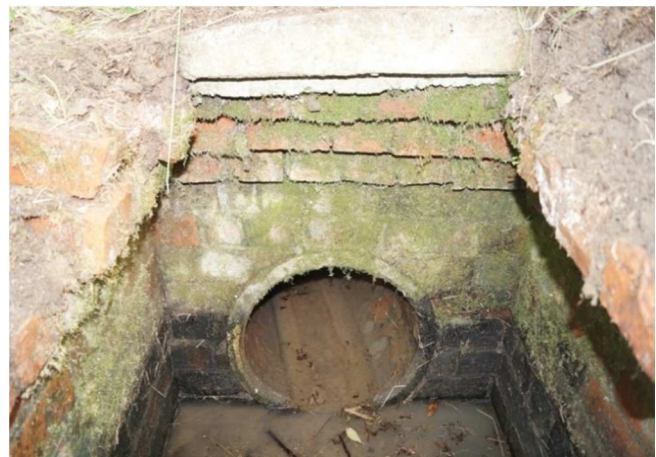
Figure 64. Clay pipe.

A glazed, 18 inch (46 cm) diameter, one inch (2.5 cm) thick, four foot (122 cm) long fire-clay pipe enters the chamber from the upstream end.

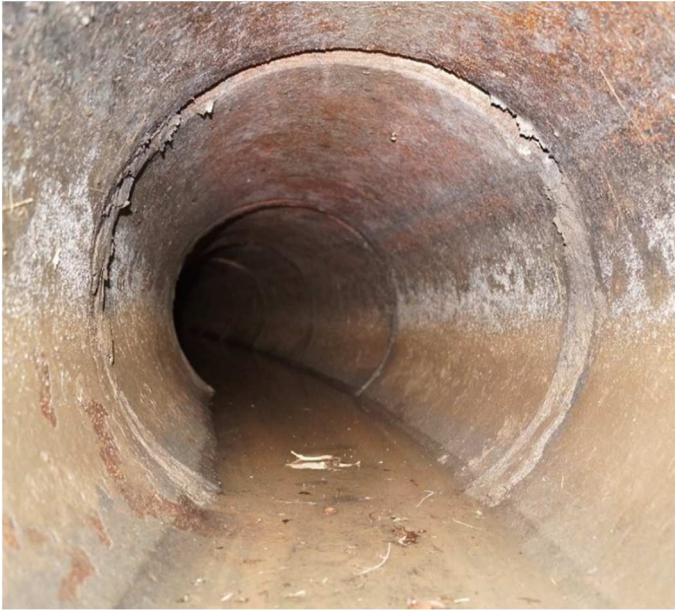
Figure 66. Clay pipe looking upstream.

The inner and outer surfaces of the fire-clay pipe are glazed. The line of the pipes can be seen bearing slightly to the left. This is possible as the pipe has spigot and faucet joints, sealed with mortar and giving a degree of flexibility in alignment. The pipe has only a small quantity of water sitting in the bottom but there is a thin line of wetness above this, suggesting that there was a higher level of water in the recent past.

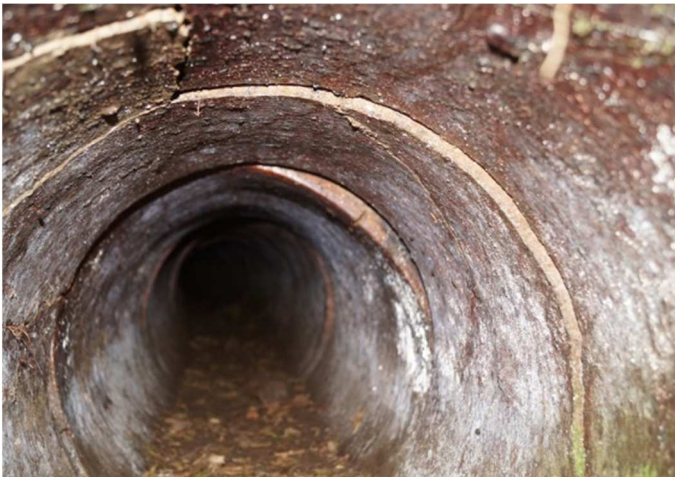
Figure 67. Craigrie lade fire-clay pipes.

The Craigrie lade had spigot and faucet glazed fire-clay pipes of the same dimensions, being four feet long, with an 18 inch internal diameter and one inch thick walls (123 cm long, 46 cm internal diameter and 2.5 cm thick walls). The Craigrie pipes were laid in 1866 in the bed of the abandoned Craigrie lade to bring a supply of water from Linn Mill to the town of Clackmannan (for fuller details see the Craigrie Lade technical report).⁽⁵²⁾

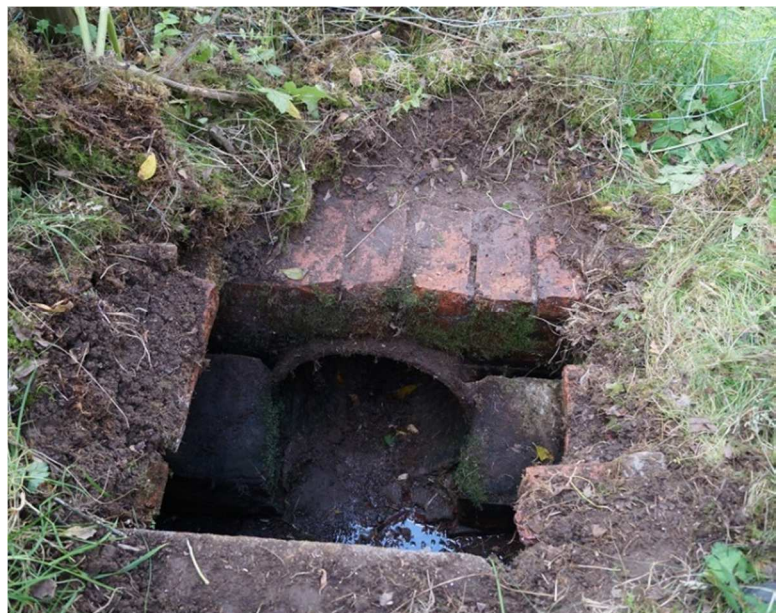
Figure 68. Iron pipe leaving the chamber.

An iron pipe exits the chamber on the downstream side. It is held in place by two small brick-built, concrete covered piers.

While the clay pipe is almost level, the iron pipe slopes downstream at a gradient of about 1:3. This pipe is the start of a siphon, taking the water under the valley to the West.

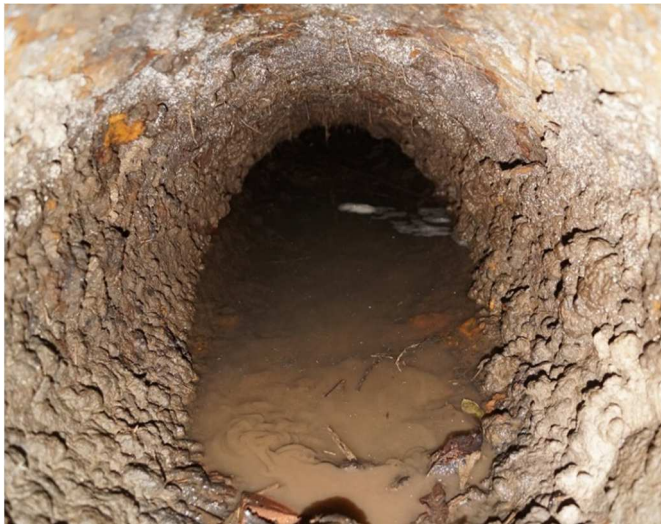
Figure 69. Iron pipe looking downstream.

The chamber appears to have served a number of purposes. It provided a means of connecting the fire-clay and iron pipes. It had a sump to collect heavy sediment and allowed access to clean it. We were surprised to find that it did not have a drain or gate to stop water flowing into the siphon.

The iron pipe is heavily corroded and filled with water. At the time this photograph was taken the layer of corrosion was damper above the water line, suggesting that the level of water had been significantly higher recently.

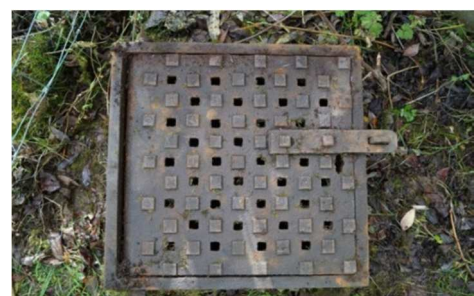
Figure 72. Cast iron cover.

Lying adjacent to the chamber was a cast iron base and hinged cover with a latch to enable the cover to be secured to the base.

This cover appears at one time to have been the on top of the chamber, the brick corbelling having been built to narrow the top opening of the chamber to hold the base. There was a thin concrete slab on the top of the corbelled bricks, perhaps once covering the edge of the base on the upstream side of the chamber.

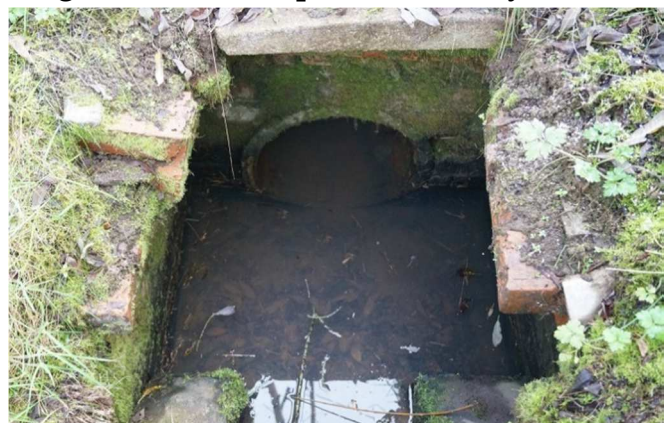
Figure 75. After a period of heavy rain.

This photograph, taken after a period of heavy rainfall, showed the water level in the chamber was significantly higher. The volume of water was too large just to have come in through the chamber top. This suggests that the pipeline might be still receiving water from the lade and the cast iron siphon is still operating.

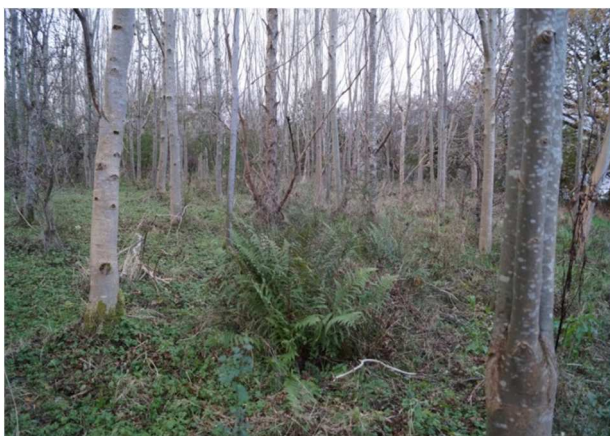
Figure 76. Line of rushes.

Using a series of poles, a line of sight was established along the line of the cast iron pipe from the edge of the brick chamber to the opposite side of the valley. At a point roughly equal to the height of the chamber there was an isolated clump of rushes and ferns. This was in the form of a short line, coinciding with the line of the wayleave for the pipeline on the Earl of Zetland's map and heading in the same direction. The pipeline then followed the contour of Gartmorn loch, turning as it crosses under the remains of a waggonway running between the early 19th century Clackmannan numbers 12 and 13 pits and heading directly towards the settling pond.

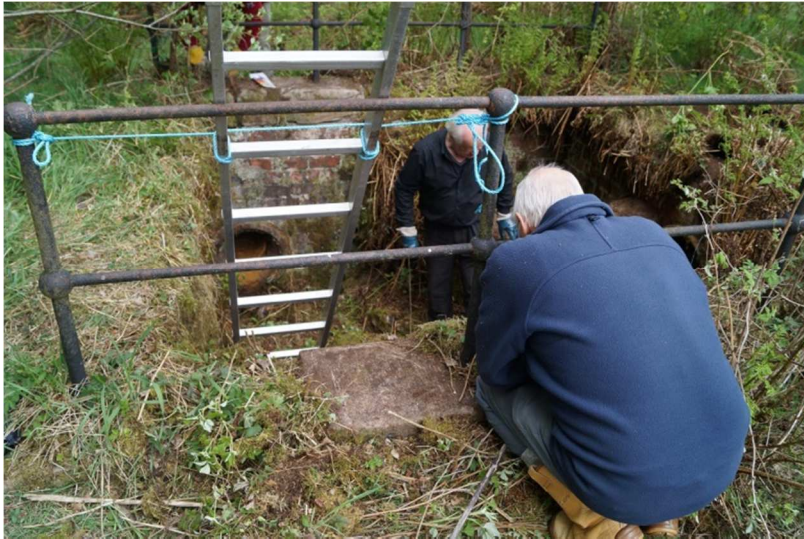
Figure 77. Inlet number 1.

On the eastern edge of the settling pond there is a large, brick-built chamber [NS 91588 93696]. The iron work is similar to than seen at the estate bridge at Shawbernaig.

This was a deep chamber made of bricks with a cope of ashlar blocks of sandstone and an iron fence. The 18 inch (46 cm) fire-clay pipe was at a very shallow depth crossing the adjacent field (less than a metre). The minimum amount of vegetation was removed to enable measurements and photographs to be taken. Wherever possible, all the vegetation was replaced.

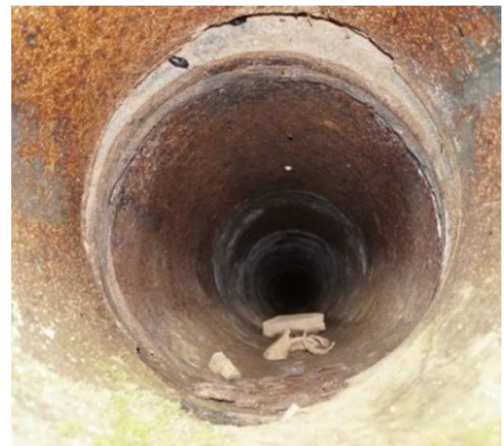
Figure 78. Fire-clay pipe.

The inlet pipe was identical to the one seen entering the siphon. It was 18 inches (46 cms) in internal diameter and made of a light yellow fire-clay, glazed on the inside and outside. It was four feet (123 cms) in length, of spigot and faucet design and mortared with cement.

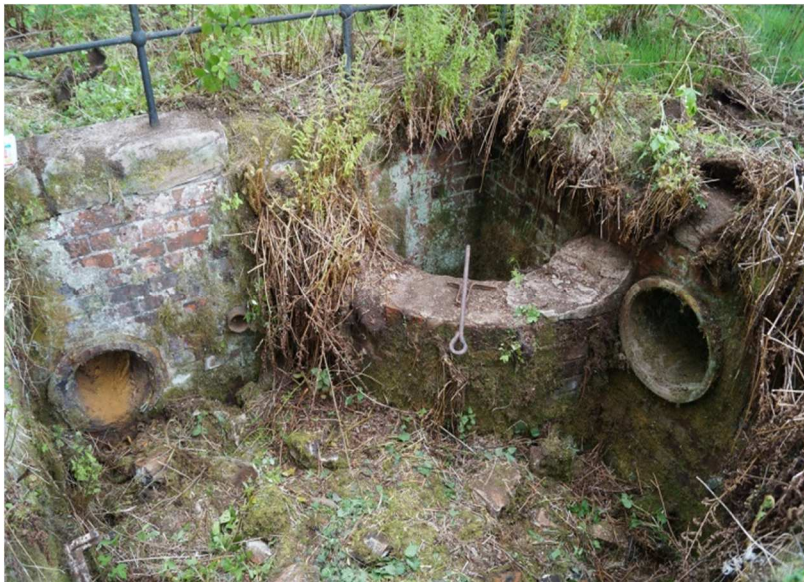
Figure 79. Northern and eastern walls of chamber.

There was an overflow wall in the corner. If the water level in the chamber reached the top of the inlet pipe, water would start flowing over the lip of the overflow wall. Due to the infill of rubble, we were not able to identify the overflow pipe, but the corner of the chamber is in line with an overflow ditch to the

North. The inlet chamber had a number of outlet pipes of different sizes, heading off in different directions. In the north western corner of the chamber a 24 inch (61 cm) cast iron reduction pipe connected into a 12inch (30 cm) diameter cast iron pipe.

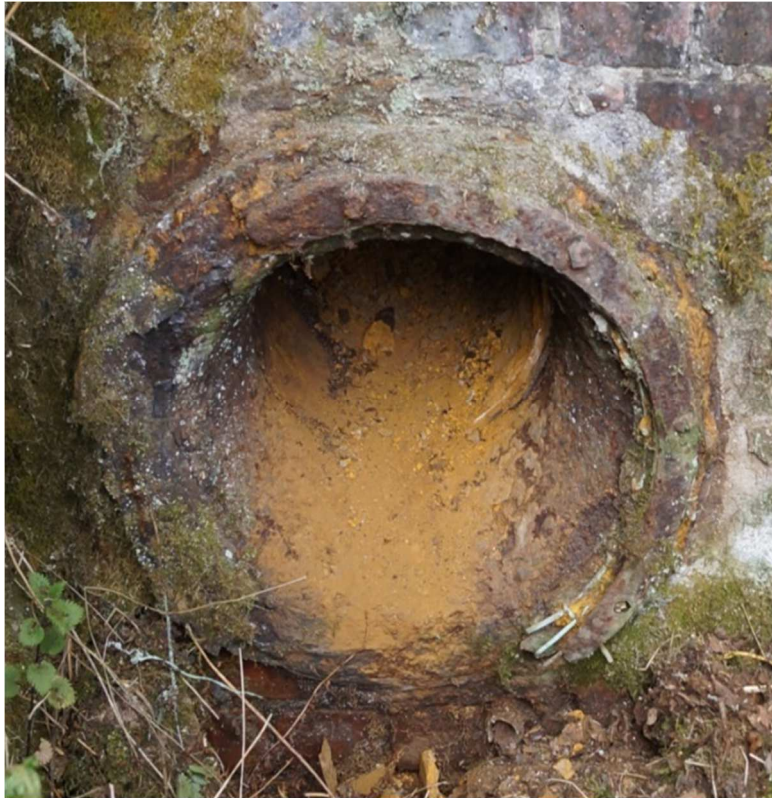
Figure 80. 24 inch filter.

The 24 inch (61 cms) filter had a bolt-on housing and there were traces of a galvanised filter in the bottom right corner. The reduction pipe and the filter were badly corroded.

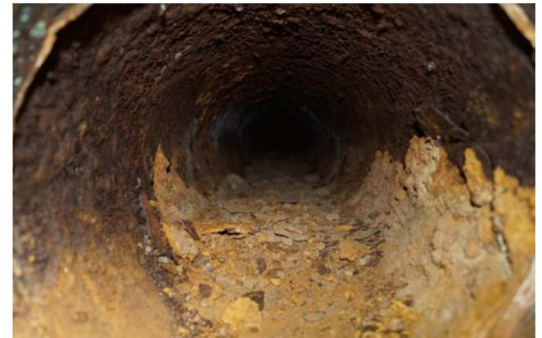
Figure 81. 12 inch pipe.

The 12 inch (30.5 cms) pipe was also badly corroded, with a layer of rust in the base.

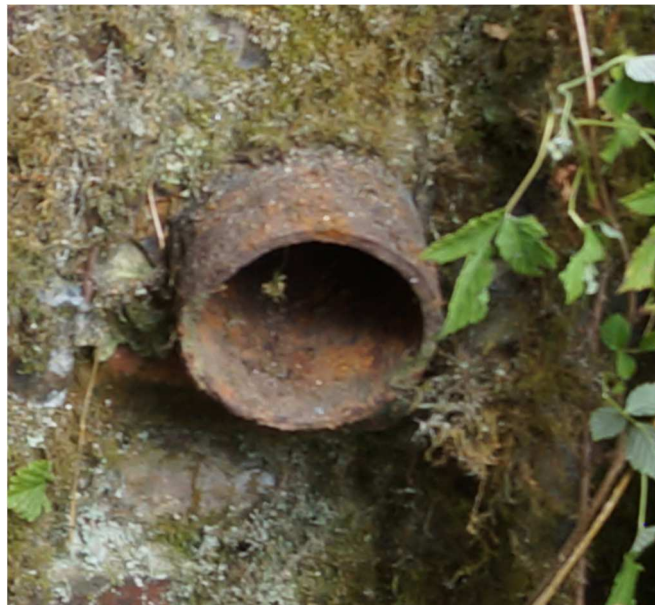
Figure 82. Four inch pipe.

A four inch (10.2 cms) badly corroded cast iron pipe also went through the northern wall of the chamber. Both of these pipes headed towards the filters and each had a toby box associated with it off the northern edge of chamber.

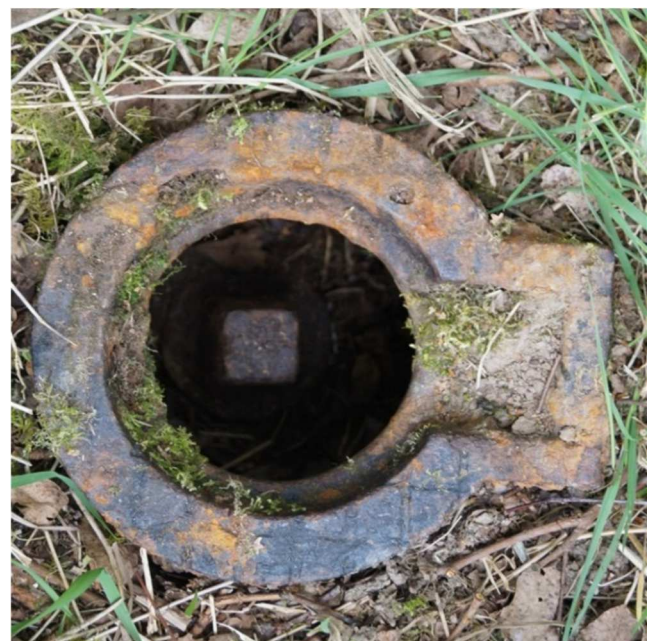
Figure 83. Toby box.

The presence of toby boxes on the edge of the chamber indicates that both these pipes had a valve to control the flow of water out of the inlet chamber.

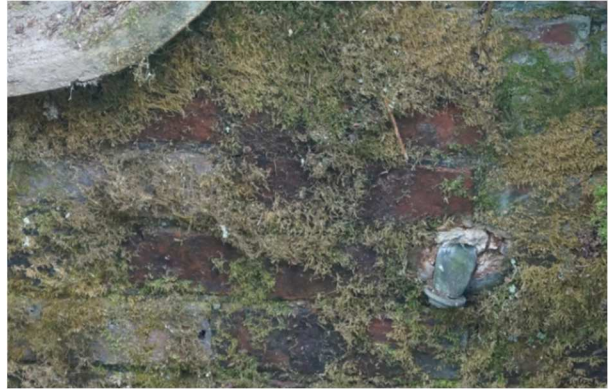
Figure 84. One inch lead pipe.

The end of a one inch (2.64 cms) lead pipe was situated out of the eastern wall of the chamber, just below the level of the fire-clay inlet. We have no indication where this pipe went, but its small diameter and lead construction is suggestive of a local supply. Perhaps this pipe took water to the nearby waterman's cottage and/or to the water house to the North of the filter beds.

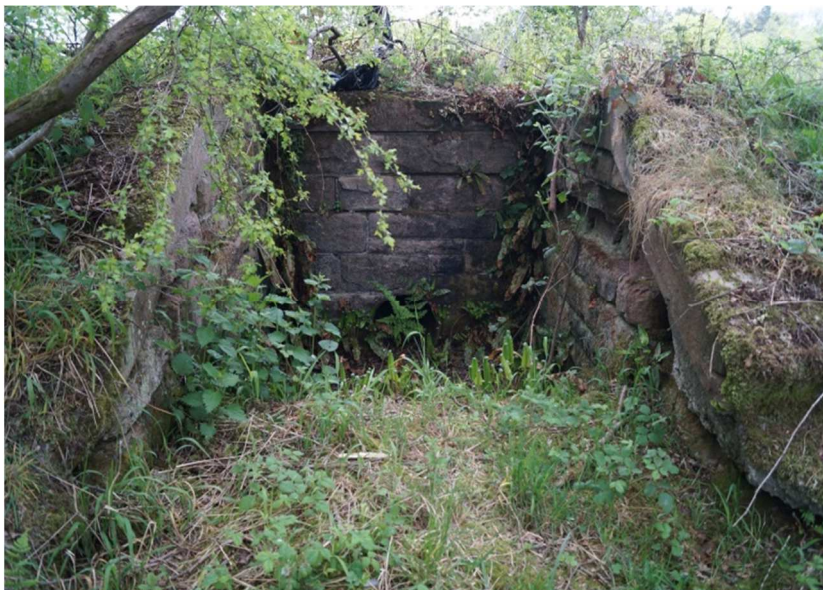
Figure 87. Outlet chamber on the edge of the pond.

There is an outlet chamber on the edge of the pond, made of well-cut ashlar blocks of sandstone, with a sandstone coping. An 18 inch (45.7 cms) cast iron pipe connects the inlet chamber through to this outlet chamber. The outlet pipe has a small settling chamber in front of the pipe before water was directed into the settling pond.

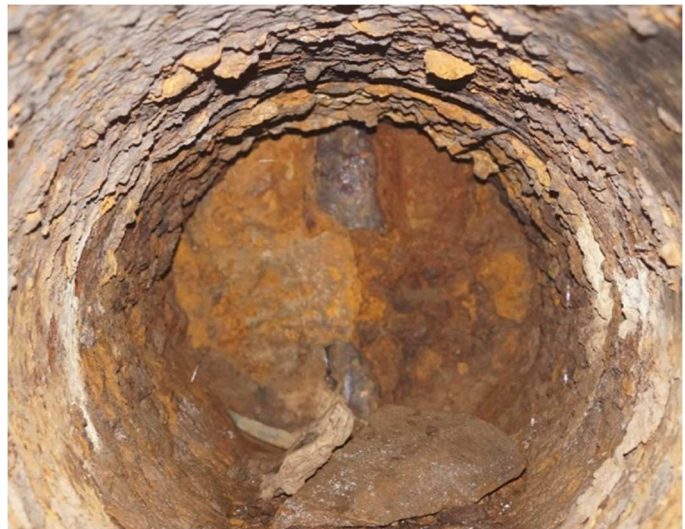
Figure 92. Butterfly valve in inlet pipe.

A butterfly valve is used to cut off the flow of water where there is not any great pressure in the pipe. When the shaft is turned so that the circular plate is across the pipe, the flow of water is cut off. Turning the plate so that it is in line with the pipe lets the water flow through the pipe.
