Two Estates Project

The Clackmannanshire Field Studies Society [SCIO]

The Two Lades Project - The Gartmorn Lades

1890 - 2006

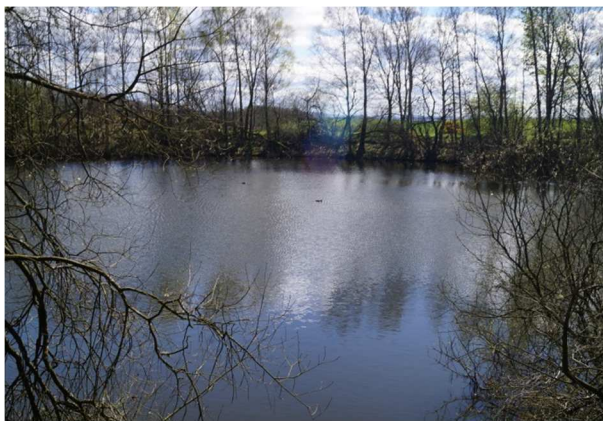
Figure 95. Settling pond.

The surface of the water presently lies about two metres below the top of the embankment and one and a half metres below the level of the inlet pipe from the number one inlet. The water still appears to be of a considerable depth in the centre of the pond.

The settling pond is currently filled with rainwater and surrounded by a skirting of mature trees [NS 915936]. It is roughly 58 metres in diameter ⁽⁵⁴⁾ and of unknown depth. It is surrounded by an embankment of clay, about 1.5 metres above the ground surface.

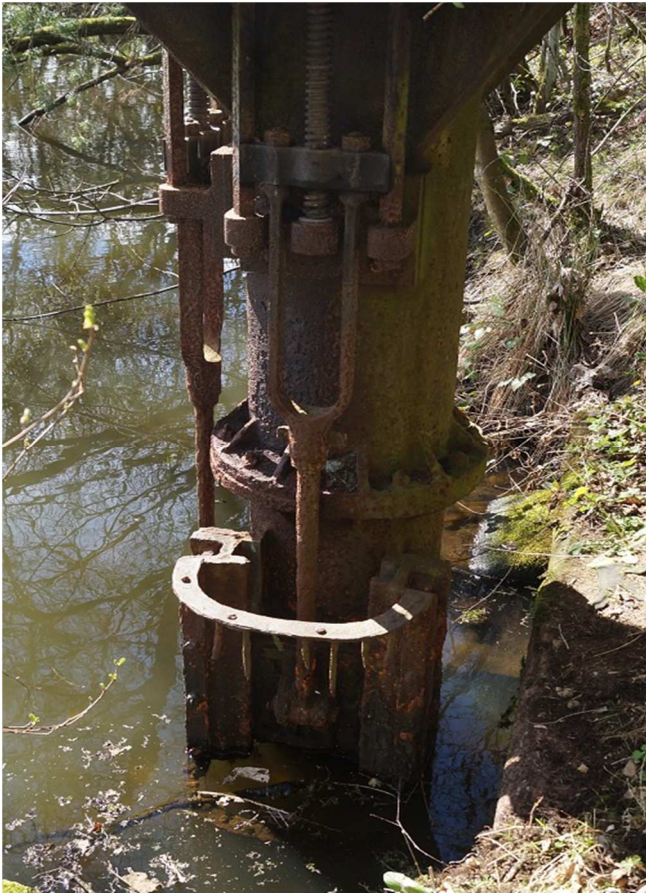
Figure 98. Slide valve screw lifts.

Two vertical rods are bolted to castings on the side of the pipe. A bar slides up and down between the two side rods. The bar has a vertical, screwed shaft running through its centre, with a squared top end. Using a key to turn the squared end raises and lowers the horizontal bar. The horizontal bar is also attached to the two ends of a u-forked shaft.

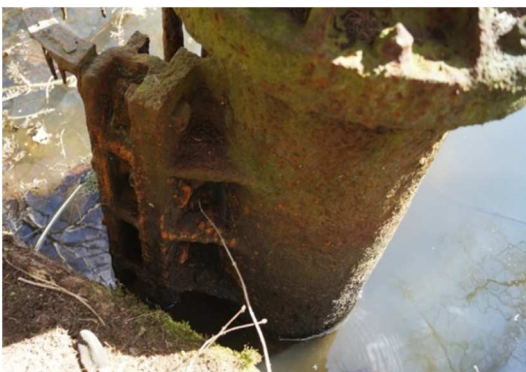
Figure 100. Gate valve side fitting

The u-forked shaft connects to the top of a shaft fitted to a sliding gate valve. The gate valve sits within two side plates bolted on to a cast fitting on the pipe. Turning a key on the top of the screwed shaft raises and lowers the gate valve. Both gate valves are sitting in the closed position.

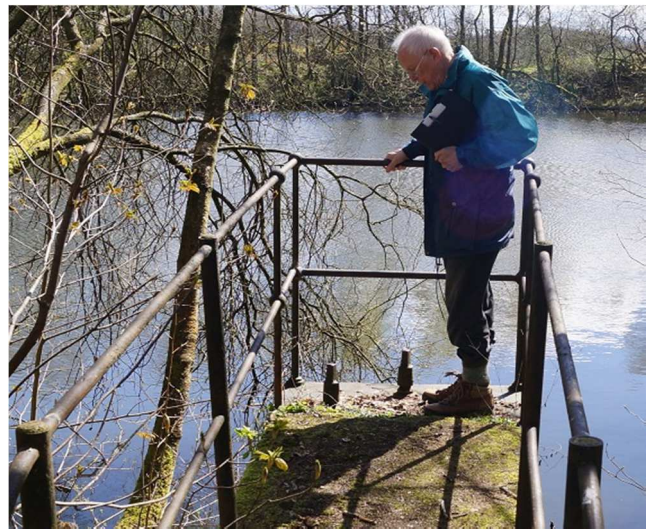
Figure 97. Settling pond outlet tower.

The main pond outlet sits on the northern edge of the pond [NS 91530 93711]. The outlet is a vertical cast iron pipe, with a connecting bridge giving access to two square topped shafts leading to slide valves below.

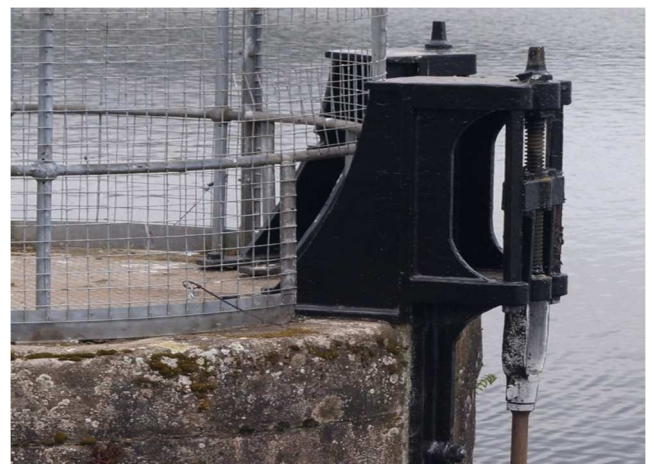
Figure 99. Gartmorn dam slide valves.

The design of the slides is identical to those on the tower of Gartmorn dam.

A description of a visit by the Alloa Burgh Water Commissioners in 1895 suggests that the compensation supply for the town of Clackmannan was drawn from the settling pond at that time. ⁽⁵⁶⁾ This pipe is at the same level as the upper gate valve on the settling pond outlet tower (see figure 99) and a "rose" was mentioned as part of the input to the 18 inch (45.7 cms) fire-

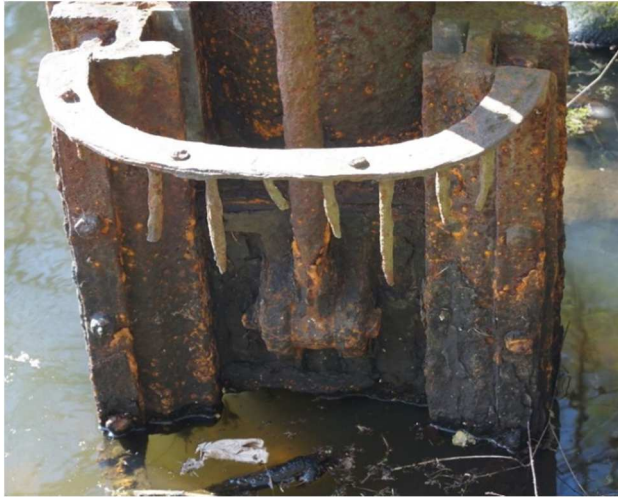
Figure 101. Upper gate valve.

The two gate valves lie at different heights. The upper valve is just above the current water level in the pond. The lower gate valve is located well below the water level. This arrangement allows the water going into the pipe to be taken from close to the surface or, if the water level in the pond is low, from a greater depth.

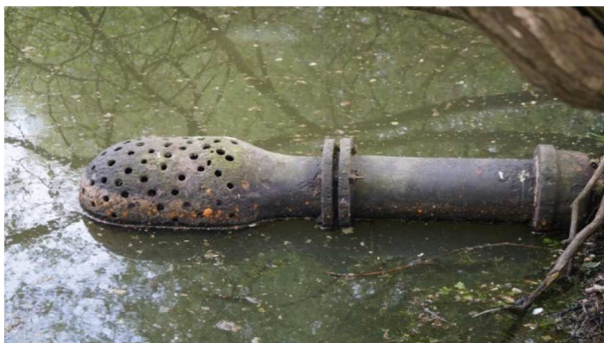
Figure 103. Rose-ended pipe.

A rose-ended six inch (18 cms) cast iron pipe is situated in the South bank of the settling pond [91548 93652]. This location is shown on the wayleave plan from the Earl of Zetland in 1895 as the start of the pipeline from the Alloa Burgh Water Works, by way of Hillend, Fauld (Helensfield) and the Pottery to the filters on King Seat Hill at Clackmannan. ⁽⁵⁵⁾

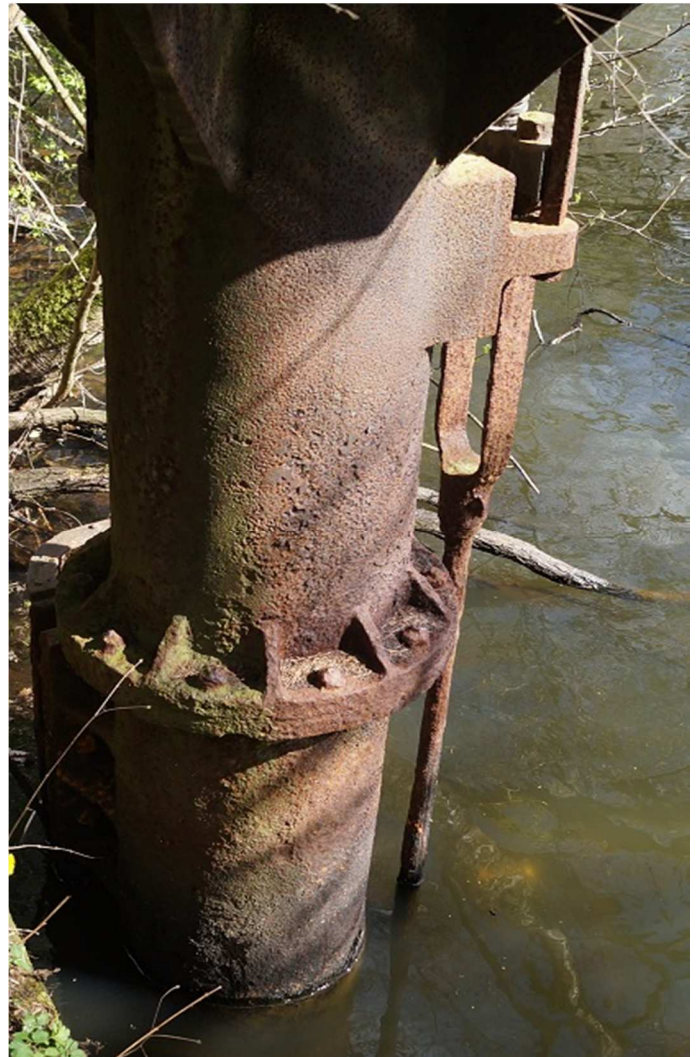
Figure 102. Lower gate valve.

The gate valve is a simple metal plate sitting over a hole in the vertical pipe. Moving the plate up admits water into the pipe. Lowering it back cuts off the water supply. The slides for the gate valve have a metal screen bolted on. This would have prevented floating debris getting down into the pipe.

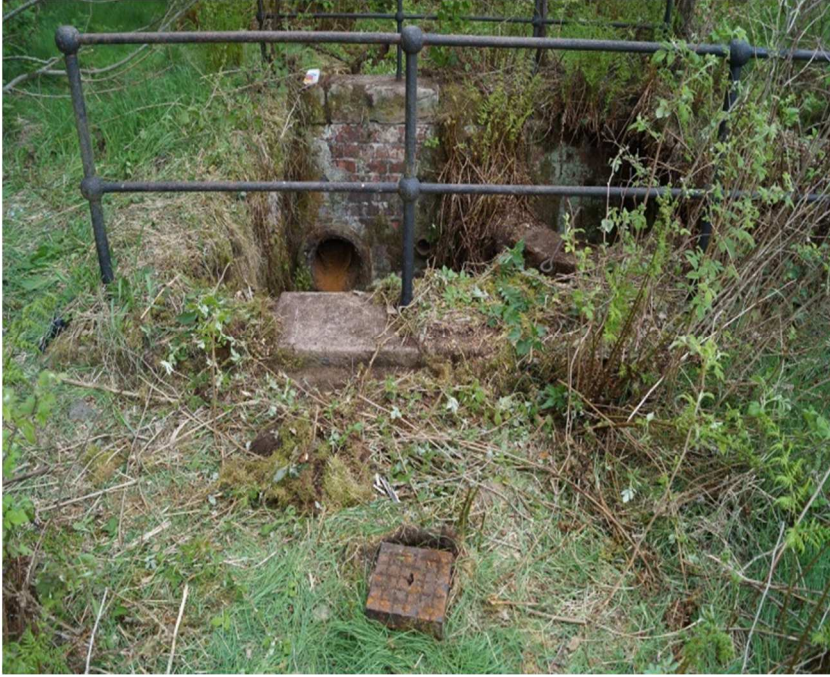
Figure 104. Toby box at the inlet.

A toby box on the southern edge of the number one inlet chamber controlled a pipe taking water directly from the chamber. This might be a connection to the Clackmannan pipe providing a supply of water if the level in the settling pond fell below that of the rose-ended pipe. This would work in the same way that the lower valve in the settling pond allowed water to be directed to the Alloa filter beds if the level of the water in the settling pond fell below the level of the upper valve.

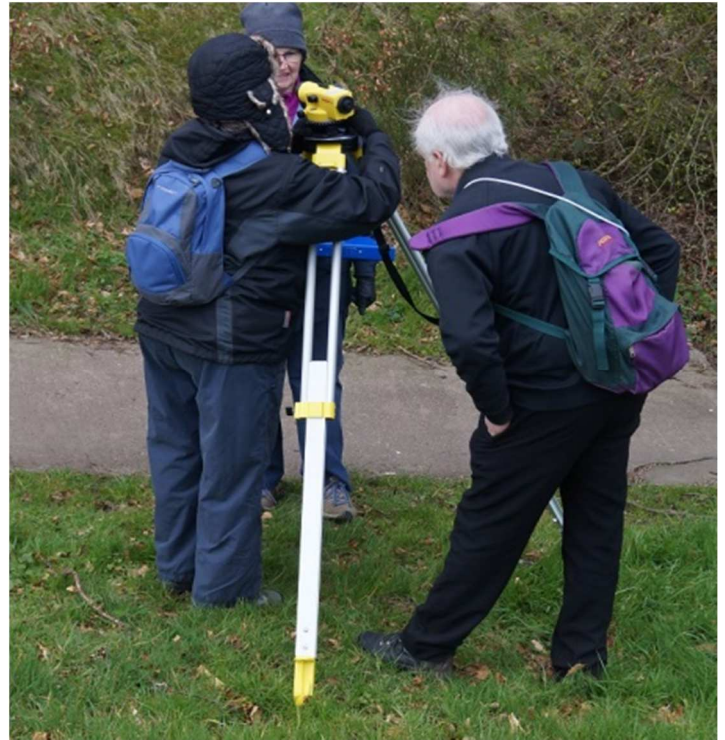
Figure 105. Surveying.

A considerable time was spent surveying the heights of the filter beds and settling pond at the dam and comparing them with the height of the remains of the filter beds on top of Kings Seat hill at Clackmannan.

The water level in the main inlet for the settling pond at Gartmorn would have been at a height of about 53 metres Ordnance datum (OD). This dropped to about 52 metres OD above the rose in the pond (if the pond was full). The level in the high level filters below the settling pond would have been at about 49 metres OD.

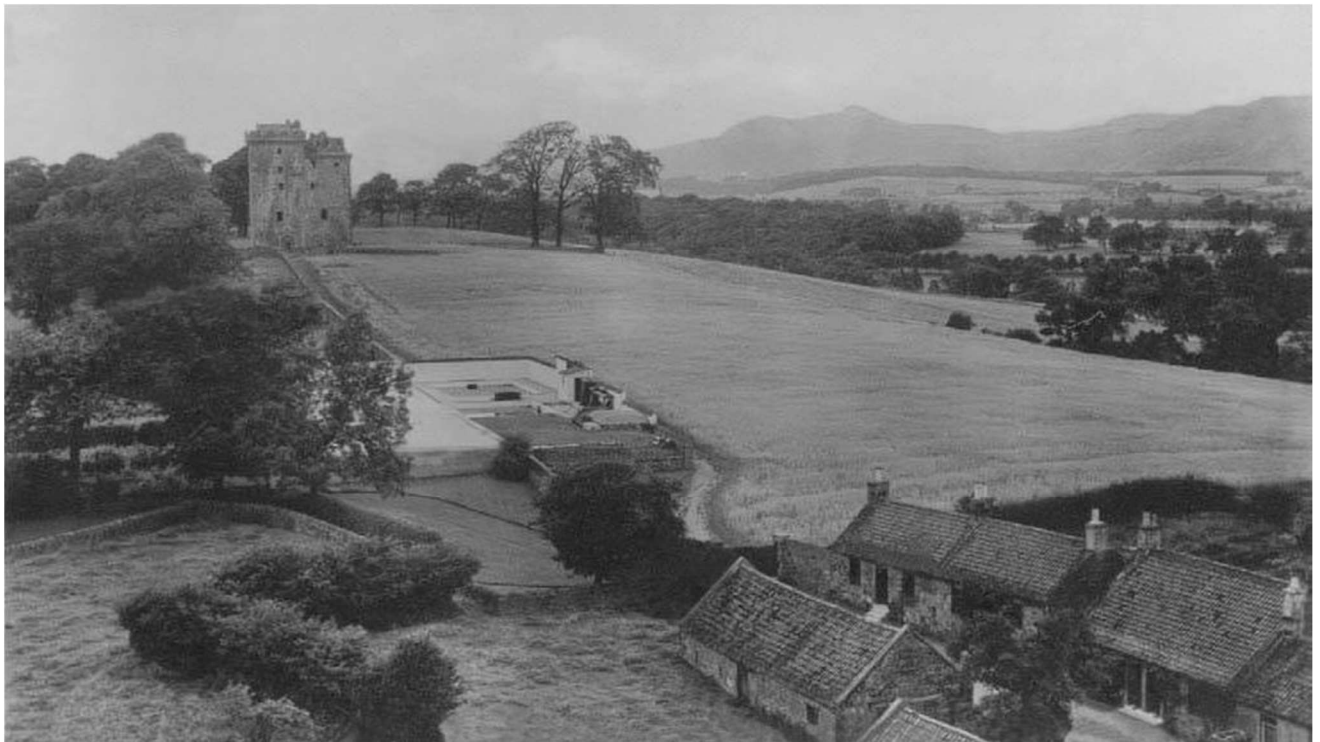
Figure 106. Clackmannan filter beds.

The inlet for the filter beds at Kings Seat hill at Clackmannan was about 51 metres. It would have been difficult to deliver a supply running from the chamber of the number one inlet at the settling pond using a gravity fed pipeline to the Clackmannan filters. The rose in the pond (if the pond was full) was still possible, but slightly more challenging. It would not have been possible to deliver water from the high level filter beds at Gartmorn to Clackmannan using a gravity fed system.

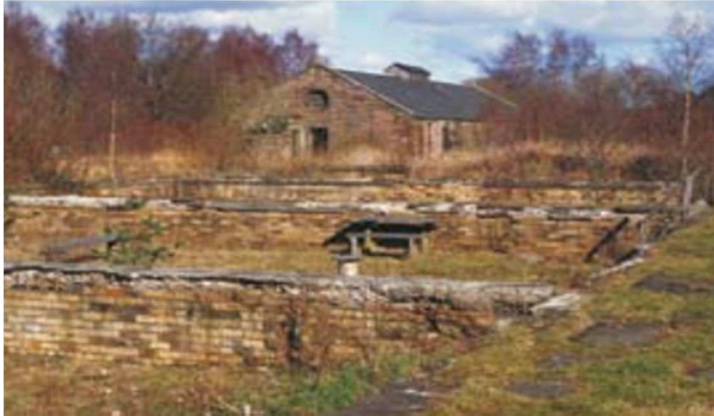
Figure 107. Filter beds and water house (1980).

The 1892 high level water house and filter beds have been lost and are now grassed over. The remains of filter beds built after 1892 have been redeveloped as a sunken garden. These remains give some idea of the design of the original filters.

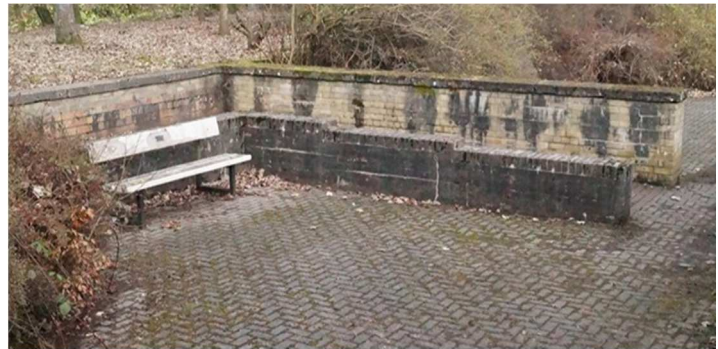
Figure 108. Early 20th century filter bed walls.

Several weirs, which collected water from the base of the filters on the northern side, were made of brick with concrete tops and metal grilles.

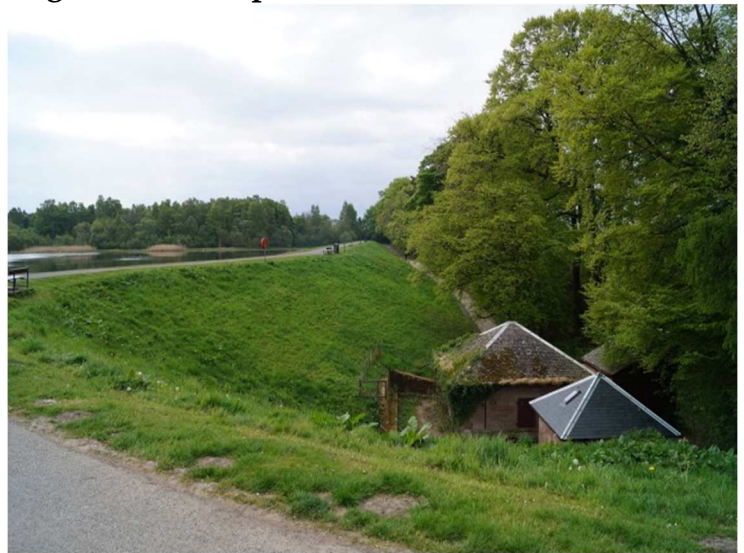
Figure 111. Pump house and water house.

In 1894 a small turbine, made by the Glenfield Company, Kilmarnock, was installed in the pump house ⁽⁶⁹⁾ (the larger stone building in the photograph). It used the pressure off the supply pipe from the control tower at the dam going to the Jellyholm filters to pump some of it up to the settling pond. The rest continued into the Jellyholm pipeline. In 1904, "the hydraulic was in full operation pumping at the rate of 258 gallons (1,173 litres) per minute to the high service system." ⁽⁷⁰⁾

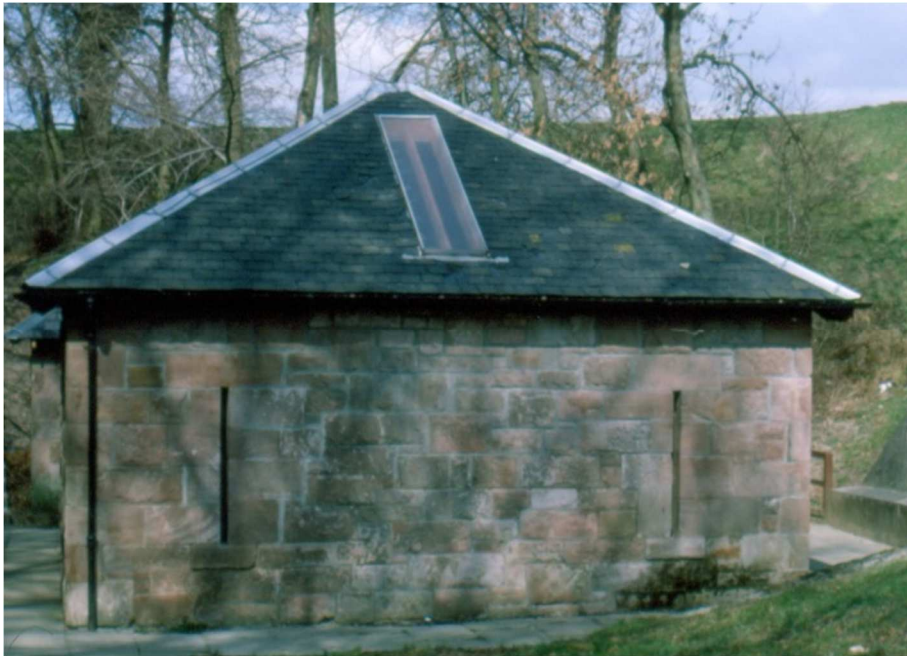
Figure 112. Pump house.

The required head of water for the turbine was 10 feet (3 metres). It was 24 inches (61 cms) in diameter powering a pump 11 ¼ inches (30 cms) in diameter with a 30 inch (76 cms) stroke. It worked at 30 single strokes per minute, delivering about 250 gallons (1,137 litres) of water to a height of 34 feet (10.4 metres). ⁽⁷¹⁾ The cost of purchasing and installing the engine was £210.0.0. ⁽⁷²⁾

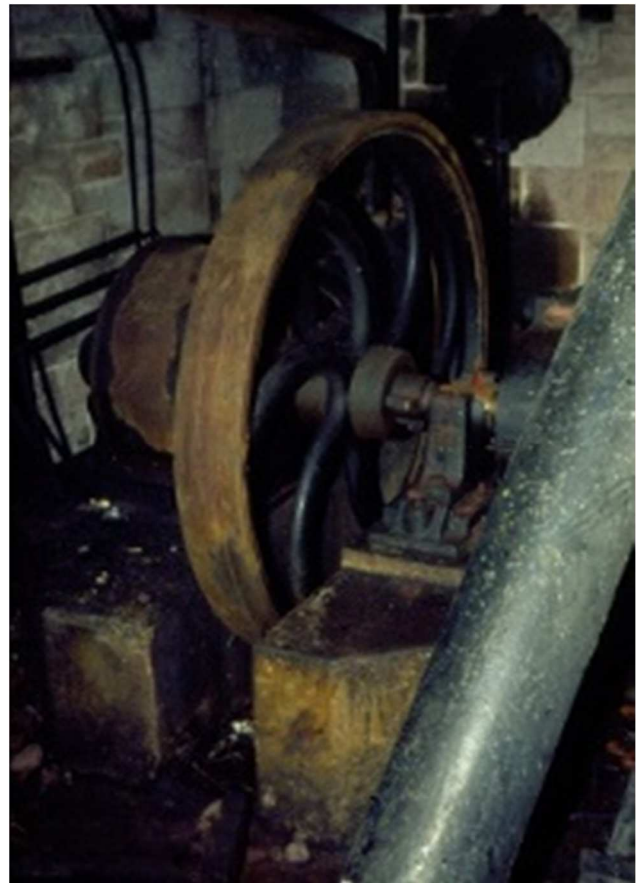
Figure 113. Remains of engine (1976)

A similar pipe to the one in the photograph in figure 113 (above) comes out of the dam to the South of the water tower. This 14 inch (35.6 cms) pipe is part of a siphon and lies directly in line with the pump house. We think that this pipe supplied water to the gas powered pump. The town gas engine drove a three-throw pump ⁽⁷⁷⁾ with three pumping cylinders in tandem. It had a capacity of 750 gallons (3,410 litres) per minute, ⁽⁷⁸⁾ three times the capacity of the water turbine. By 1897, the pump was operating at 1,100 gallons (5,000 litres) a minute, nearly 67,000 gallons (304,588 litres) an hour. ⁽⁷⁹⁾ As the three-throw pump accepted the flow from the one coming down the pipe from the side of the dam, a similar size of pipe would have been required to take this flow from the pump house to the settling pond.

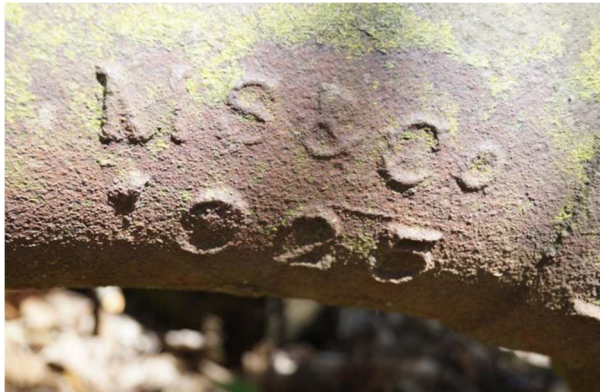
Figure 117. Cast details on pipe.

The cast iron pipe has standard spigot and faucet joints and a manufacturer's initials "M S & Co" cast into the side of the bend. We think that this pipeline at inlet number two, having a much smaller internal diameter to the one seen at the water tower and the one connected to the gas engine, might have been related to supply from the water turbine. Further research will be required to confirm or refute this.

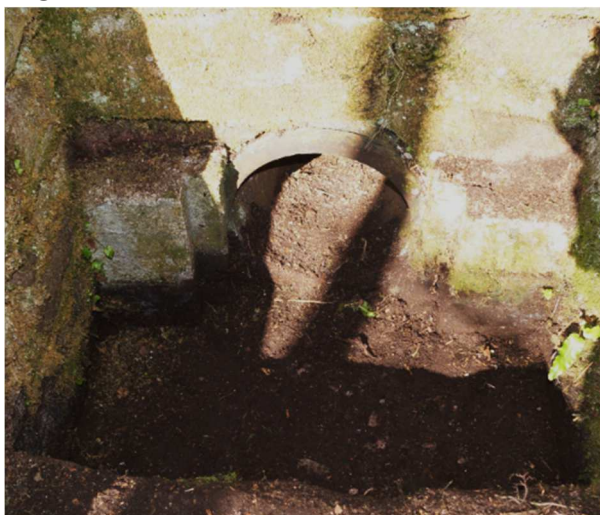
Figure 119. Brick sluice at inlet three.

There are the remains of two brick-built piers, one on either side of the outlet pipe. They appear to have retained a wooden sluice gate at one time, perhaps to prevent water from the pipe entering the settling chamber.

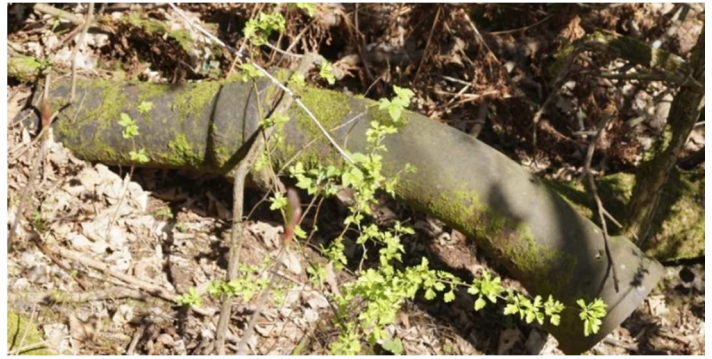
Figure 116. Inlet number two.

As well as the main inlet number one from the 18 inch (45.7 cms) fire-clay pipe, there are two other inlets to the settling pond. Inlet number two is an eight inch (20.3 cms) cast iron pipeline, immediately adjacent to the outlet sluice of the settling pond [NS 91530 93711].

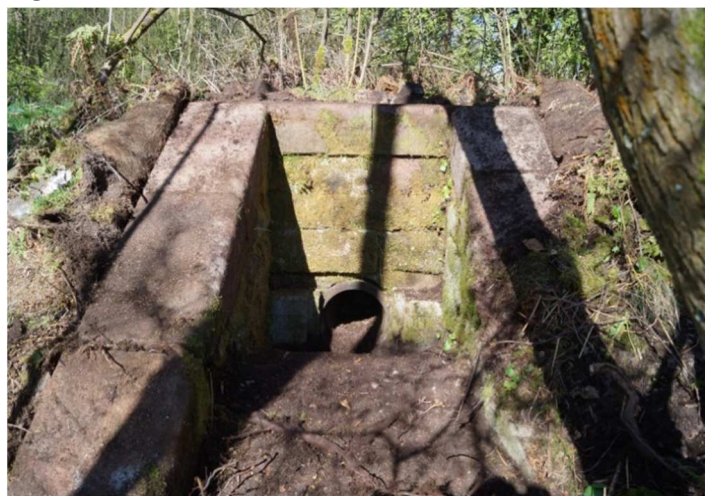
Figure 118. Stone-built inlet number three.

Inlet number three is a small, ashlar block sandstone structure, very similar to that of inlet number one. It is also built into the inside of the embankment of the settling pond [NS 91563 93710]. A 14 inch (35.6 cms) diameter metal pipe from the North East comes into a settling chamber before flowing over the sill into the settling pond.

We were not able to categorically determine the source of water for inlet three. The style of stonework is very similar to that of other constructions on the site dated to 1891 to 1896 and the pipe size suggests that it might be related to the three-throw gas powered pump.

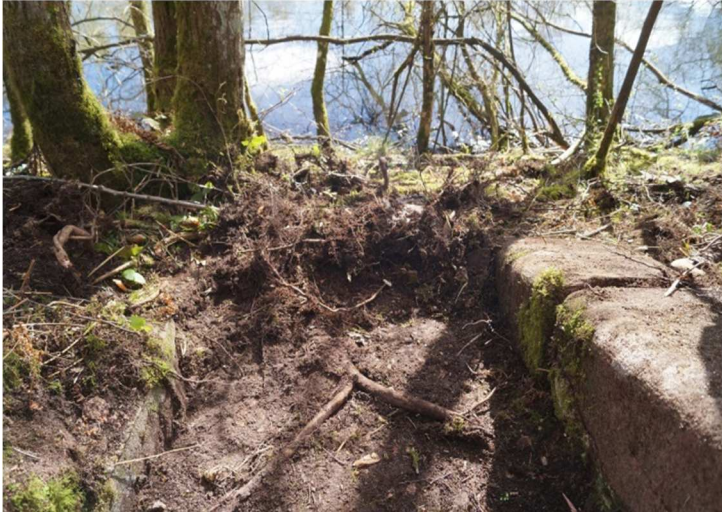
Figure 121. Inlet three spillway into pond.

The spillway into the settling pond has several mature trees growing in it, so has been abandoned for some time. We were not able to date the abandonment.

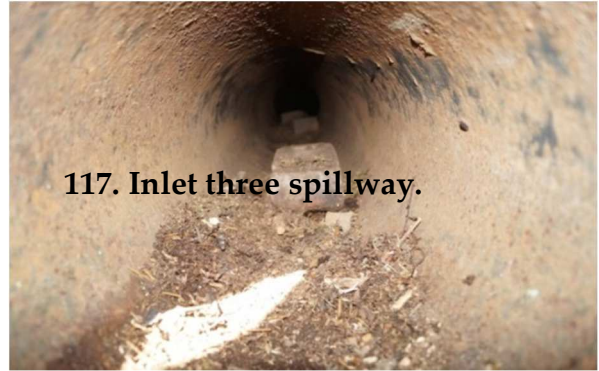
Figure 120. Pipe at inlet three.

The 14 inch (35.6 cms) internal diameter metal pipe is significantly better preserved than the other pipes around the pond.

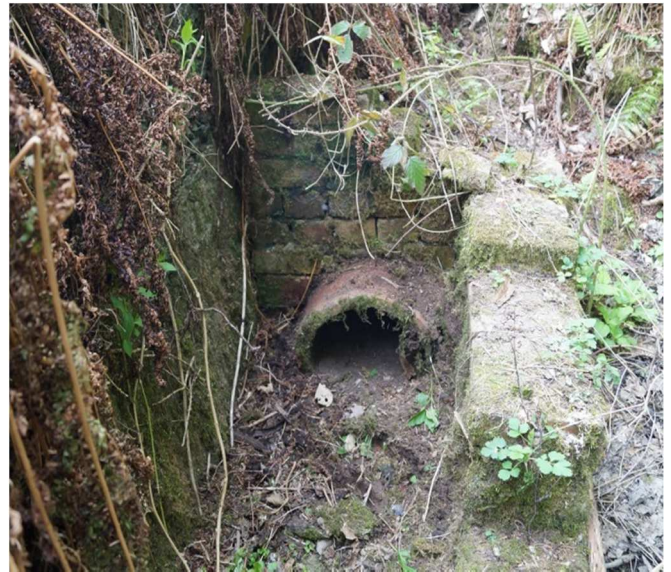
Figure 124. Brick-built chamber.

There is a small brick built overflow chamber at the head of a small ditch running down the eastern edge of the site [NS 91563 93763]. The ditch drains northwards into Gartmorn Loch [NS 91535 93843]. On the second edition 25 inch OS map of 1898 ⁽⁸⁰⁾ an the revised second edition OS map of 1920, ⁽⁸¹⁾ this ditch starts further to the North [NS 91553 93795]. It is shown in its present position on the RAF aerial photograph of 1945. ⁽⁸²⁾ This chamber has two fire-clay pipes leading into it. The larger pipe, with a 12 inch internal diameter, appears to be coming from the main inlet chamber to the South.

The smaller pipe, with a four inch internal diameter, is coming from the West. This pipe appears to be associated with a structure immediately to the West of the chamber.

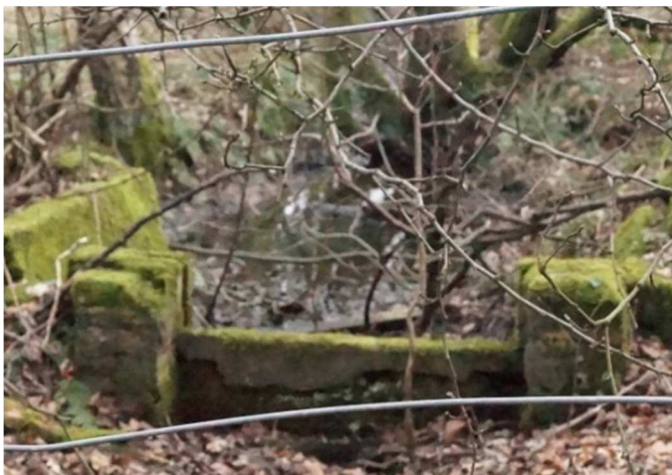
Figure 125. Settling weir.

The overflow ditch enters a small settling weir, just before it goes under the round-the-dam path [NS91568 93808]. Two brick piers with vertical slots could support wooden boards. The small pool behind would have allowed sediments to drop out rather than being carried down into the dam. This suggests that the overflow might have been carrying a flow of silty water at times. The waterman had a sand washer to clean the sand from the filters. ⁽⁸³⁾

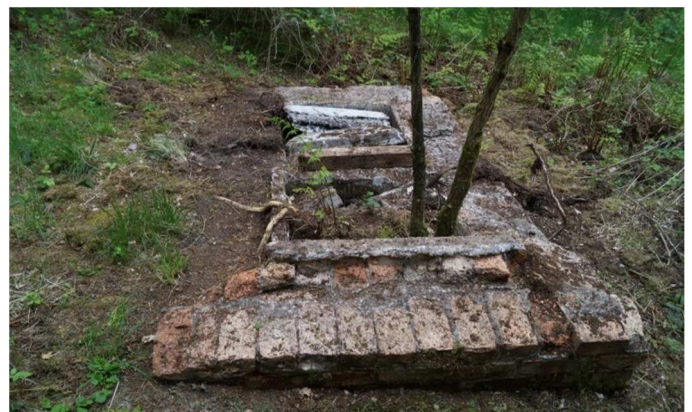
Figure 126. Brick-built structure

We did find two other constructions whose purposes we were not able to identify. The first was a brick-built, double trough immediately next to inlet number three beside the settling pond [NS 91561 93726]. The walls were double thickness brick, reduced now to the tops of the troughs.

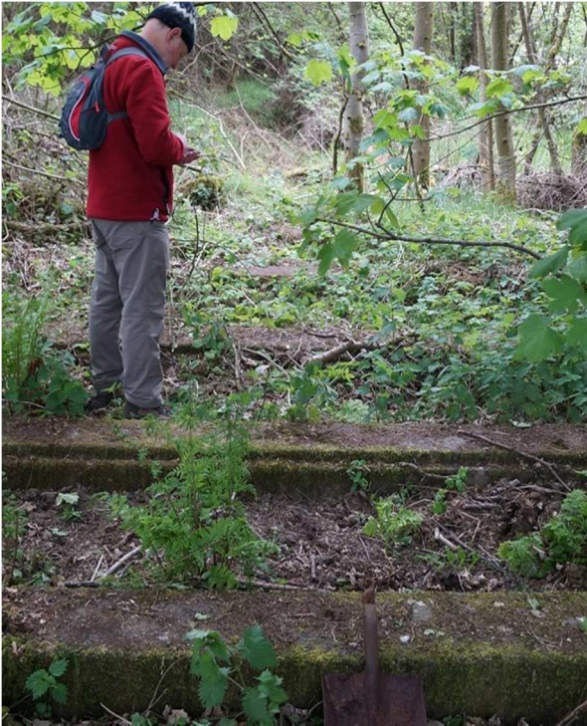
Figure 128. Brick built tank.

The second structure was a rectangular, tank-shaped feature. The outside perimeter wall was composed of double bricks. The top course was laid side across the wall and there was a cast cement cope, slightly narrower than the brick wall. There were three internal walls, linked at the southern end, but not at the northern end.

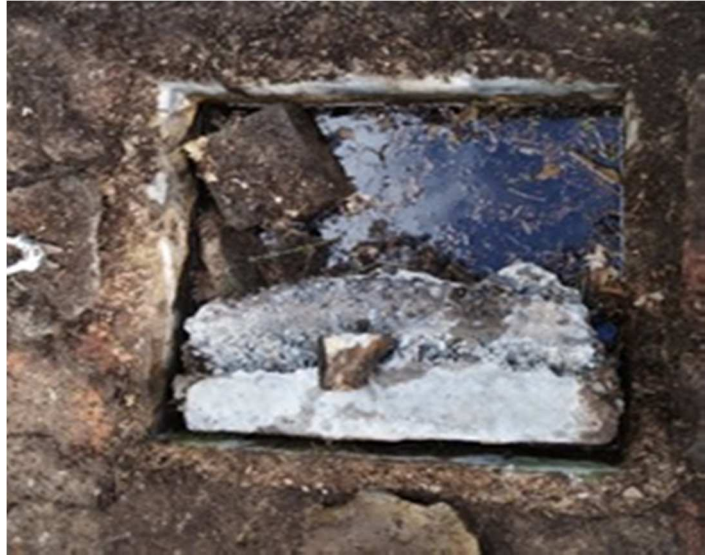
Figure 127. Trough.

The troughs had a white mortar lining and, as they were filled with rainwater, probably made it waterproof. Although the double brick wall had been reduced to the level of the troughs, it looked as if it had been higher.

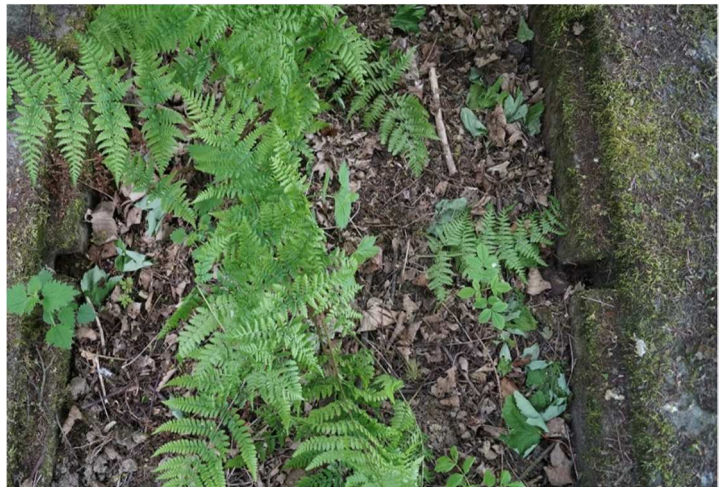
Figure 129. Slots and slots.

As the cement cope was narrower than the wall, the feature formed horizontal side slots along the top of the walls, possibly for covers. There were also vertical slots in the brick wall close to the open ends of each wall, possibly for boards. The structure was filled with and surrounded by fine sand.

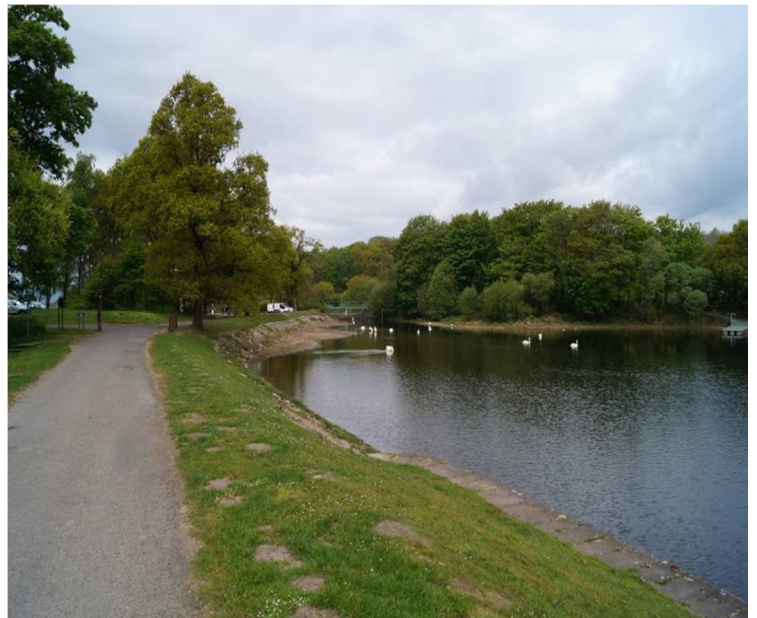
Figure 131. Gartmorn Dam

In 1891-92 Alloa Burgh had the earthen dam strengthened and heightened and a stone facing and cope installed. The dam was drained in order that these works could be carried out. ⁽⁸⁶⁾ It was reported in 1897 that *"Before the dam was increased in capacity the top water area when full was 147 acres, and the reservoir was capable of containing 47-48 million gallons. The top water area of the dam at present covers 167 acres and the reservoir has capacity for 48-49 million gallons, giving storage equal to 162 days' requirements"*. ⁽⁸⁷⁾

A road was built across the top to access the settling pond, filters and waterman's cottage. ⁽⁸⁸⁾ There also were constructed a central tower to control the flow of water out of the dam to the lower level, a stone-built pump house and a smaller stone-built house over the line of the main outlet from the tower to the lower level. ⁽⁸⁹⁾

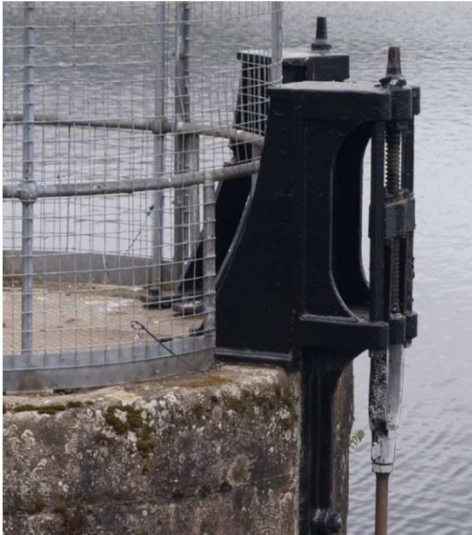
Figure 133. Control valves.

The tower was accessed by a small bridge. The wall is constructed of carefully fashioned blocks of sandstone and there is an access hatch into the centre void. There are two side valves of the same design as those at the settling tower. The side valves have lifting screws with squared tops and the screws control horizontal bars connected to u-forks, linked to a shaft. Although the valves cannot be seen, it is likely that, as in the settling pond, the two would be at different heights. The top valve would be used when the level in the dam was high. The lower would be used if the water level in the dam dropped. The style of the castings is very similar to the sluice gates.

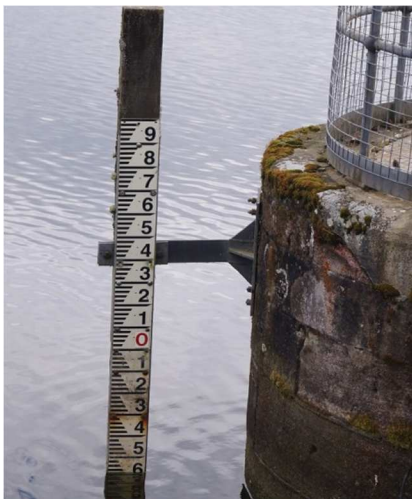
Figure 134. Depth gauge.

There is now a metric gauge, the original one measured in feet and inches. The level on the gauge was a matter of great concern as the dam had at times been very low, particularly in 1870 when it was seen to be at its lowest level in thirty years. ⁽⁹⁰⁾ The water tower supplied water to the water house, the smaller stone building below the dam.

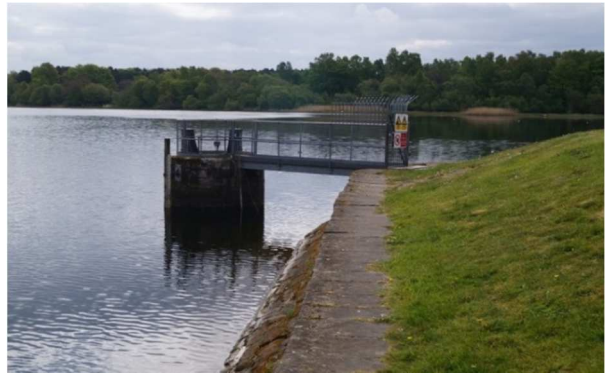
Figure 132. Circular tower.

The water tower controlled the outflow of water to the water house below (the smaller of the two buildings). The dam provided water to the Jellyholm filters, the Carsebridge distillery and the Keilarsbrae filters, which were still serving the houses in the lower part of Sauchie.

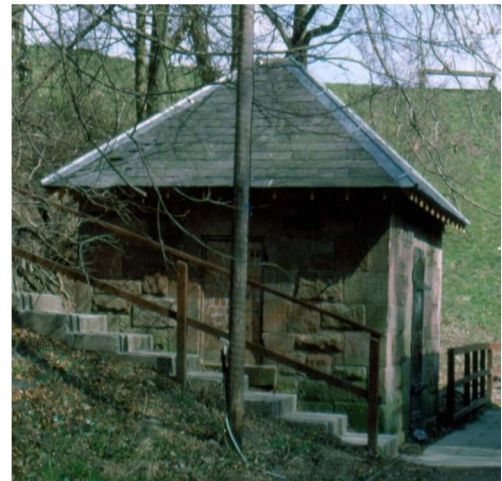
Figure 135. Water House.

The pipeline from the tower entered the water house and was sent in three directions. A cast iron pipe took water to the Jellyholm filters. Water was supplied under pressure to drive the turbine in the adjacent pump house, with some of the flow pumped up to the settling pond. Lastly, water was directed down the Upper Gartmorn lade to supply the filter beds at Keilarsbrae, the Watermill pit and the Carsebridge distillery.

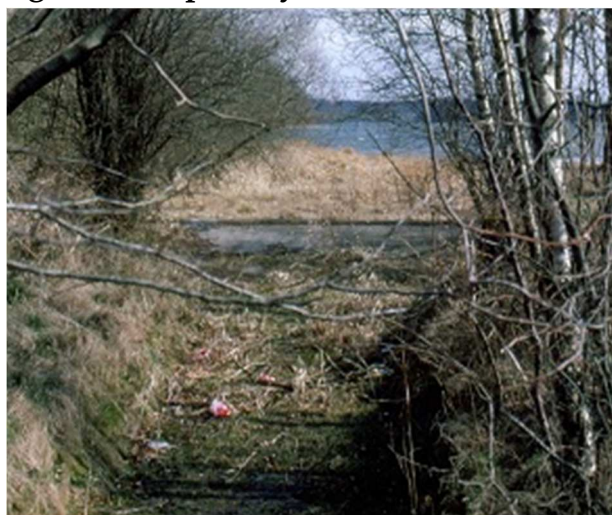
Figure 137. Spillway.

The spillway channel went underneath the two cast iron supply pipes leading from the water house at the dam to the filters at Jellyholm.

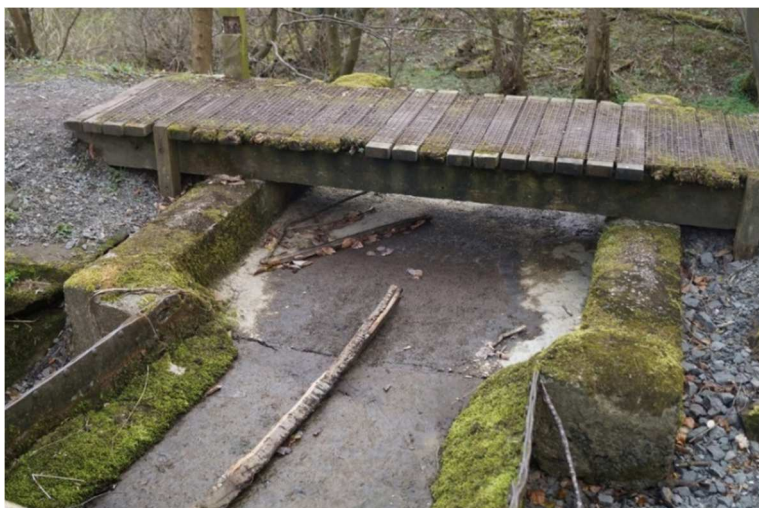
Figure 139. Spillway crosses the lade.

The water from the spillway channel was carried across the Upper Gartmorn lade in a stone, concrete and metal trough. The lade is supported at this point by a stone wall which is starting to collapse. A modern wooden bridge carries the lade side path across the channel. This path is one of Clackmannanshire Council's core paths.

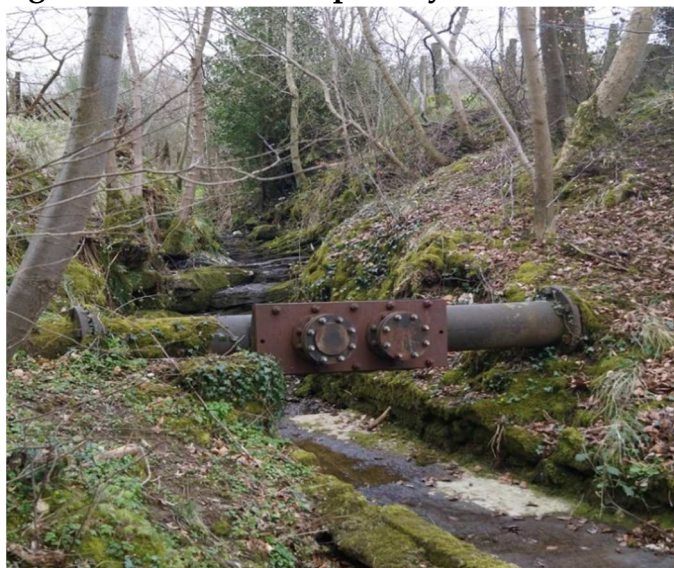
Figure 138. Bottom of spillway channel.

In 1892, a new overspill and channel was built at the northern end of the dam, connecting into the Brothie burn downstream.

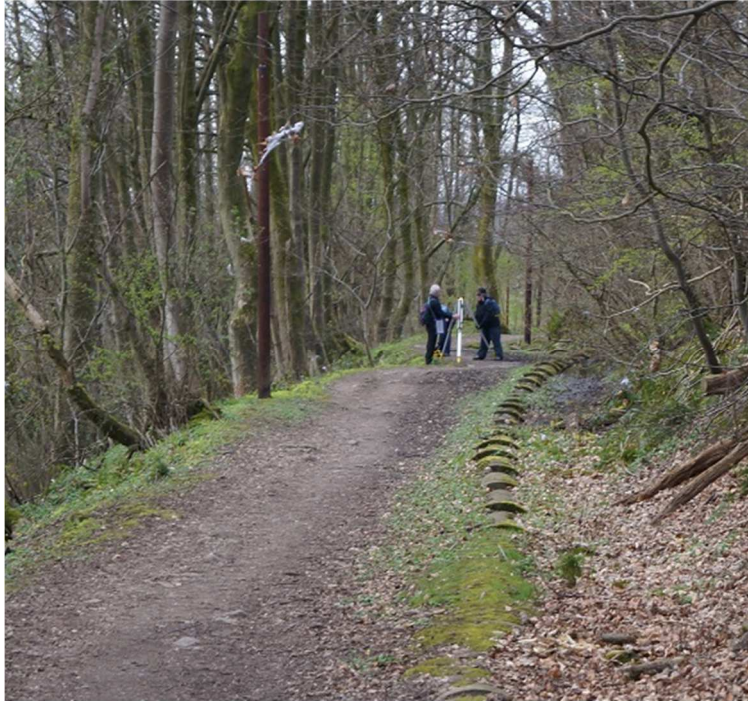
Figure 140. Upper Gartmorn lade.

The Upper Gartmorn lade followed the line established circa 1690 when the 6th Earl of Mar used the water from the small earthen dam across the Brothie burn to power his drainage engine at the Alloa colliery pit at Holton. The Brothie burn lies to the left in this photograph [NS 91223 93051]. The slight depression of the lade can be seen on the right. The 10 inches (25.4 cms) cast iron pipe taking water from the dam to the Jellyholm filters was set in to the bank to the right of the lade. The concrete pipe was added when the new Jellyholm filters were built.

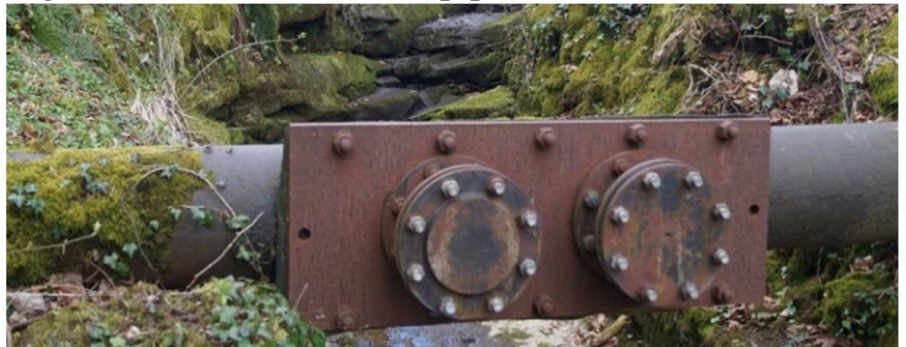
Figure 141. 10 inch (25.4 cms) pipe.

The 10 inch (25.4 cms) supply pipe to the filters installed in 1867 can be seen crossing the spillway channel [NS 91090 93896]. By 1898 the Jellyholm filters had had a much larger water house added, which, in 1909, was reported as holding 550,000 gallons (2,500,350 litres), representing half of an ordinary day's supply to the burgh at that time. ⁽⁹¹⁾

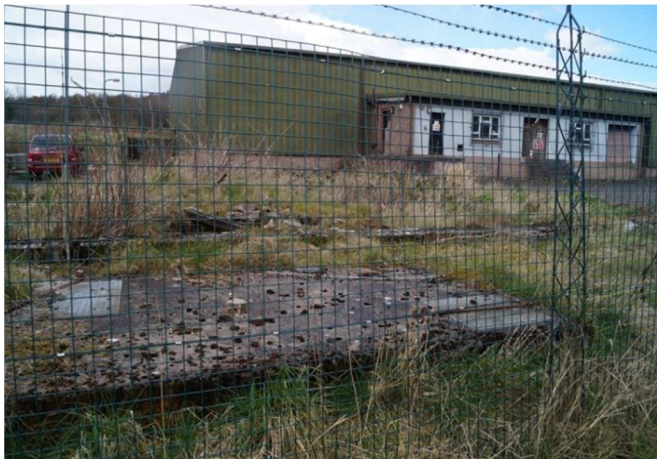
Figure 143. Remains at Jellyholm.

In 1975 responsibility for Gartmorn dam was assumed by Central Region Council. The slow sand filters were replaced by a new building with mechanical filters [NS 90963 93825] in the late 1970's. ⁽⁹⁶⁾ Following an outbreak of algal bloom in the early 90's, a second filtration system and new filter house was added in 1994 [NS90893 93809] by Central Regional Council (completed by East of Scotland Water) at a cost of £2.5 million. ⁽⁹⁷⁾

Following pollution in 2004 from an open cast coal mine near Forestmill [NS 967936] the filtration systems at Jellyholm were choked and the filters were decommissioned in 2005 ⁽⁹⁸⁾ and the site was finally sold off in 2006. ⁽⁹⁹⁾ The original filter beds were finally filled in in 2011 ⁽¹⁰⁰⁾ and only the tops of some of the outside walls are still visible, together with the access points for the distribution pipes [NS 909938].

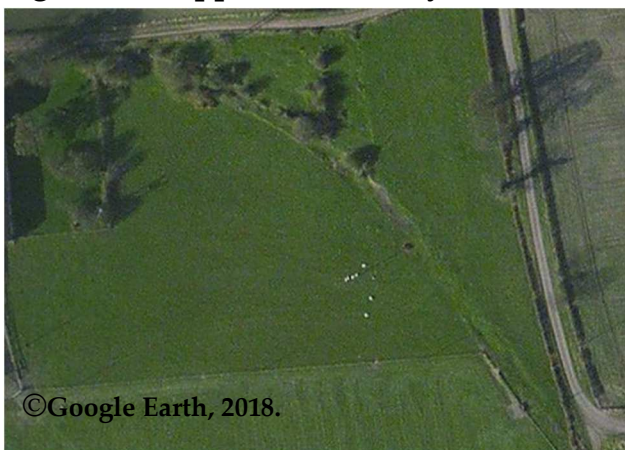
Figure 144. Upper lade to Jellyholm farm.

The Upper Gartmorn lade leaves the site of the Jellyholm filters and continues through a field to the West of the site [NS 90754 93893] to the edge of Jellyholm farm [NS 90608 93916]. The line is lost for a short distance, around the steading and farmhouse.

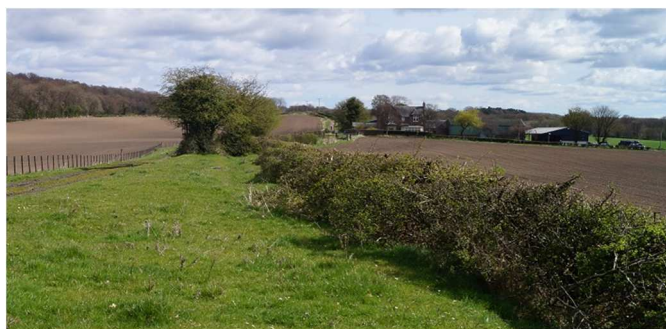
Figure 145. Lade from Jellyholm farm.

At the western edge of the farm the line of the lade reappears along a field edge as depression bordered by a hedge.

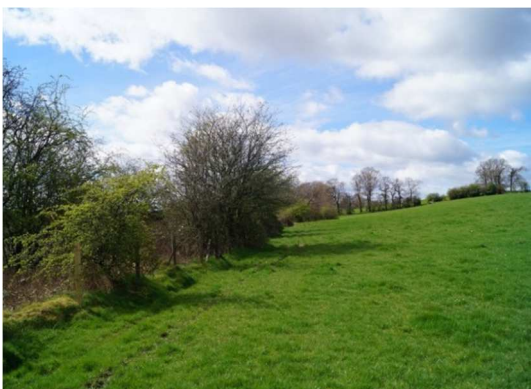
Figure 146. Running round Post Hill.

The remains of the lade can then be seen more clearly progressing along the northern slopes of Post Hill to the eastern edge of the old Keilarsbrae complex [NS 89623 93833]. Here it disappears under a modern housing development. Beyond this point, there is no trace of the Upper lade.

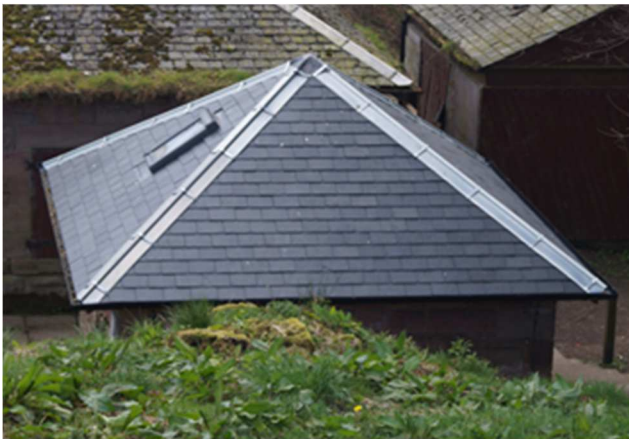
Figure 148. Water house re-roofed.

Scottish water has continued to make improvements to the safety and appearance of the dam and the surrounding area. In 2017 they re-roofed the water house and introduced drains to the area below the embankment of the earthen dam.

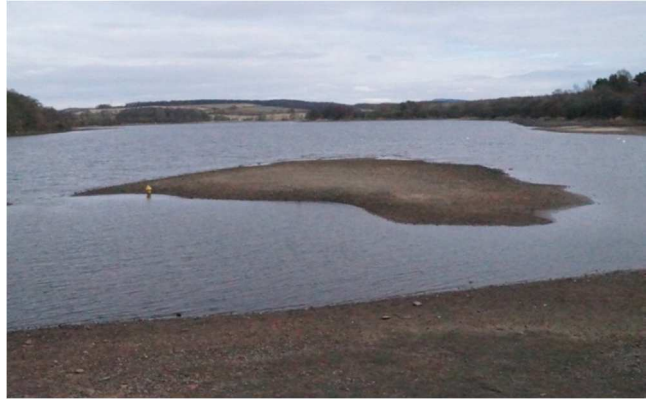
Figure 147. Dam level reduced.

Scottish Water now owns Gartmorn dam and the reservoir is redundant for the purposes of water supply, except for some cattle troughs at Jellyholm Farm. In 2013 they invested £440,000 draining water off the Dam and building a new platform and penstocks in the spillway to allow for emergency drawdown of the reservoir so that that if a reservoir breach is imminent then the penstocks can be opened to take the pressure off the dam and reduce the risk of flooding. ⁽¹⁰⁶⁾
