CAMBUSKENNETH BELL TOWER, STIRLING

A SURVEY OF MASONS' MARK'S 2015

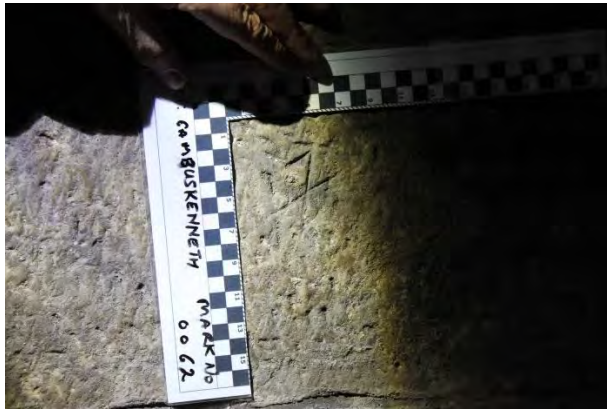
Mason 4 – Mark record 0062

The next group of masons used the number '7' or parallel lines as the basis of their mark, **Masons 4, 8, 20, 68 and 76**. **Mason 4** worked only on the ground floor where 6 of his marks were recorded. His mark is a simple 7 with a slash across the upright.

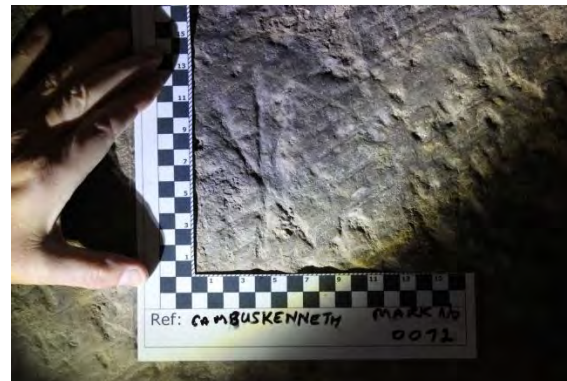
Mason 20 – Record mark 0072 on ground floor only.

Similar to Mason 4 but in reverse, so may be related.

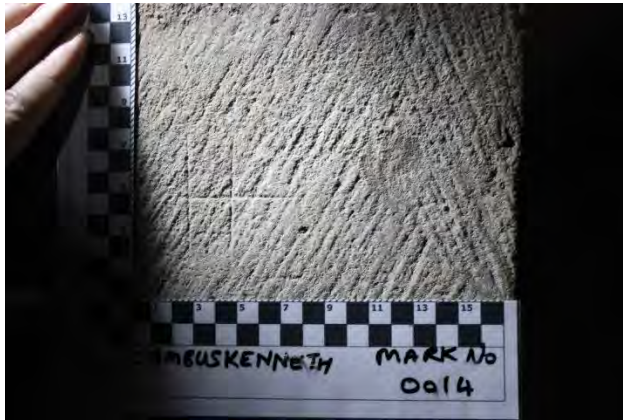
Mason 8 – Mark record 0014

Mason 8 only worked on the ground floor where 12 of his marks were recorded. His mark was two parallel lines with a horizontal from middle of one side across the other.

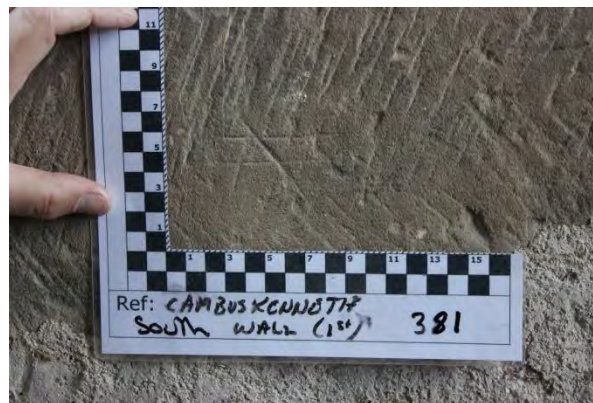
Mason 68 – Mark record 0381

Mason 68 had a similar mark as Mason 8, but the line across the parallel lines was on the diagonal and extended beyond both lines. Only one of his marks was recorded on the 1st floor.

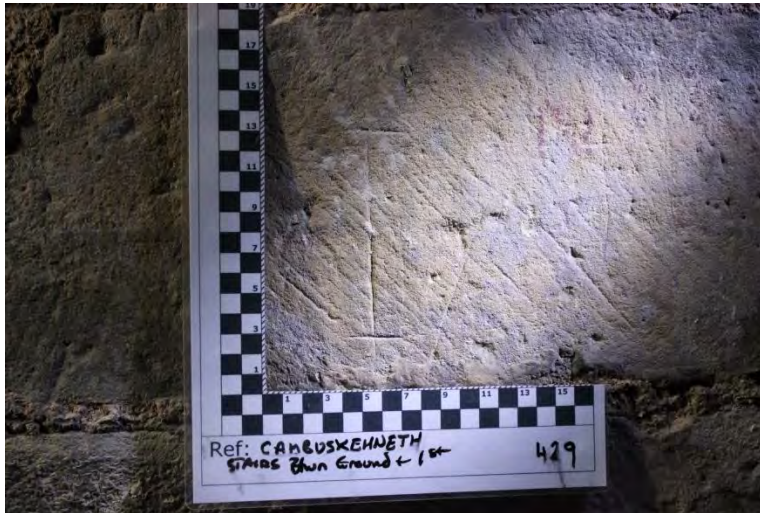
Mason 76 - Mark record 0429

Only two marks were recorded of **Mason 76**, who worked only the spiral stair and the area at the foot of the stairs. His mark is a single upright with two small parallel lines across it near the ends of the upright.

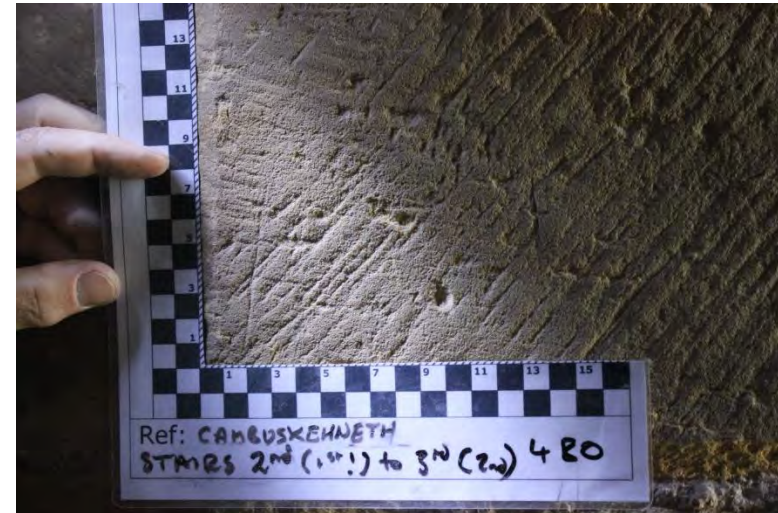
Mason 76 – Mark record 0480

Later scoring on the block of record 0480 made it more difficult to distinguish the mark clearly but the mark was allocated to this mason as it appeared similar enough to be his.

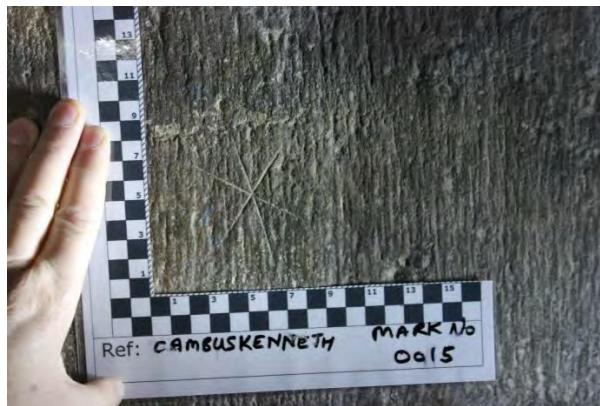
Mason 6 – Mark record 0015

Mason 6 chose 3 straight lines crossing each other in the centre forming a simple asterisk.

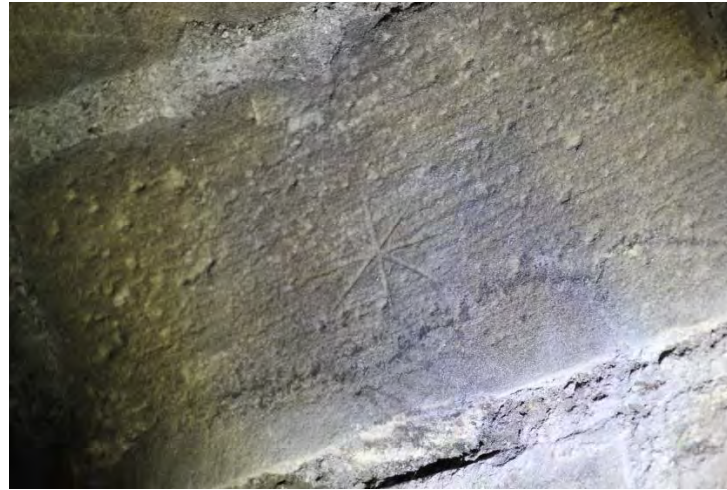
Mason 22 - Mark record 0144

A George Cross with a St Andrews cross superimposed formed the mark for **Mason 22**.

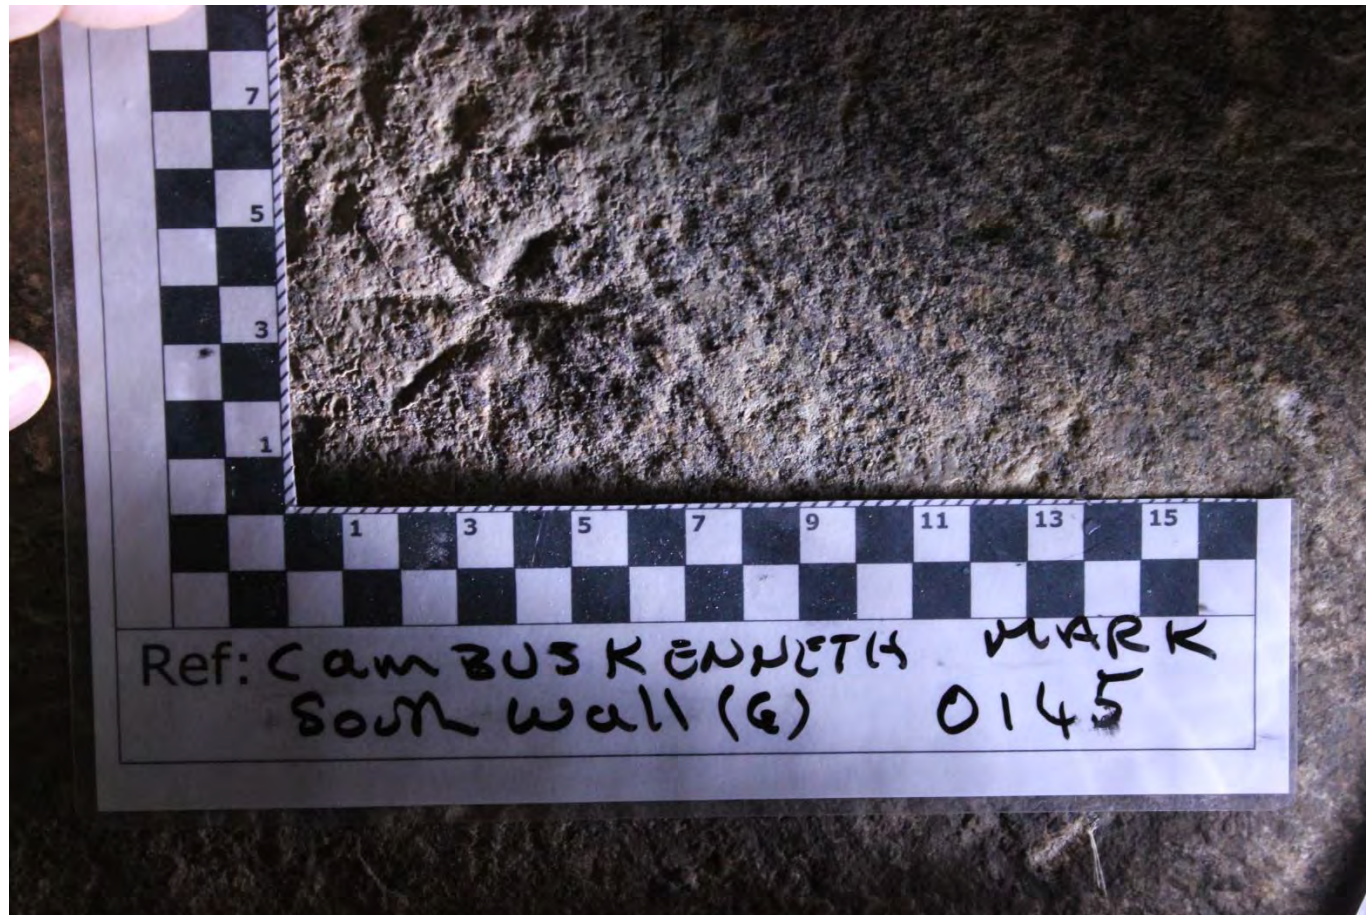
Mason 27 – Mark record 0145

Only one mark was found of **Mason 27** on the ground floor. His mark is very similar to Mason 6 but has an extra line inserted on one side only. Again this may suggest some possible relationship with Mason 6.

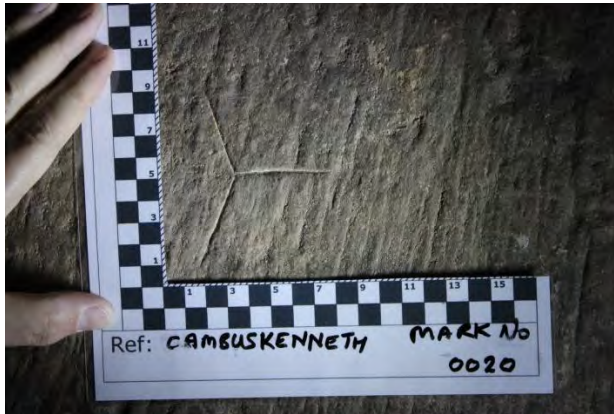
Mason 9 – Mark record 0020

Twelve masons used the shape of a letter Y or T as the basis of their marks. **These were Masons 9, 10, 11, 35, 37, 38, 40, 53, 55, 67, 70 and 77. Mason 9** worked on the ground floor only where 4 of his marks were recorded, this being a simple Y shape.

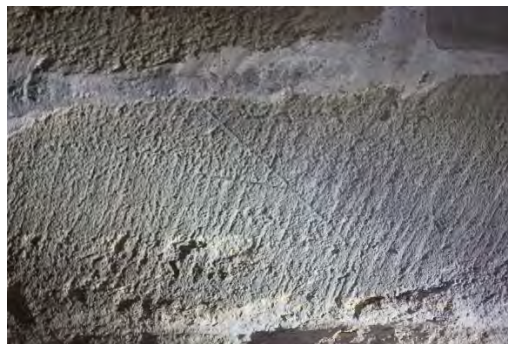
Mason 53 – Mark record 333

Mason 53 had a similar mark but less wide spread as Mason 9. He only worked on the 1st floor where 3 of his marks were recorded.

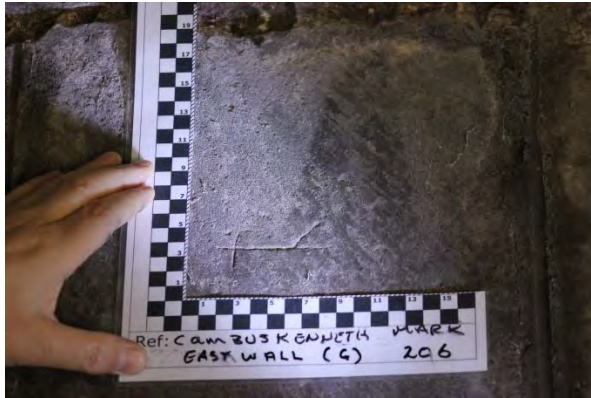
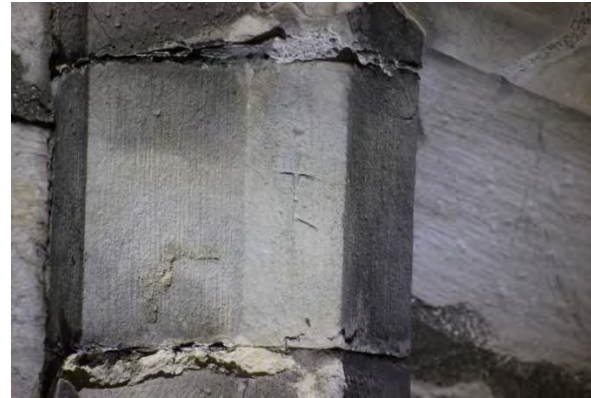
Masons 10 & 11 only worked on the ground floor, on both the walls and the ribbing of the roof vault. Both have a very similar mark to each other but in reverse. It is a small Y with a cross bar on the leg. **Mason 10** has 27 marks recorded and **Mason 11** with 20 marks recorded. Due to the similarity of their marks it is most likely that they were related in some way, or had been trained by the same Mastermason.

Mason 10 – Mark record 0206

Mason 10 – Mark record 0250

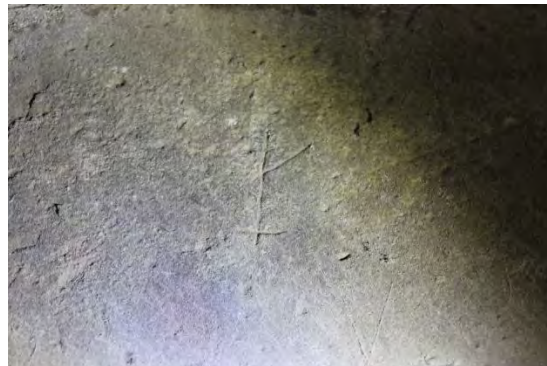
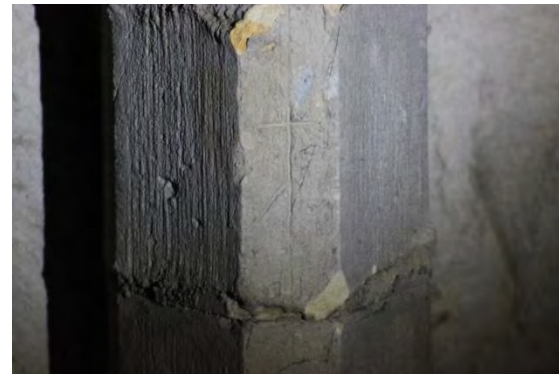
Mason 11 – Mark record 0208

Mason 11 – Mark record 0252

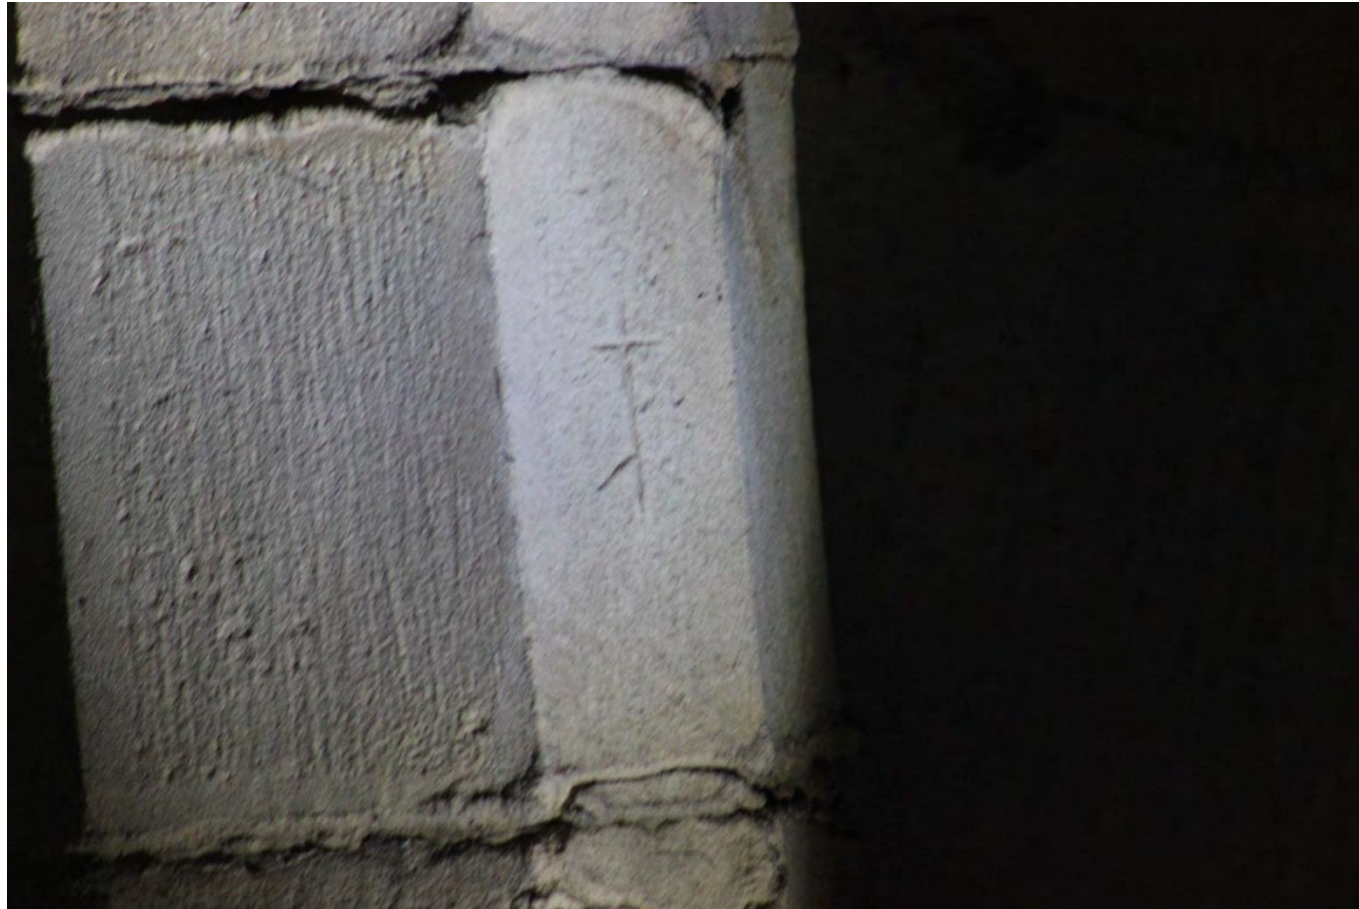
Mason 40 – Mark record 0293

Also similar to the marks of Masons 10 and 11 is that of **Mason 40**, who only worked on the ribbing of the roof vault. However, only one example of his mark was recorded. His mark is very similar but with an extra kick, or leg, added to the side, giving a sort of '3-legged cross' shape.

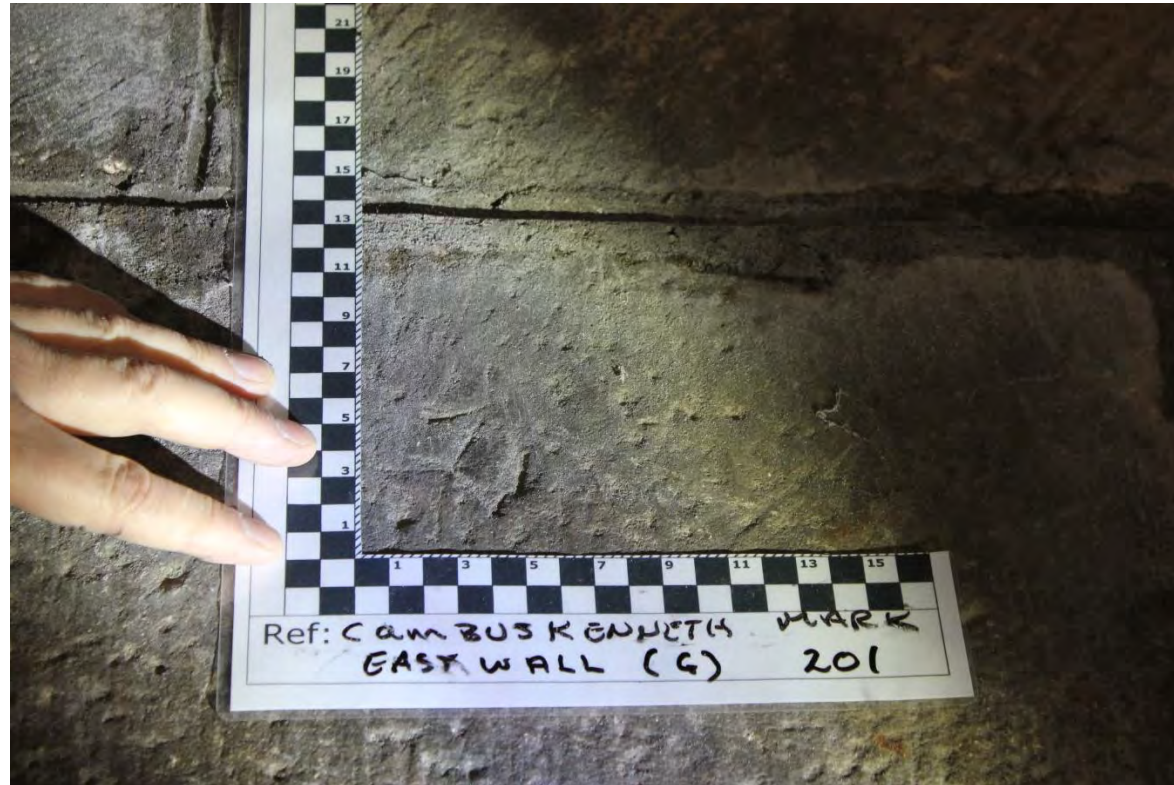
Mason 35- Mark record 0201

Another mason with only 1 mark recorded on the ground floor is **Mason 35**, who also has a slightly similar mark to Mason 40, in that it had '3 legs'. However the extension from the legs forms more of a 7 than a cross. Unfortunately the mark was not a really clear example of his mark.

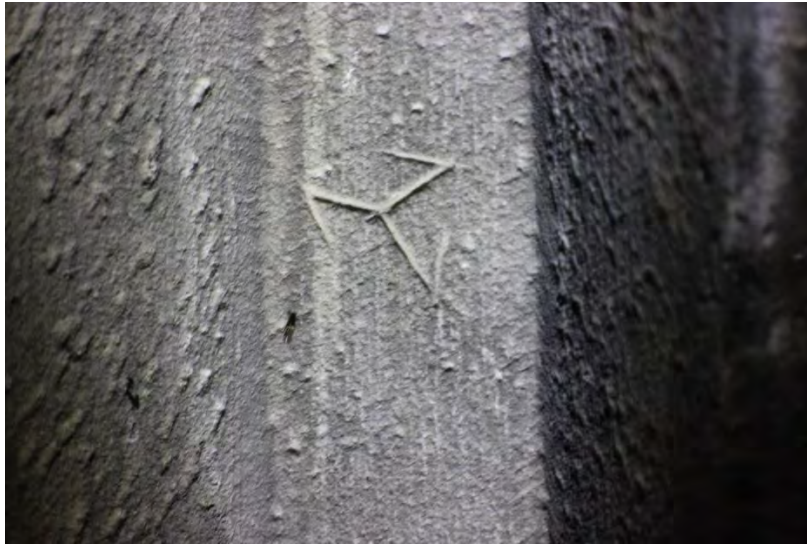
Mason 37 – Mark record 0238

Two masons who worked only on the ribbing of the roof vault of the ground floor are **Mason 37** and **Mason 38**, of which 25 marks were recorded of the former and 17 marks of the latter. Again these masons appear to be related in some way as each is a reverse of the other.

As can be noted, while the central Y-shape is similar, the arms point in a different direction, forming basically a mirror image. This has been noted on a number of previous marks, such as Masons 10 and 11.

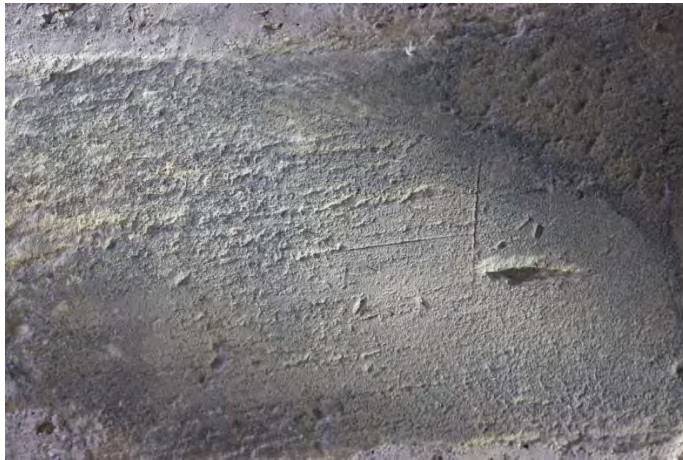
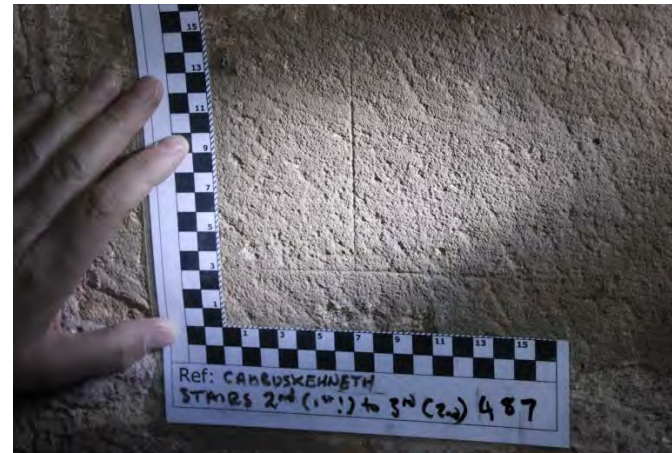
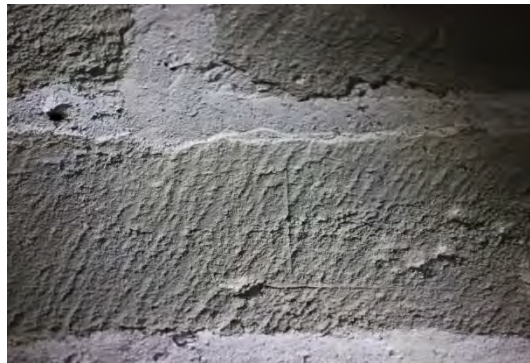
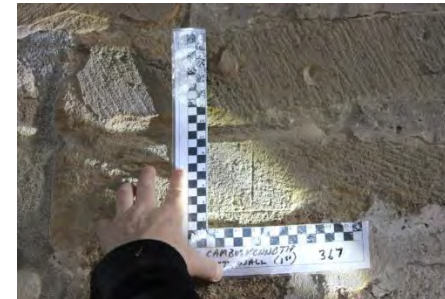
Masons 55, 67, 70 and 77 base their marks on the letter T. All worked on either the stair or the 1st floor. **Mason 55** keeps the basic shape of the letter as his mark, of which 17 examples were recorded on both the 1st floor and the spiral stairs.

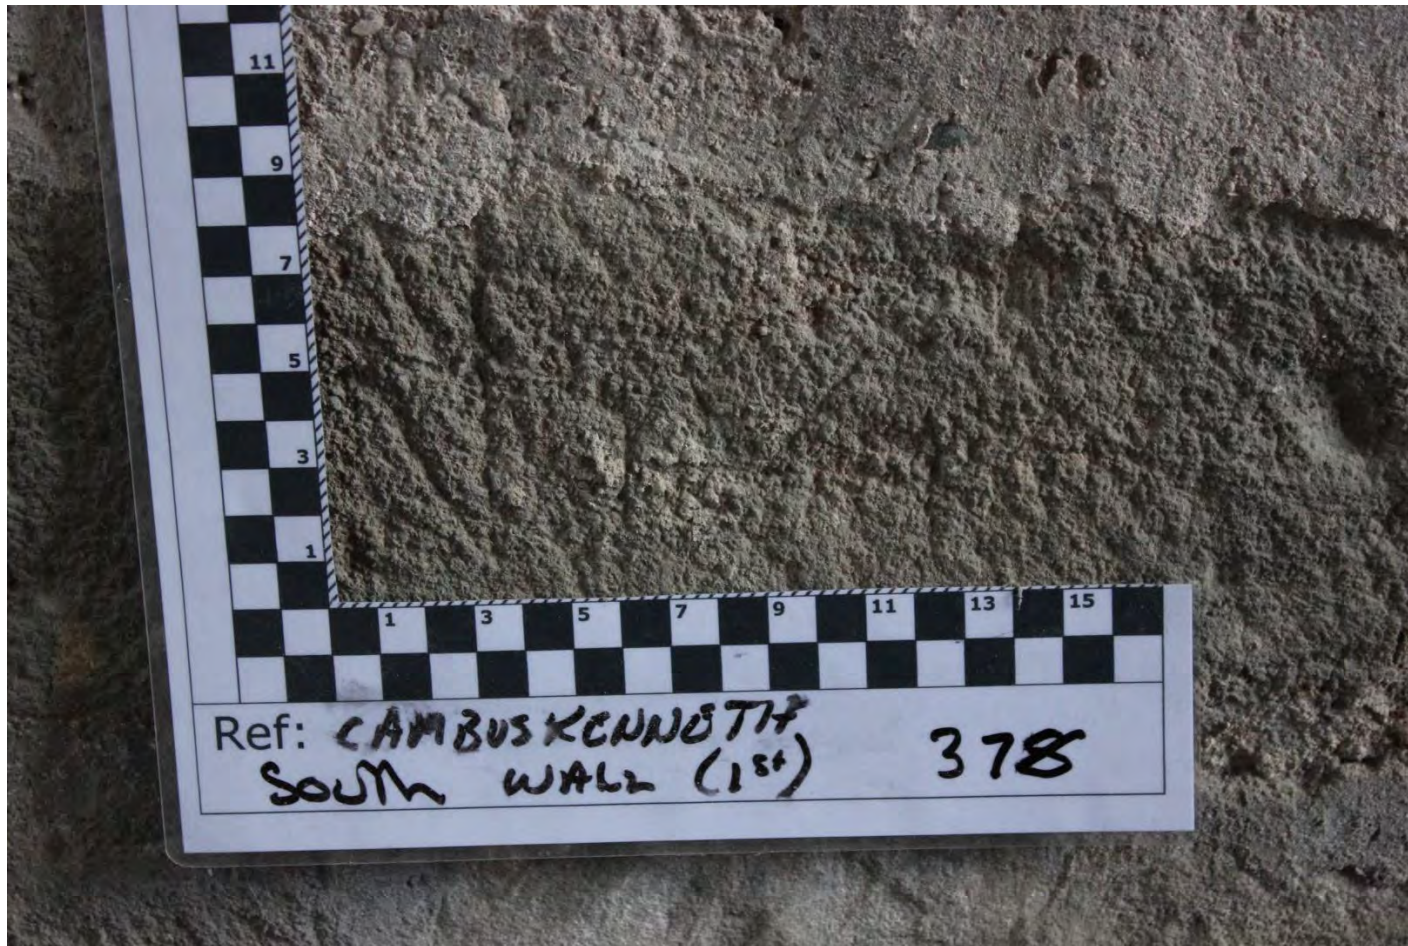
Mason 67 – Mark record 0378

Only two examples of the mark of **Mason 67** were found on the 1st floor and unfortunately neither is particularly clear. The one below was on a block with another possible different mason's mark on it. His mark is faint but shows a letter T on its side with an angled leg from it.

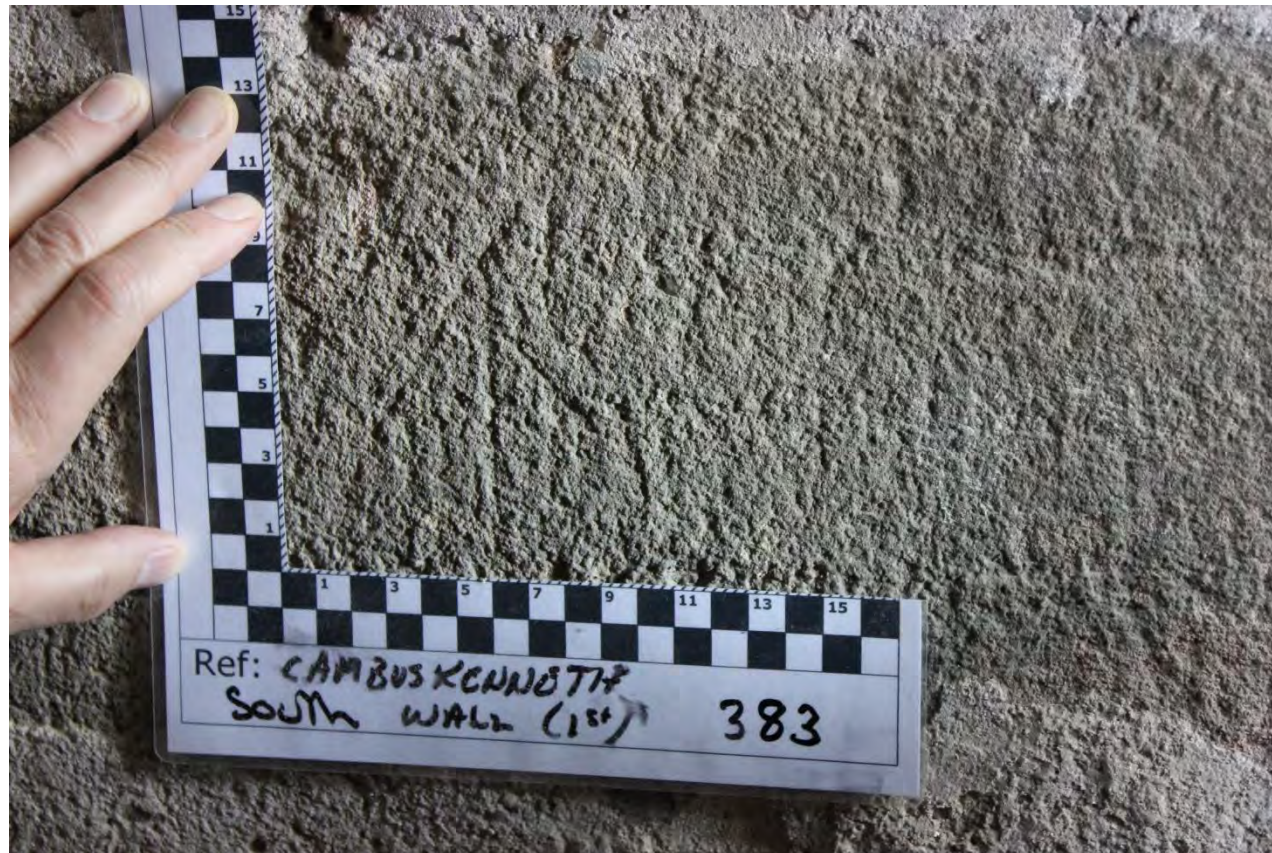
Mason 70- Mark record 0383

Only one mark was found of Mason 70 on the 1st floor. Its shape is very close in style to Mason 67 but the T is more angled. There is of course a possibility that this is actually the same mason but just cut his mark slightly different for some reason.

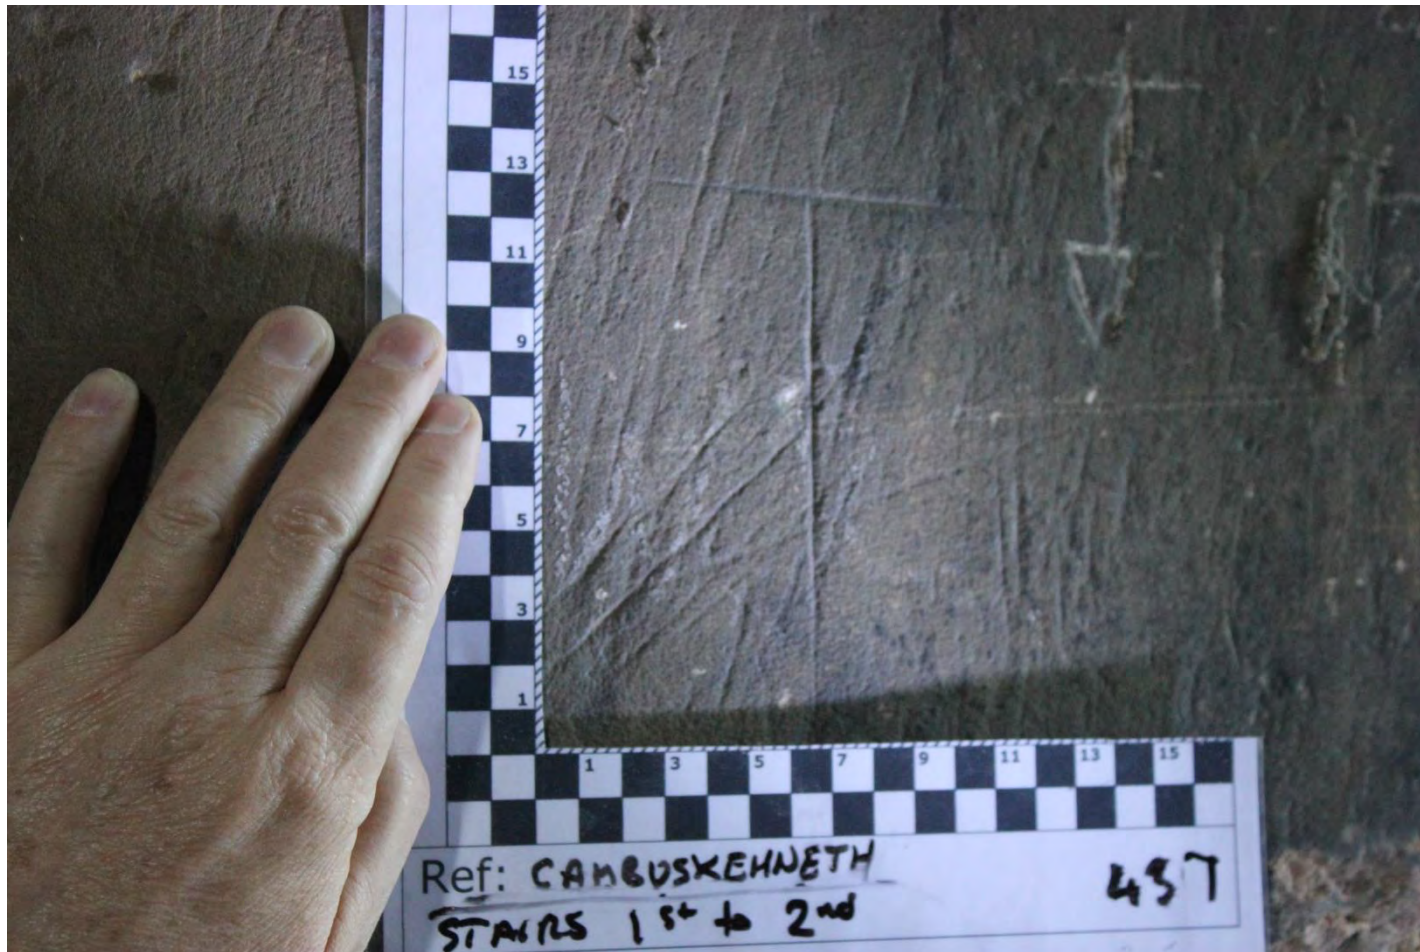
Mason 77- Mark record 0437

Mason 77 only worked on the stairs where two of his marks were recorded. He also uses the letter T but adds 3 parallel diagonals to the left side of the upright. There are also two later marks cut into the same block.

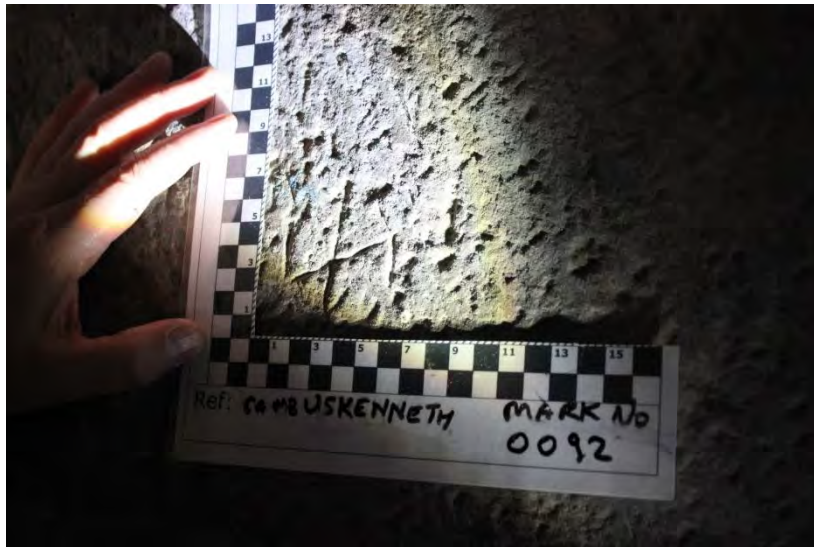
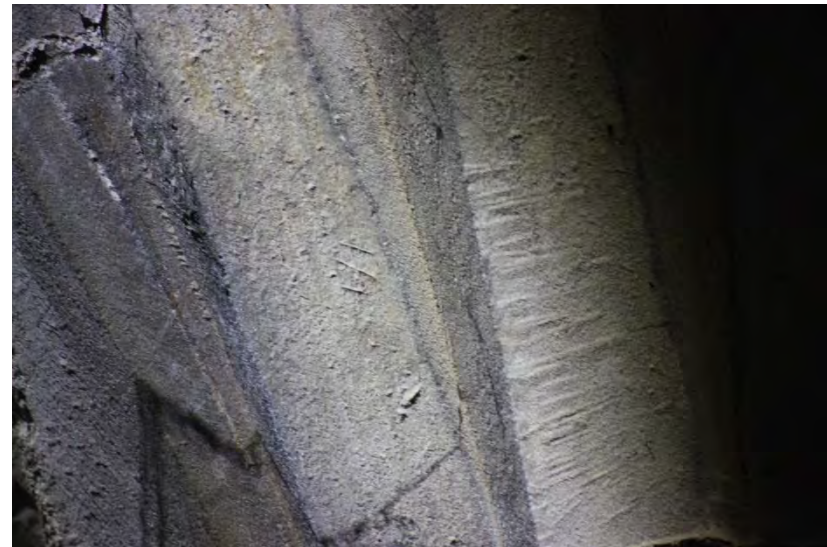
Mason 16-Mark record 0092 Mason 16-Mark records 0279 on the rib of the vault

Mason 16 only worked on the ground floor where 9 of his marks were found on the walls, at the base of the stairs and on the ribs of the roof vault. His mark is a back-to-front Z with a slash across the middle.

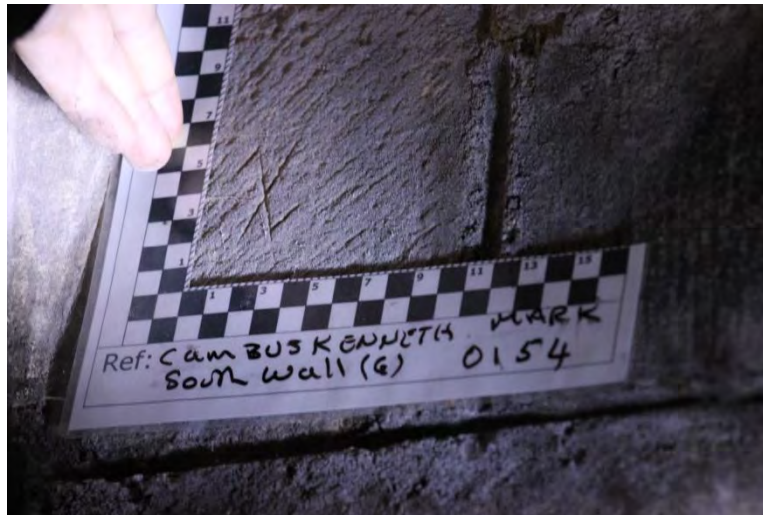
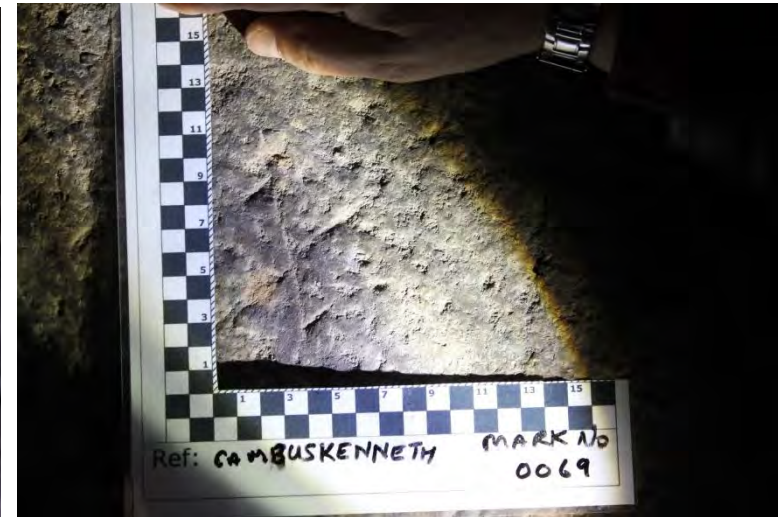
Similar to **Mason 16**, but a mirror image, is **Mason 19** worked on the ground floor and the 1st floor with 10 marks recorded.

Mason 19- Mark record 0154

Mason 19-Mark record 0069

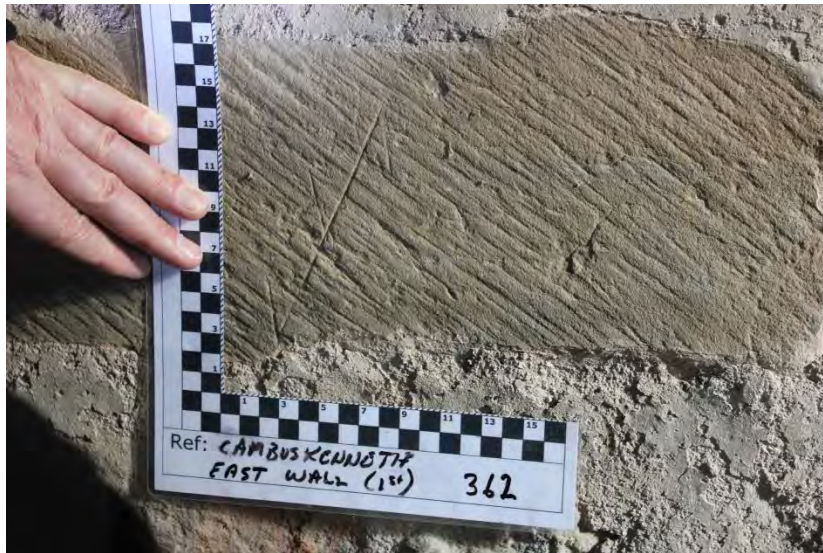
Mason 62- Mark record 0362

Two other masons used a similar mark with a narrower Z and only half a bar starting from the central line. These were **Mason 62** and **Mason 65**

Again these were mirror images of each other. Both worked on the 1st floor with Mason 62 also working on the stairs. Thirteen marks were recorded of Mason 62 but only one of Mason 65.

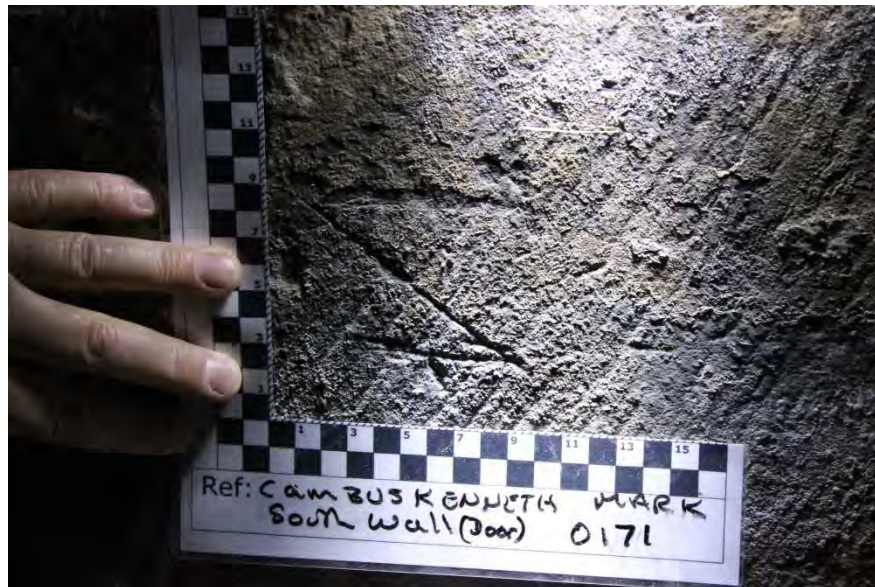
Mason 24-Mark record 0171

Two masons had a simple N for their mark but again mirror images. **Mason 80** used an N while **Mason 24** used it in reverse. Only 2 marks of **Mason 80** were recorded on the stairs, whereas **Mason 24** worked on the ground floor, 1st floor and the stairs with 4 marks recorded.

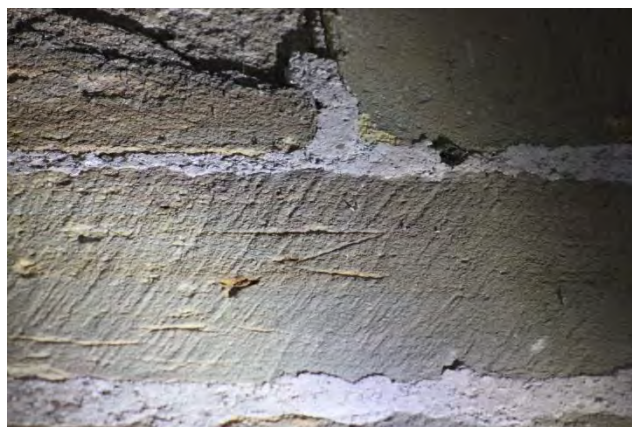
Mason 56- Mark record 0345

Three other **Masons**, **56**, **58** and **26** also used the letter N but each extended a leg. Two of them **Mason 56** and **Mason 58** were mirror images of each other but **Mason 26** added a line across the extension, making a cross. **Mason 26** only worked on the ground floor where two of his marks were recorded. Both **Masons 56 & 58** worked on the 1st floor only, where five marks were recorded of **Mason 56** and three marks of **Mason 58** (see below).

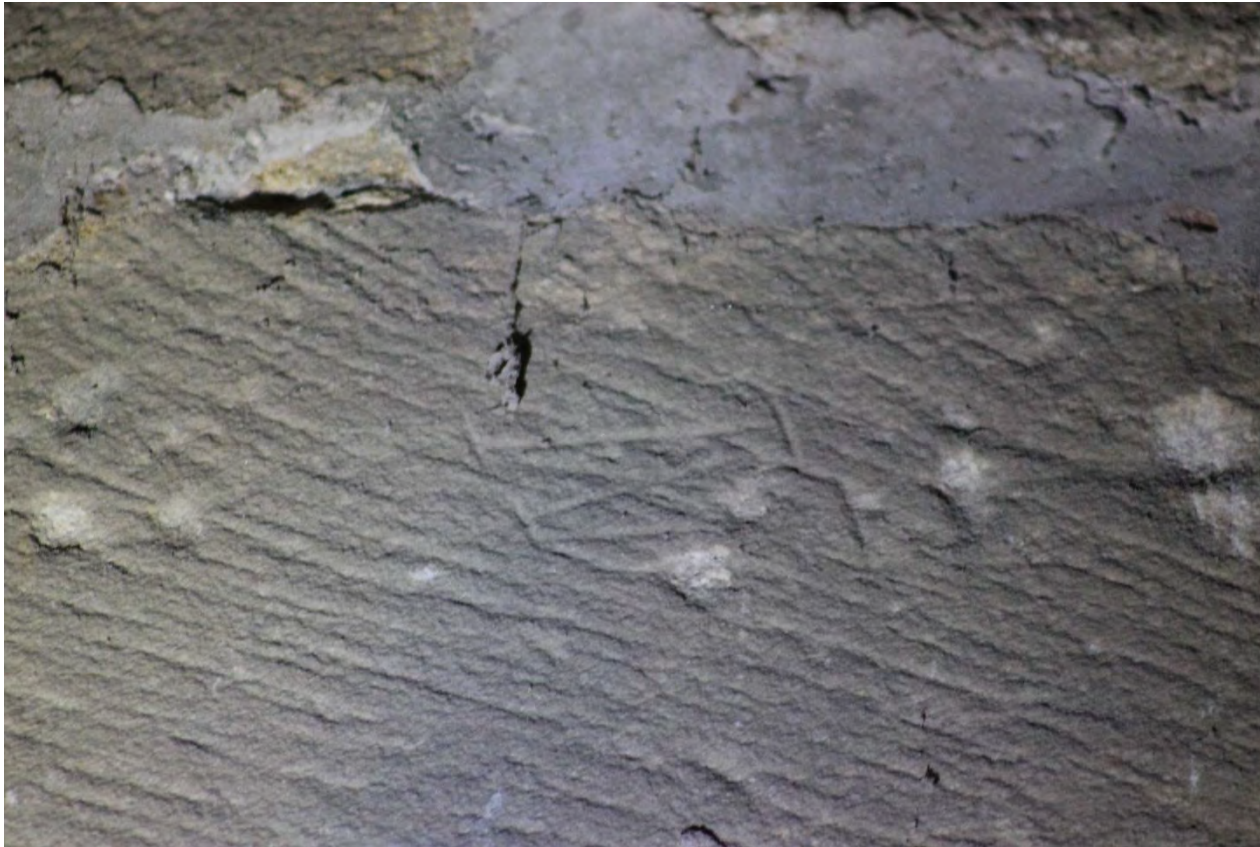
Mason 71 – Mark record 0408

One other mason, **Mason 71**, appeared to use the letter N but with short lines across at either end of the verticals. However, given the similarity to Mason 82 they may in fact be the same but one line may not be quite as visible as the others. Only one mark of Mason 71 was recorded on the 1st floor where as 82 was found on the stair.

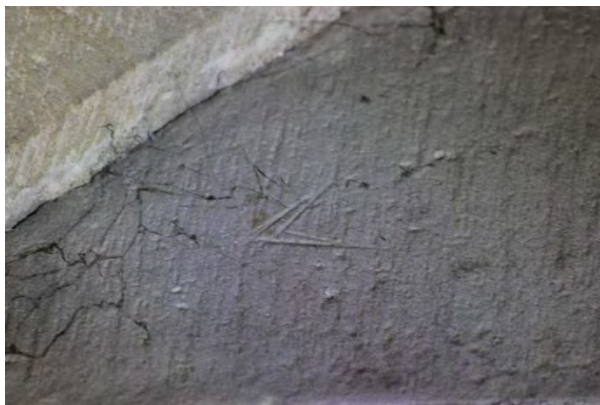
Mason 12 – Mark record 0041

Mason 12's mark is a double V joining at the top of the legs, whereas Mason 44 has a simple thin V. Mason 73's mark is a V with one side having a double line forming another V within.

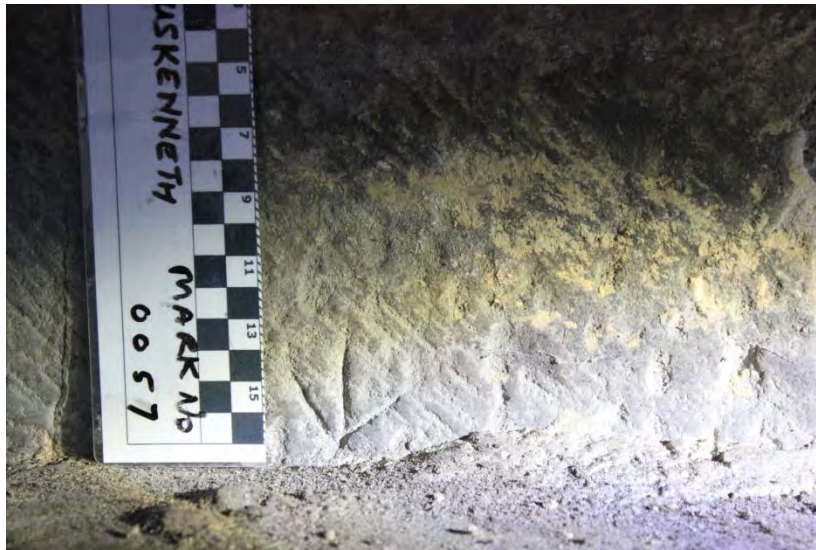
Mason 18 – Mark record 0057

Mason 18 had a simple 3-line arrowhead, whereas **Mason 28** joined the two outer lines to make a triangle.

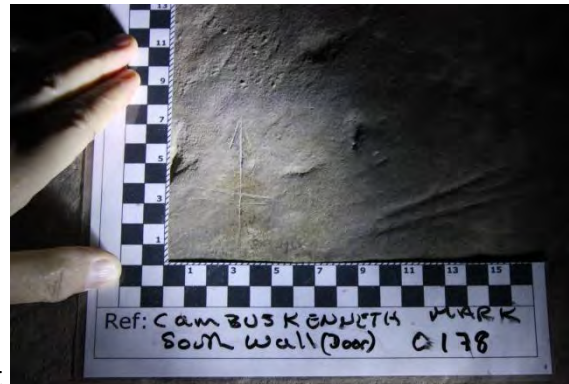
Mason 32- Mark record 0178

Mason 32 had a simple arrow with a bar across the shaft

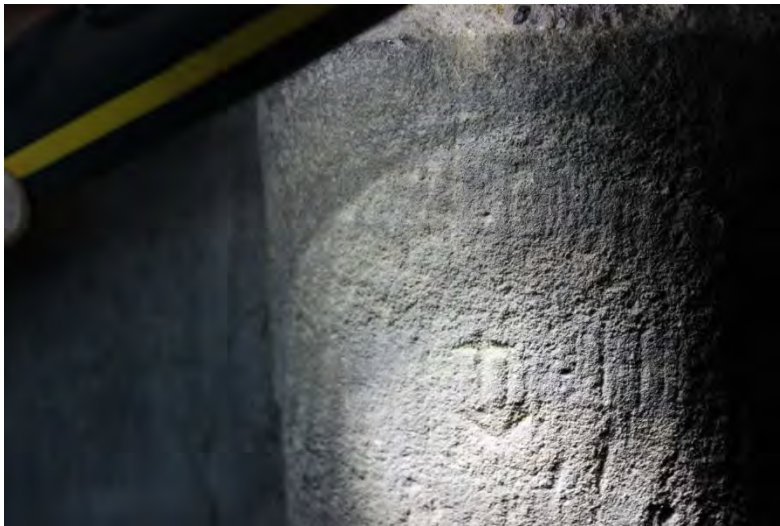
Mason 69- Mark record 498

Mason 69's mark was a triangular arrowhead with a shaft & crossbar. Mason 81 an arrowhead with a cross bar on the shaft and a V overlying the arrowhead.

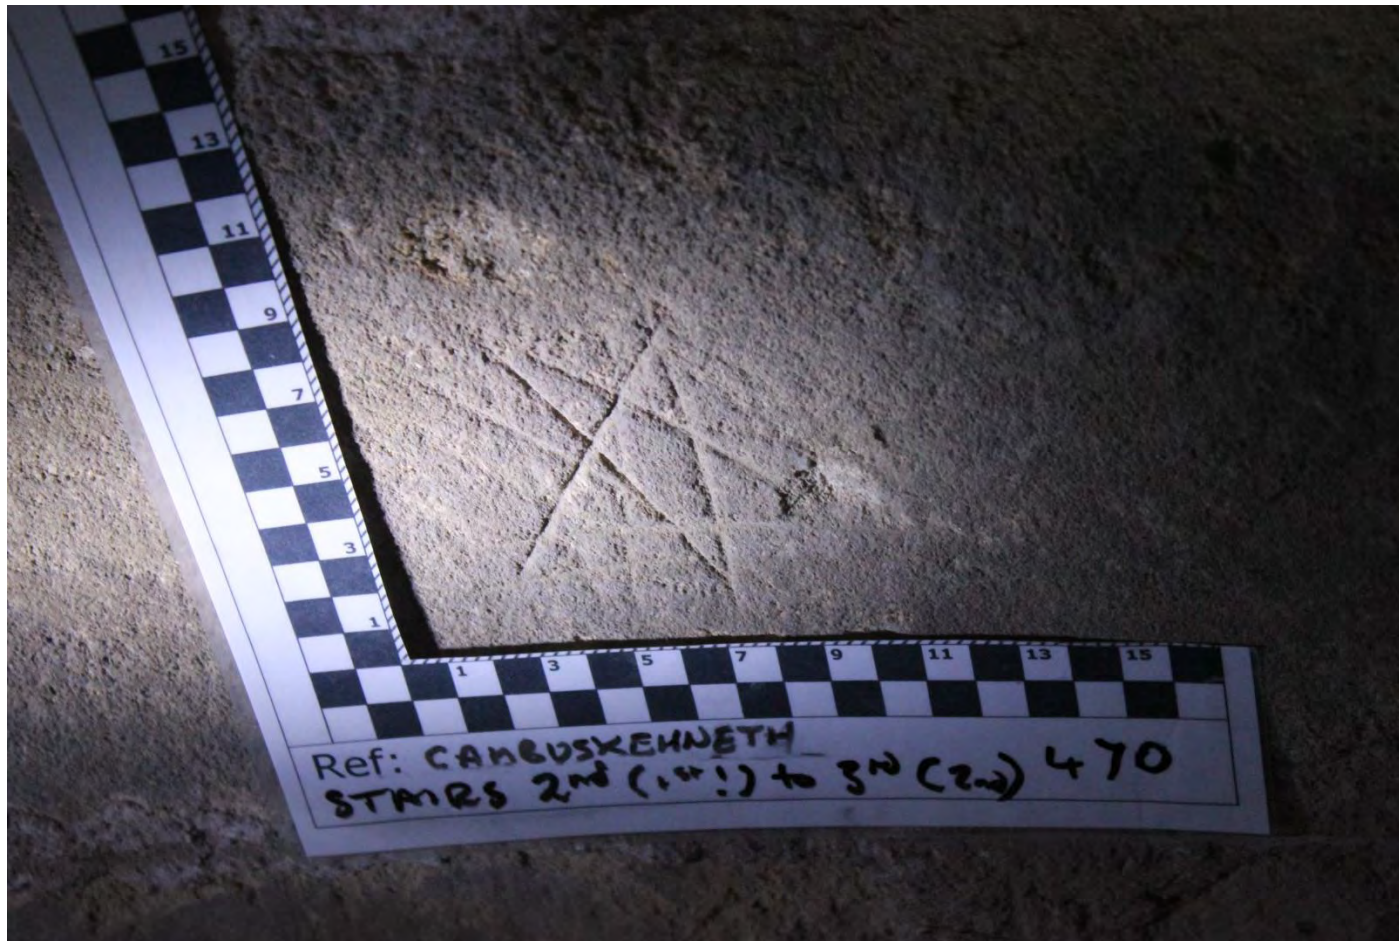
Mason 45 Mark record 0470

Only one mason used a star shape for his mark. This was mason 45 who worked on the stairs and 1st floor, with 15 of his marks recorded.

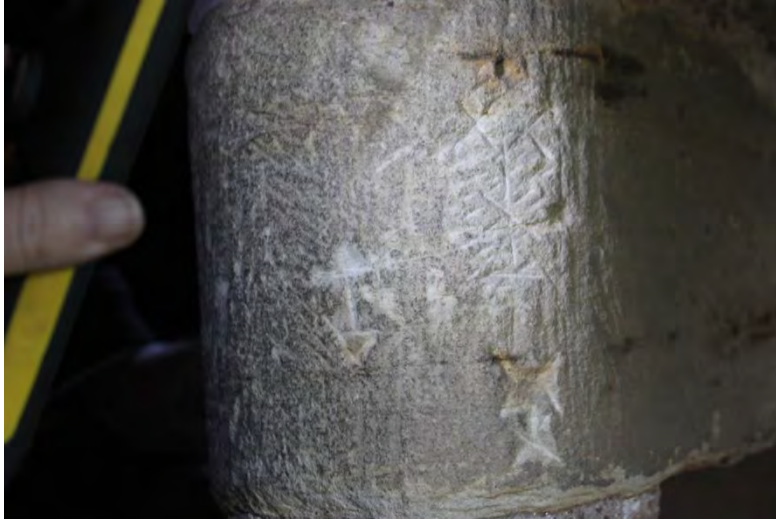
Several blocks bear more than one mark such as that with 15, 69 & 72 which is found on the newel of the stairs.

On newel of Stair (15, 69, 72)

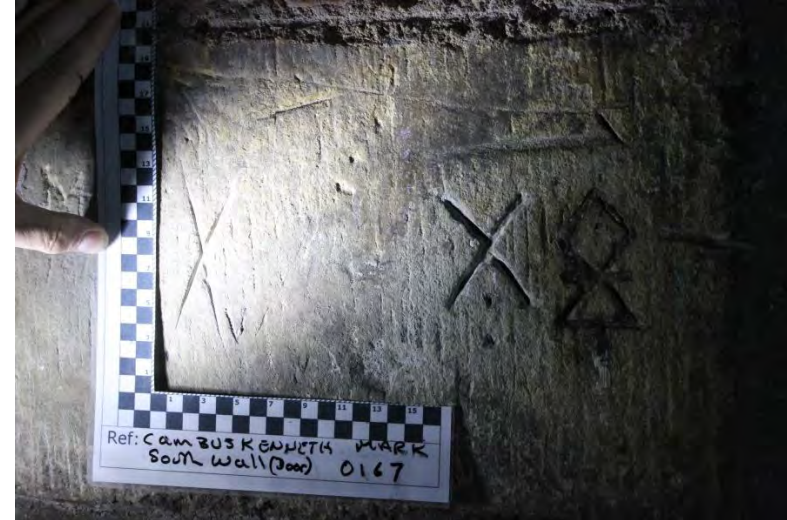
Ground floor North wall (7, 29, 30)

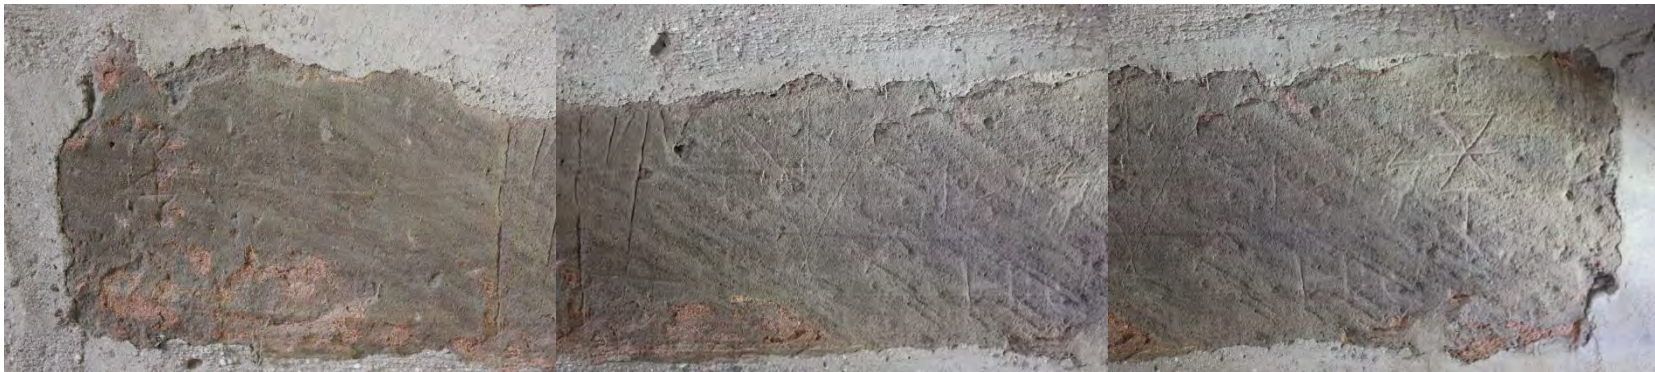
This block has at least four marks, some of which are older than others, as well as other indistinct marks & graffiti, noted on the wall of the 1st floor.
