CAMBUSKENNETH BELL TOWER, STIRLING

A SURVEY OF MASONS' MARK'S 2015

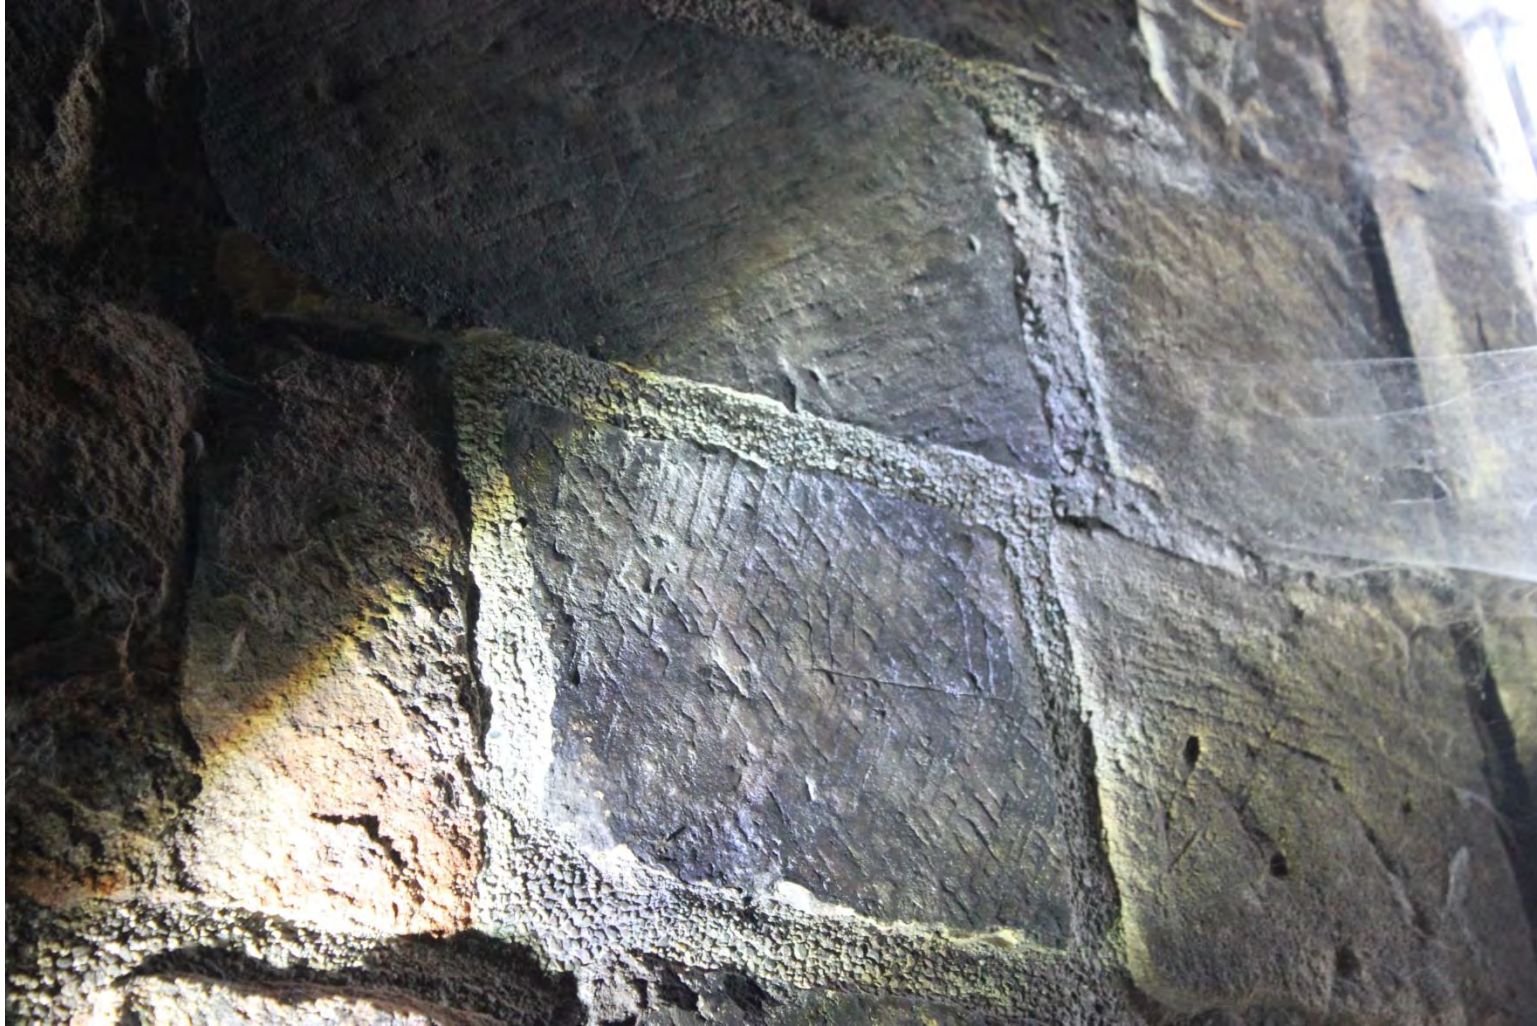
Two features were recorded are possible building instructions from the Mastermason. One, which was given a mark number (23), is most likely to be instructions on how the window was to be built, as it was noted on the left window recess of the North wall on the ground floor.

Instructions? Originally recorded as Mason 23 – Mark record 0120

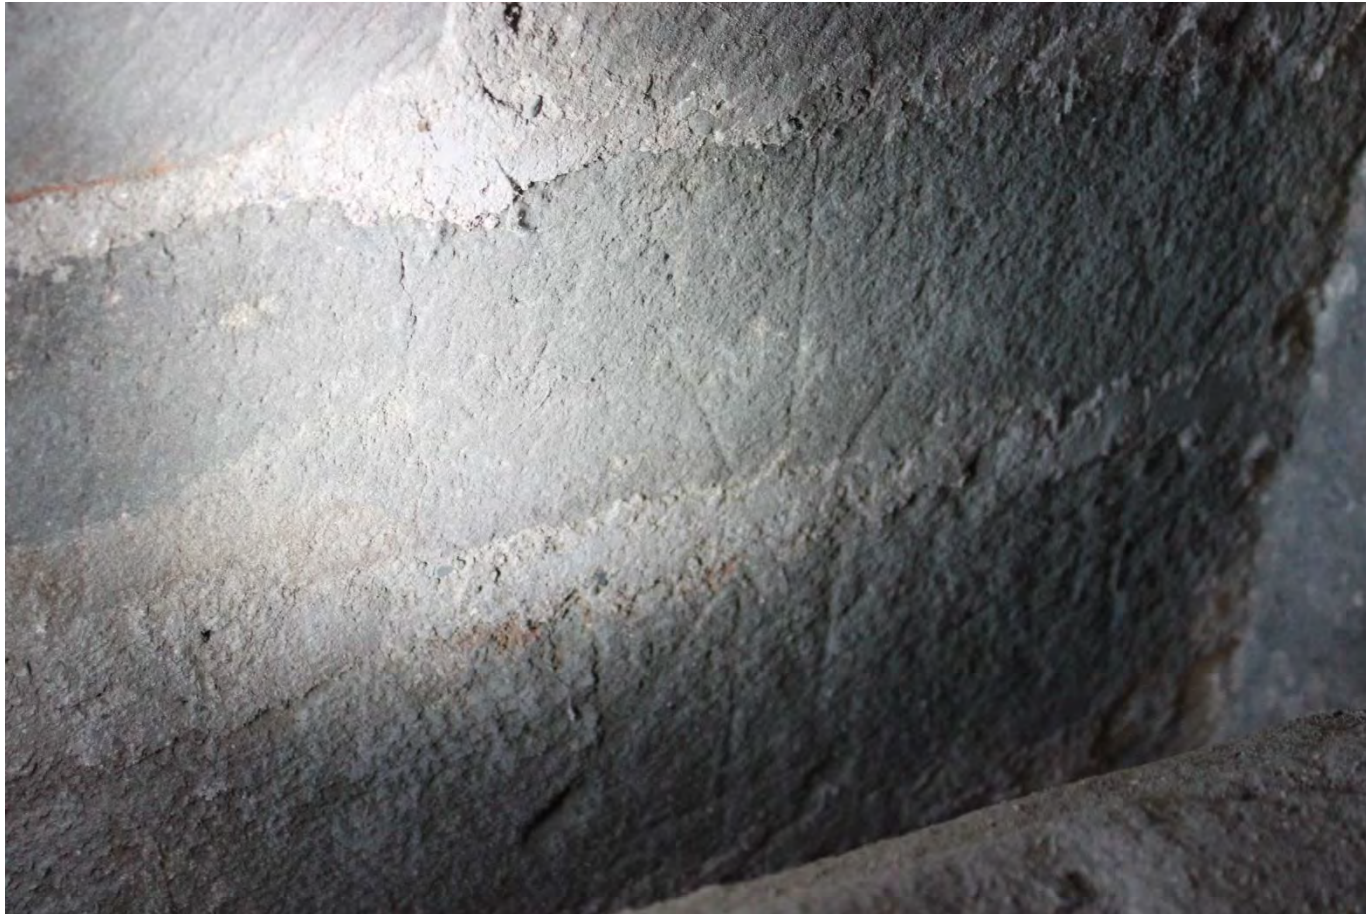
Photo 1514

The other possible Builders mark was found in the corner of the 1st floor, although it may simply be coincidence that 2 similar marks are pointing towards each other. They could however be an instruction on how to lay the two blocks.
